# **Verde River Navigability**

**Presentation to ANSAC**

**Bob Mussetter, Ph.D., P.E.**

**February 2015**

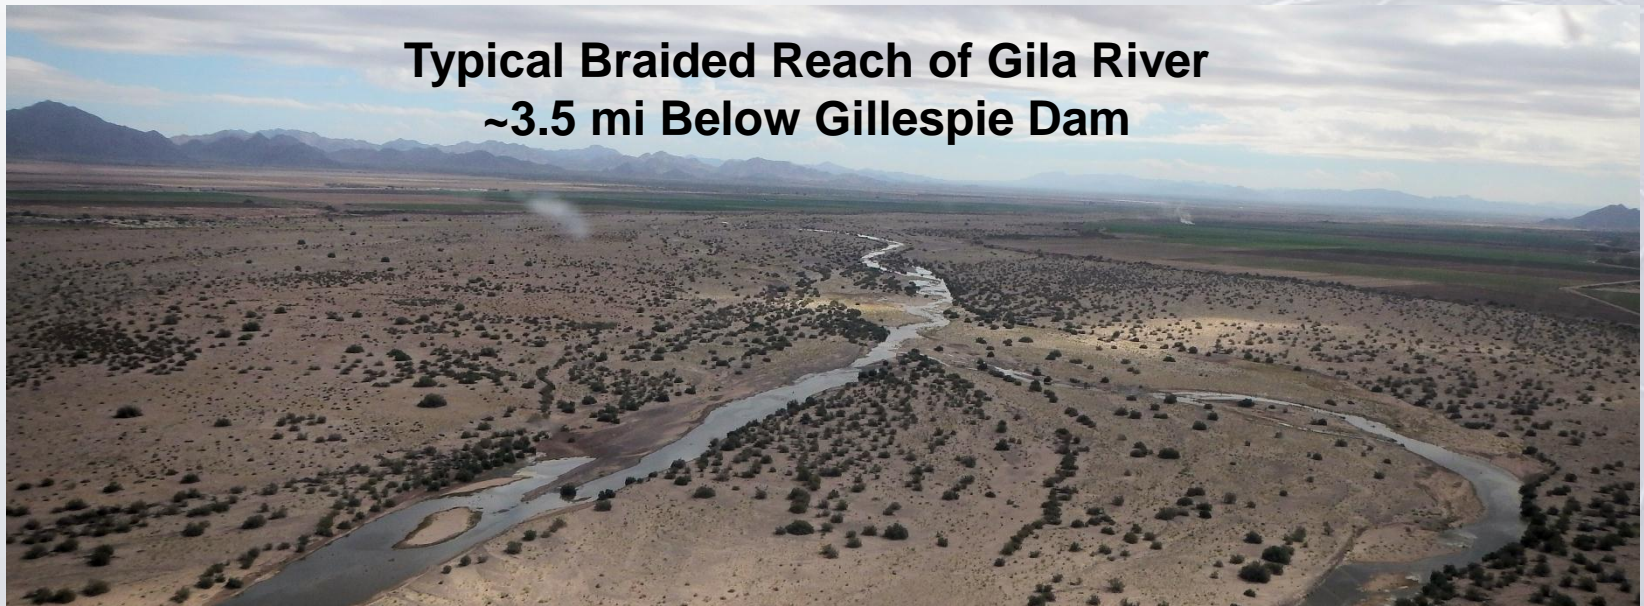
# Channel Pattern IS Relevant to Navigability

- Braided channels:
  - Wide, shallow cross section
  - Multiple, unstable (i.e., shifting) channels
  - NOT conducive to boating

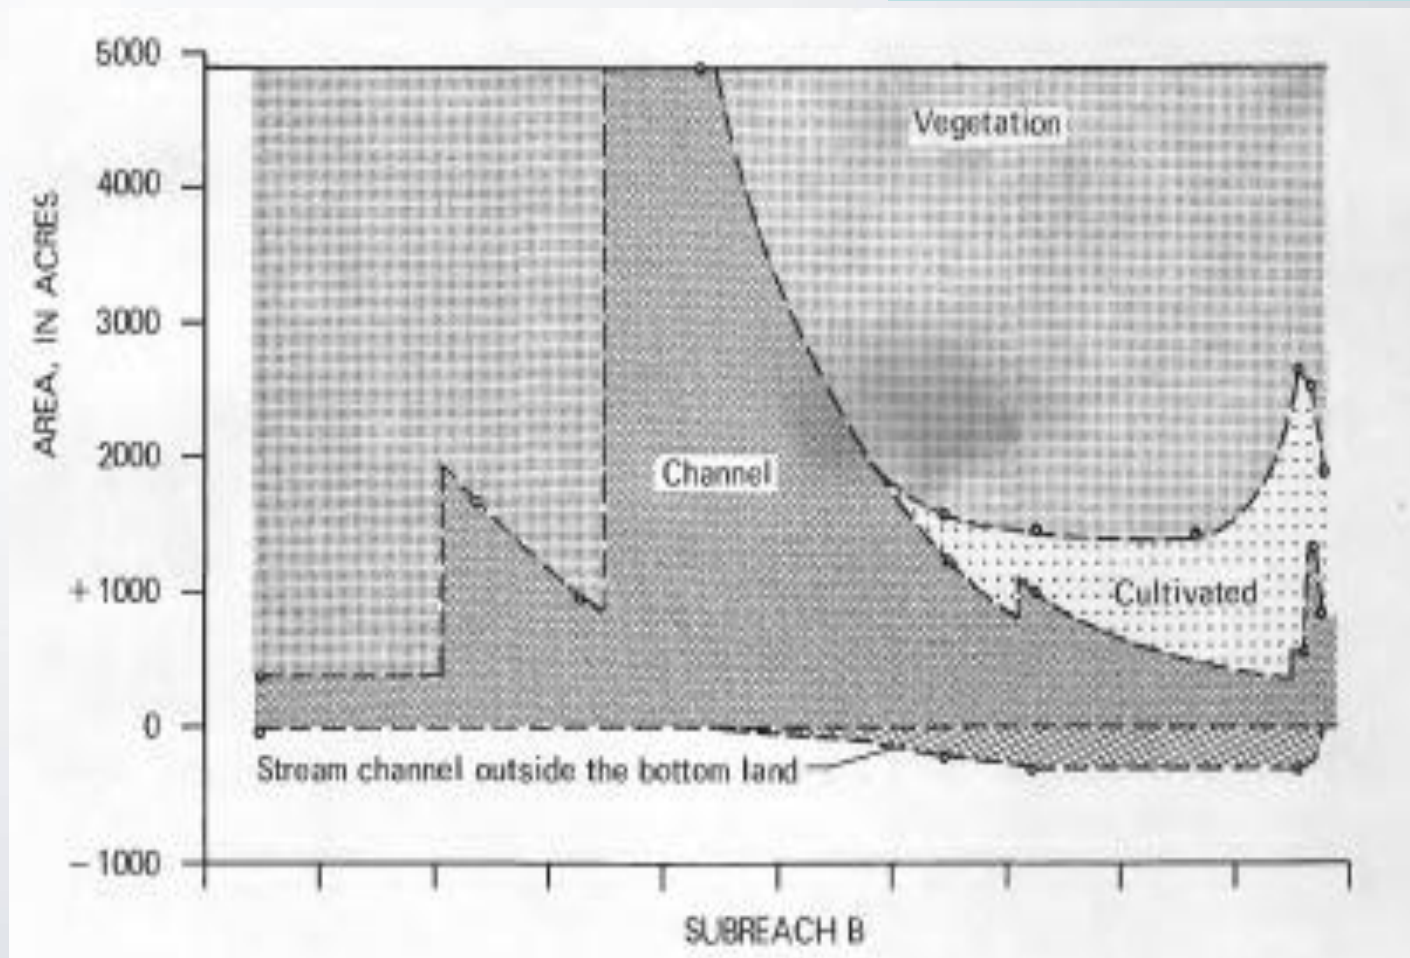
## Historical changes in channel area of upper Gila River (San Simon to Pima)

Source: Burkham, 1972

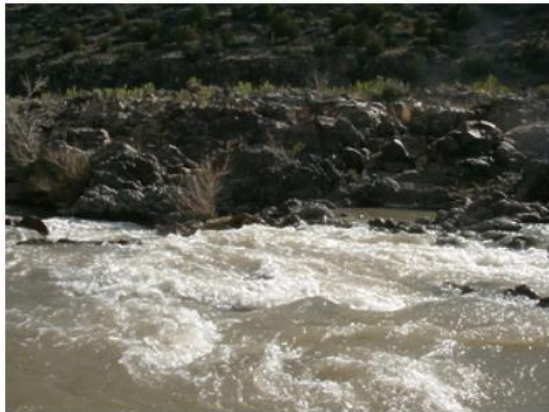
Verde Falls, class IV, scout left

The no-stopping zone for eagle habitat starts just upstream, but you must stop to scout or portage this rapid, so the sign seems out of place. Different guidebooks say the falls is either 5 feet or 8 feet high. Both statements might be true at different water levels. At ultra low flows the falls is too rocky to run. At minimum recommended flows, far right is relatively straightforward. As flow increases, alternate routes become available on the left. At high flows (see YouTube videos) the holes are truly monstrous.

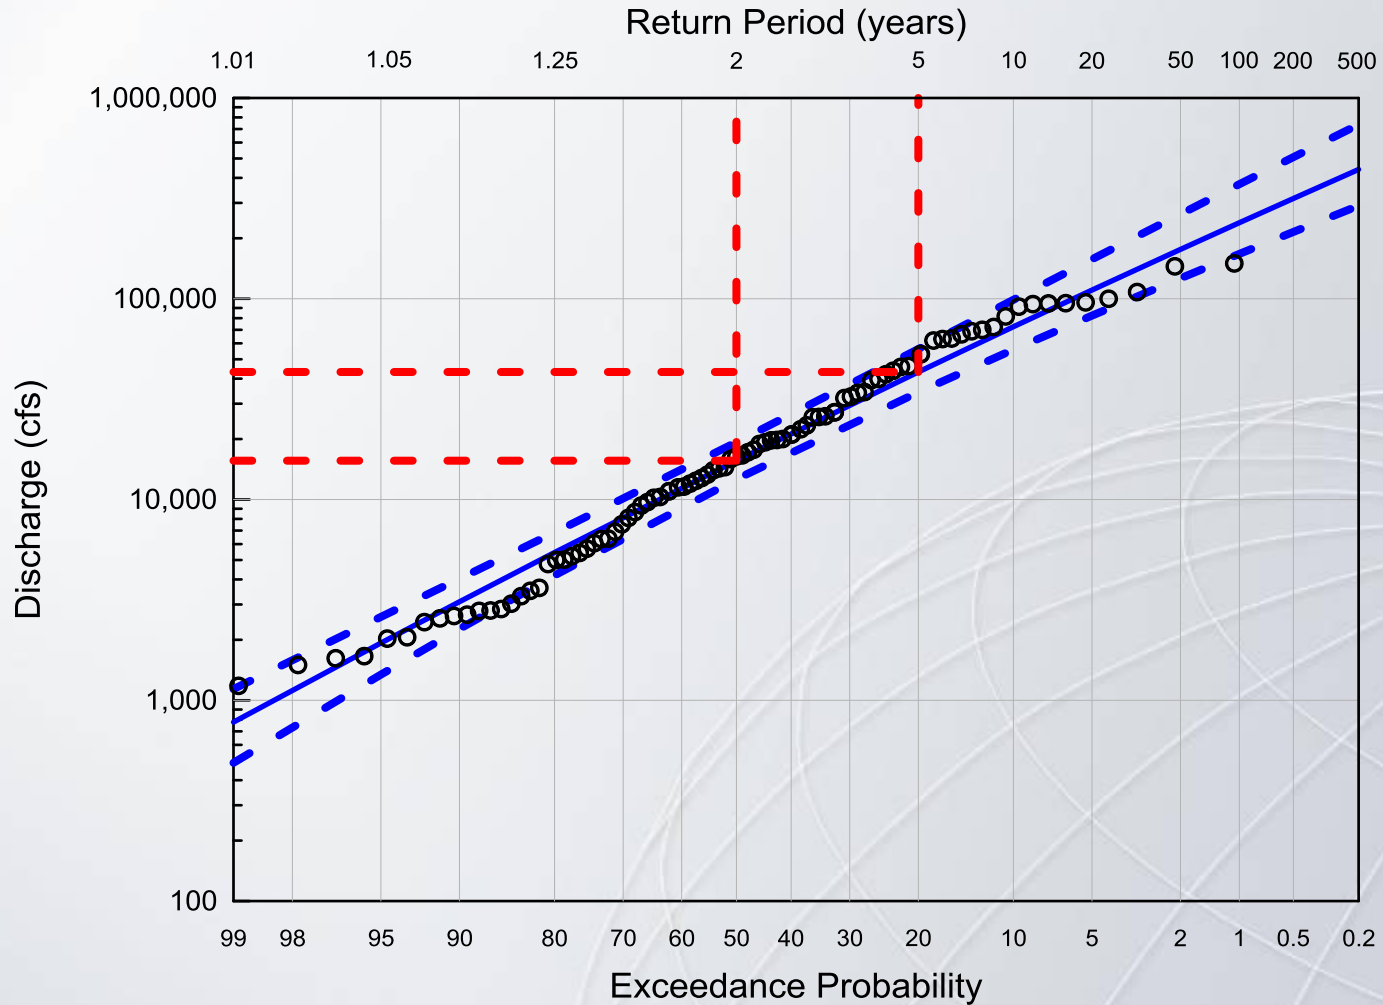
# Verde Below Tangle Creek Peak Flood Frequency Curve

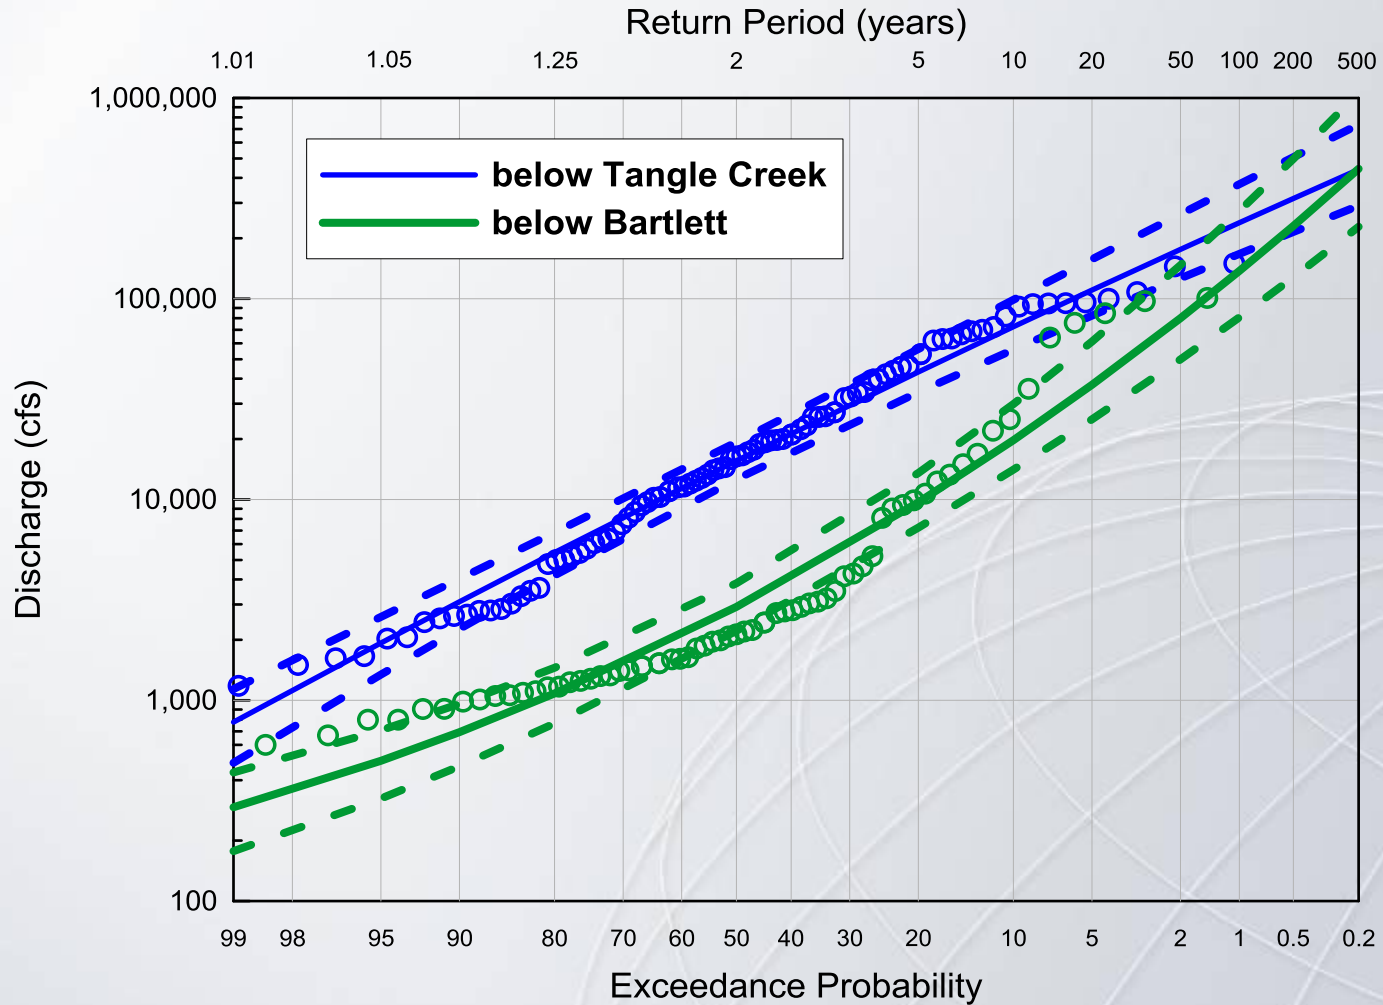
# Verde River Flood Frequency Curves

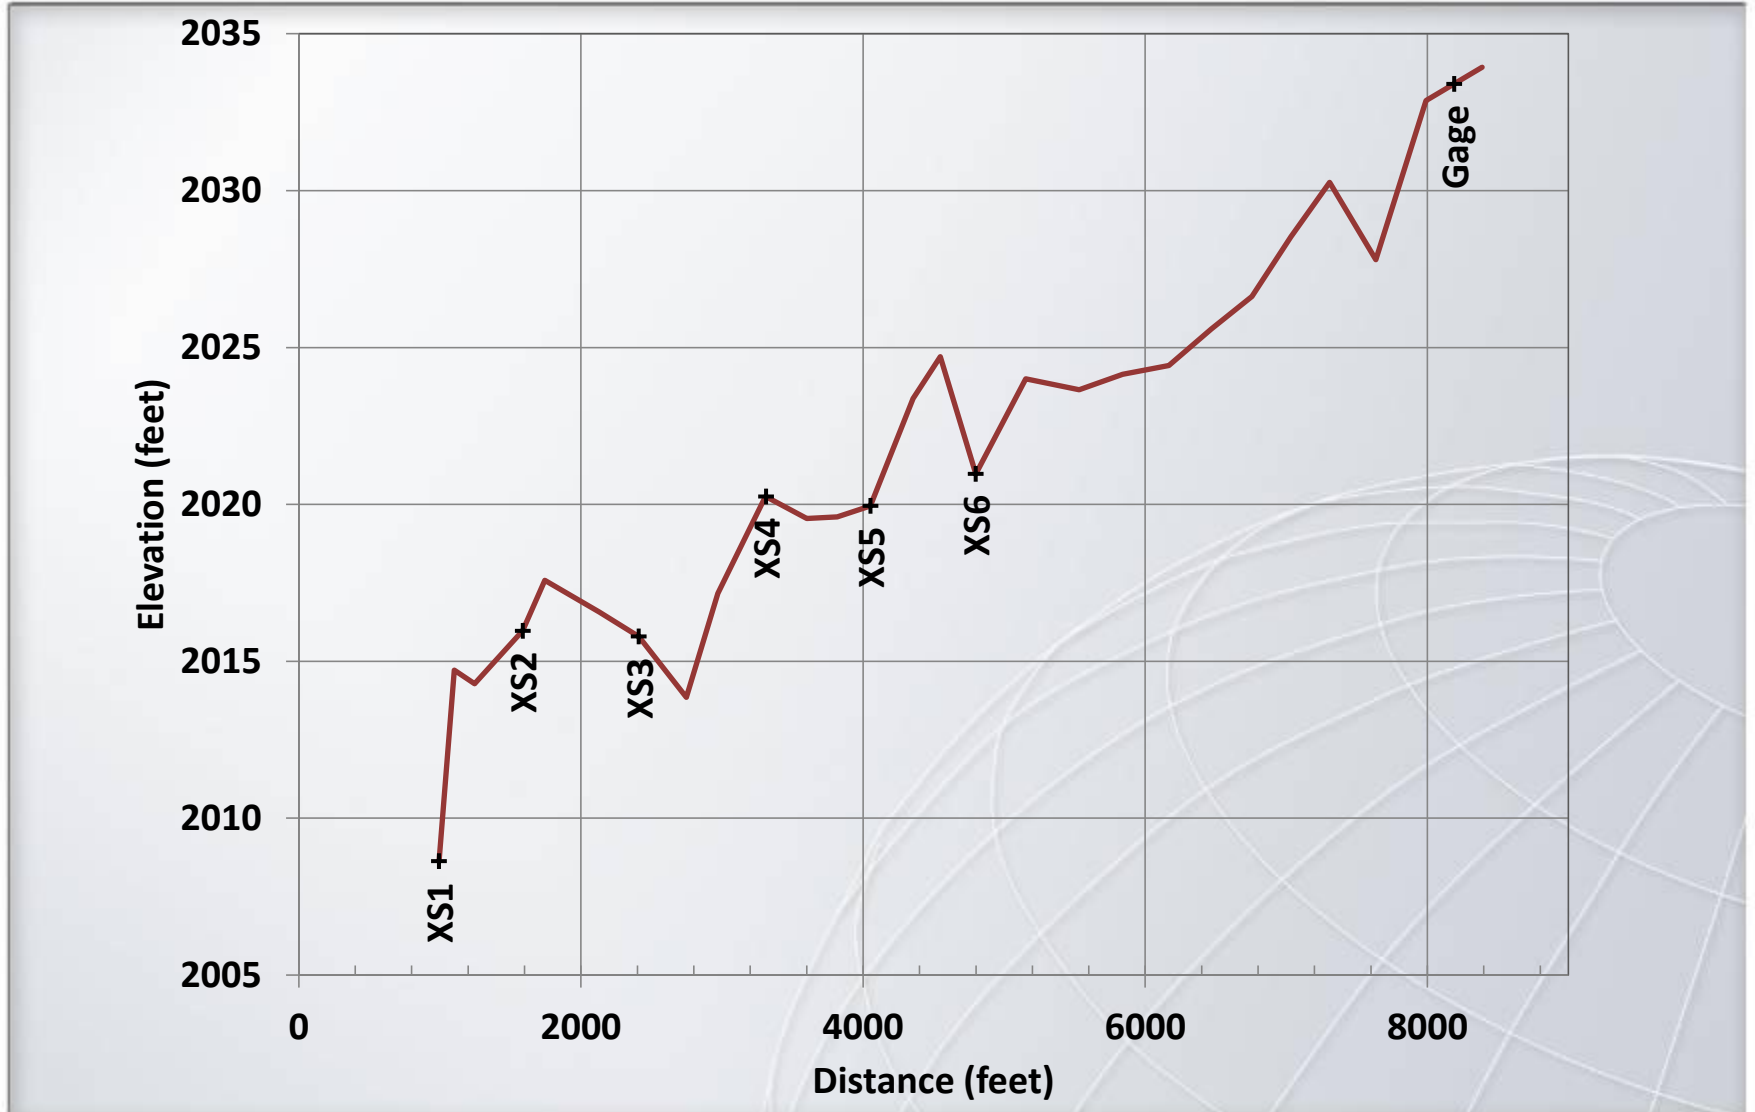
# MEI (2003) Site 1 Profile

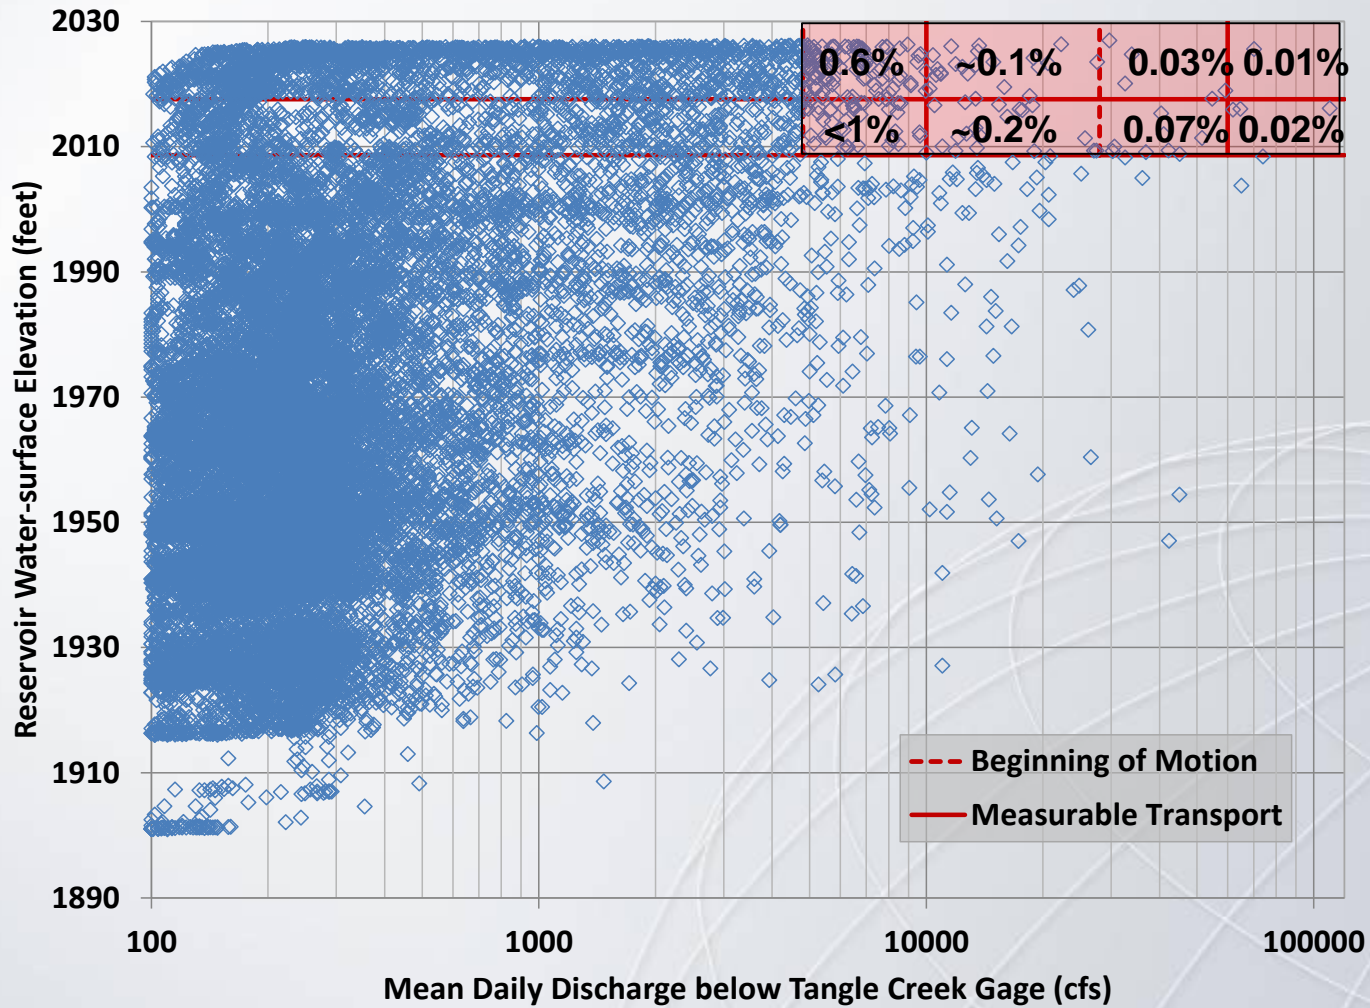
# Horseshoe Reservoir versus *below Tangle Creek* Discharge
