Gila River Navigability

Presentation to ANSAC

Bob Mussetter, Ph.D., P.E.

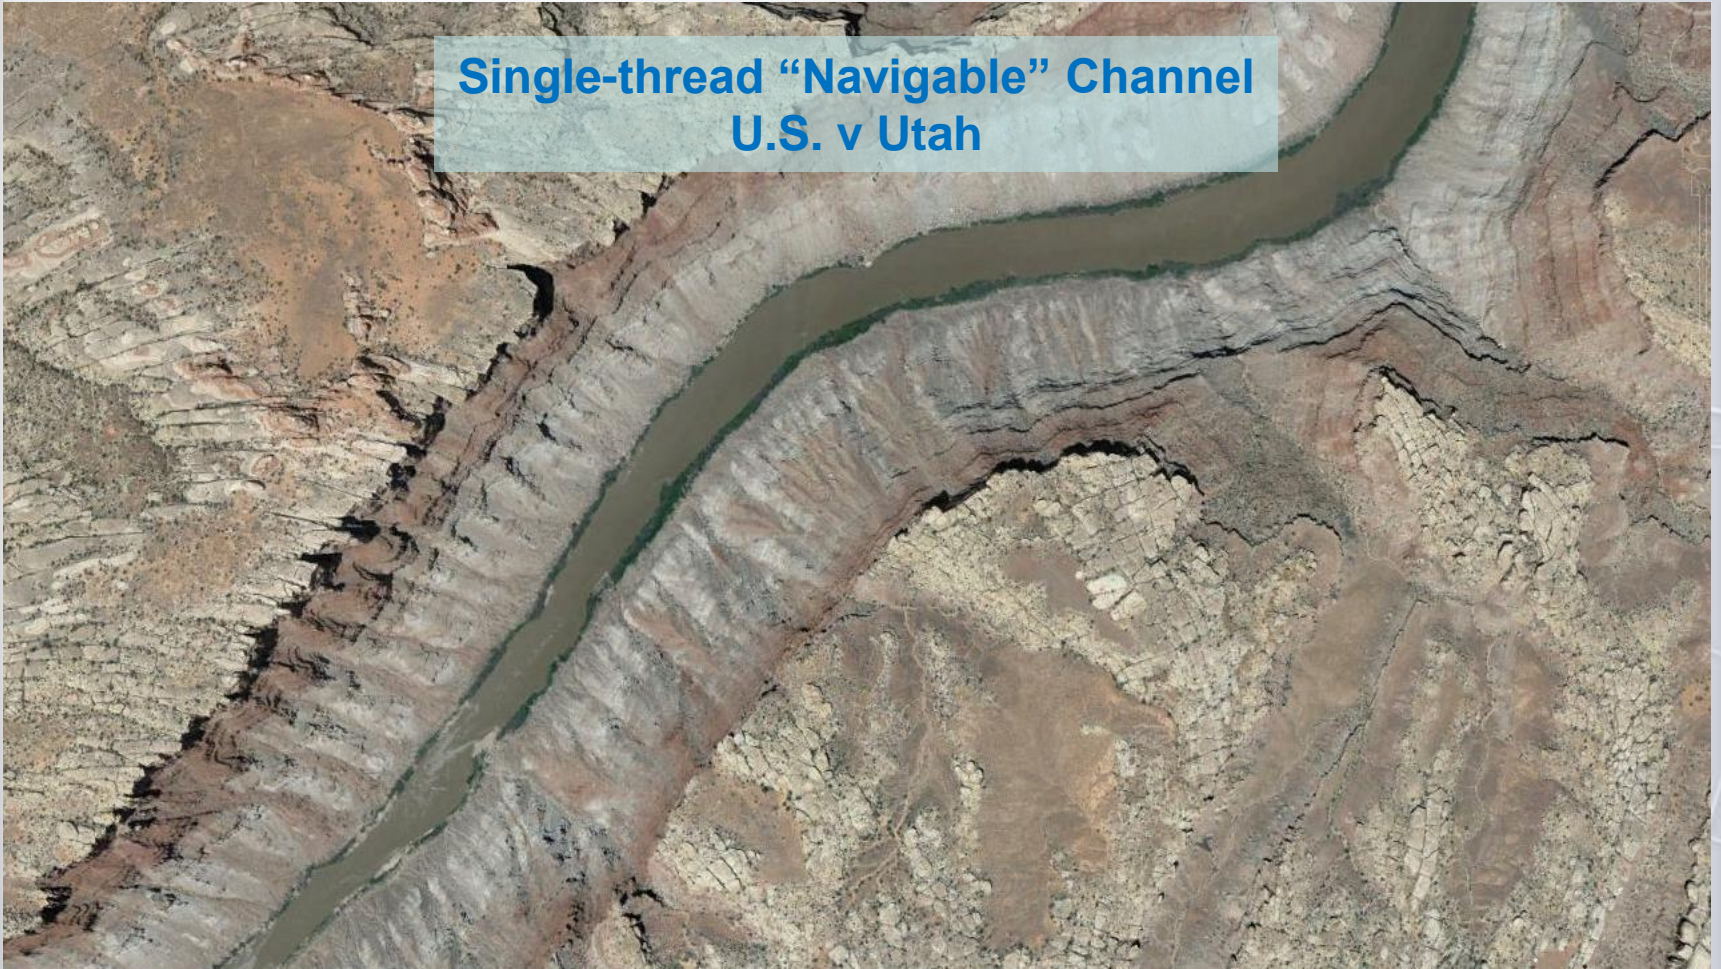
Single-thread “Navigable” Channel
U.S. v Utah

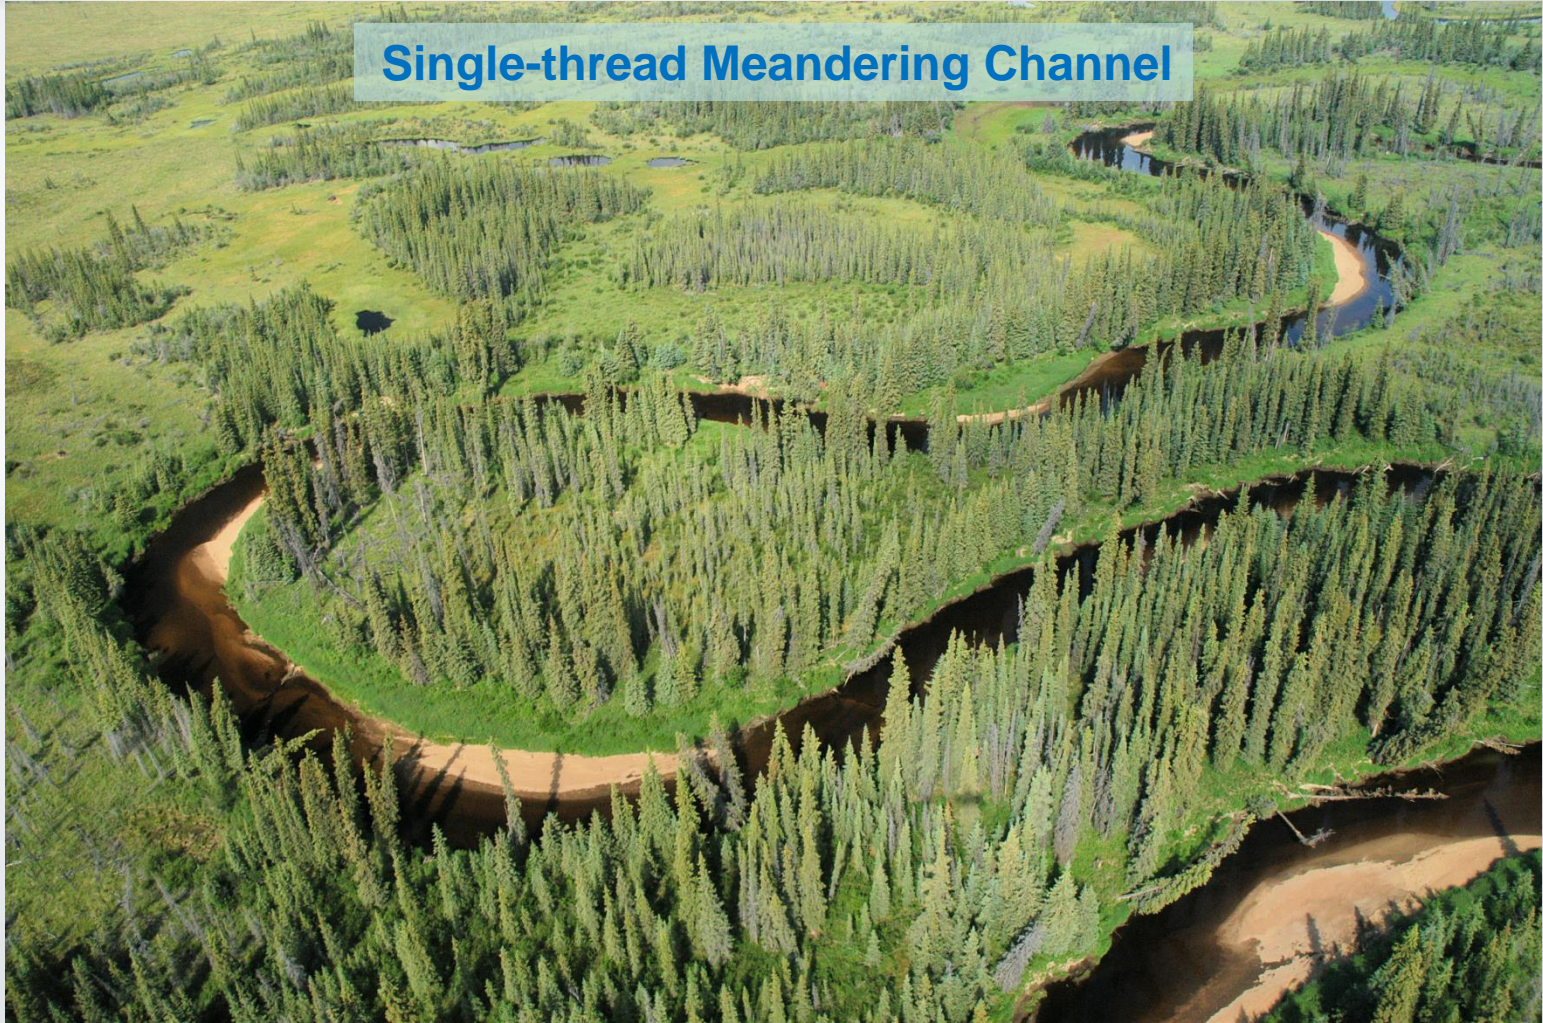
Single-thread Meandering Channel

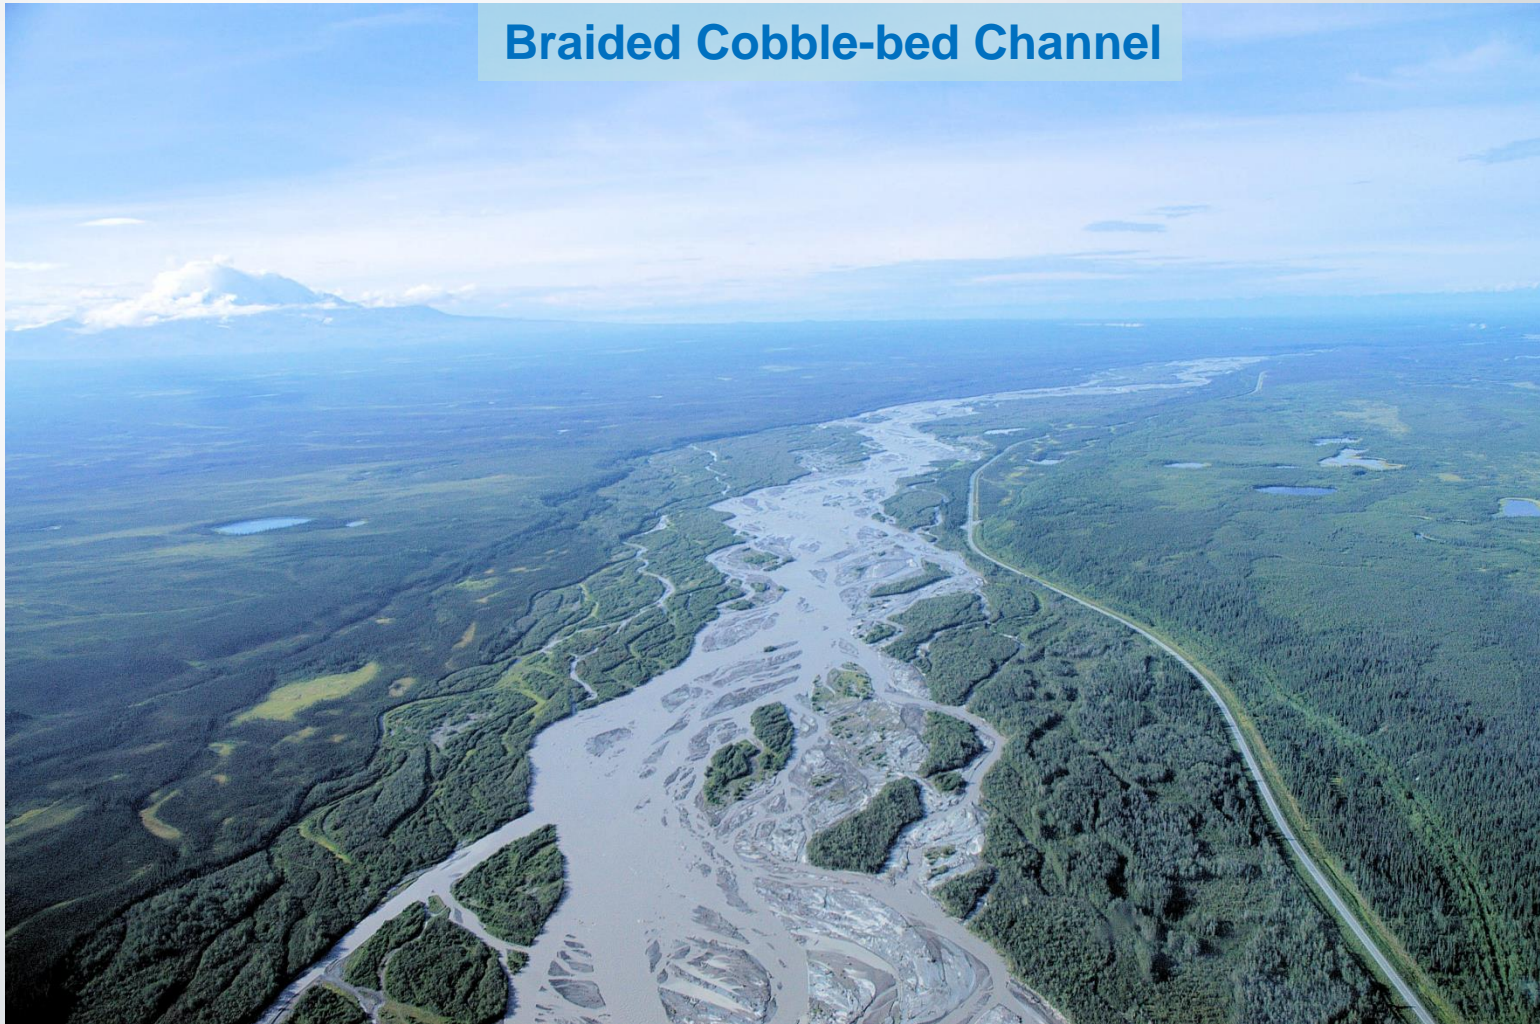
Braided Cobble-bed Channel

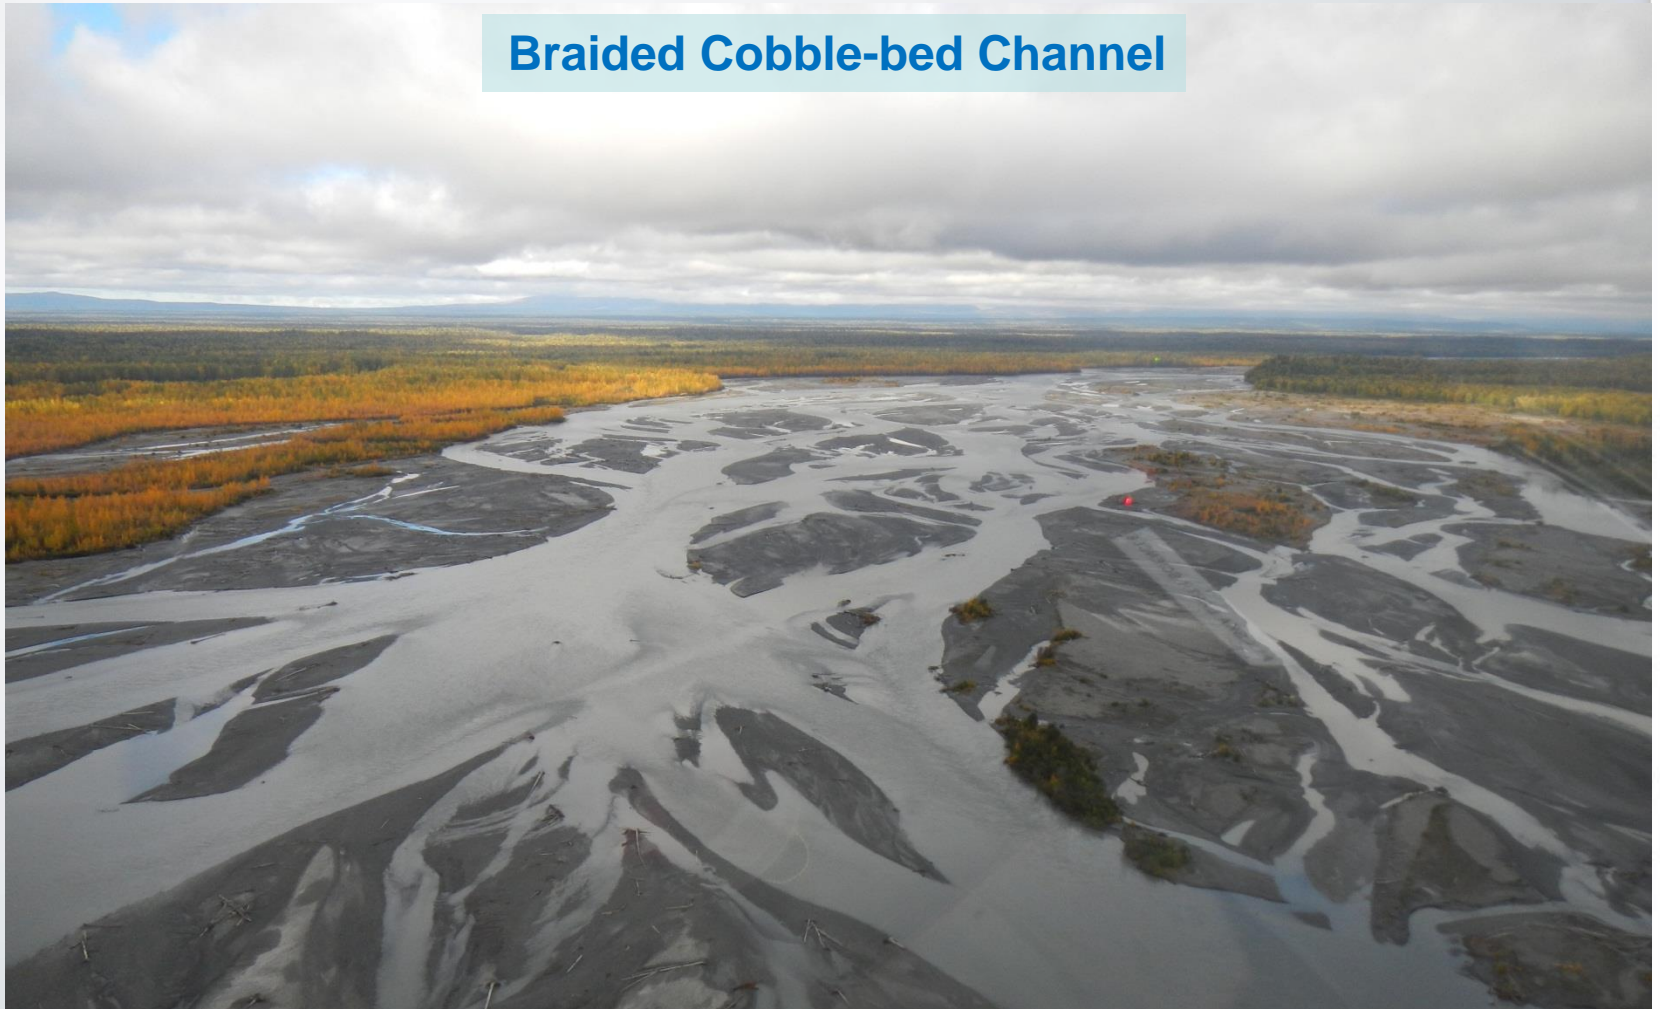
Braided Cobble-bed Channel

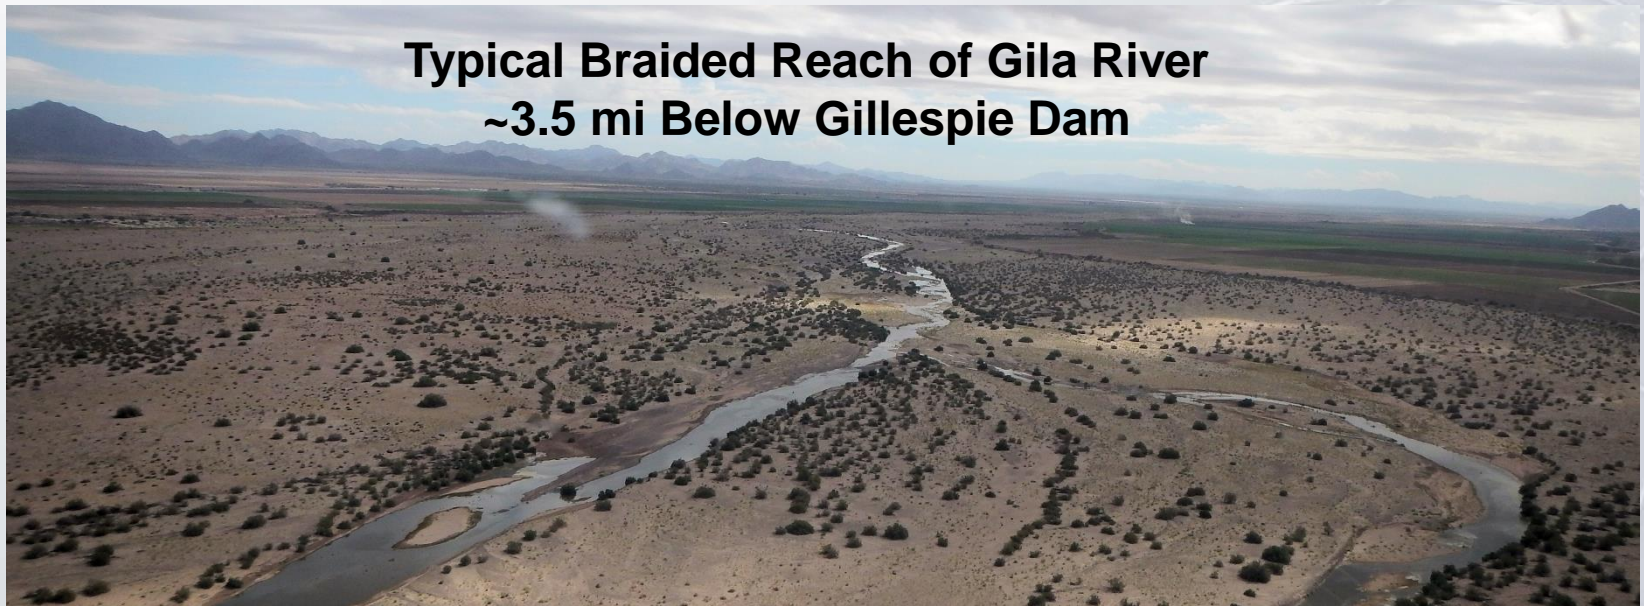
Channel Pattern IS Relevant to Navigability

- Braided channels:
 - Wide, shallow cross section
 - Multiple, unstable (i.e., shifting) channels
 - NOT conducive to boating

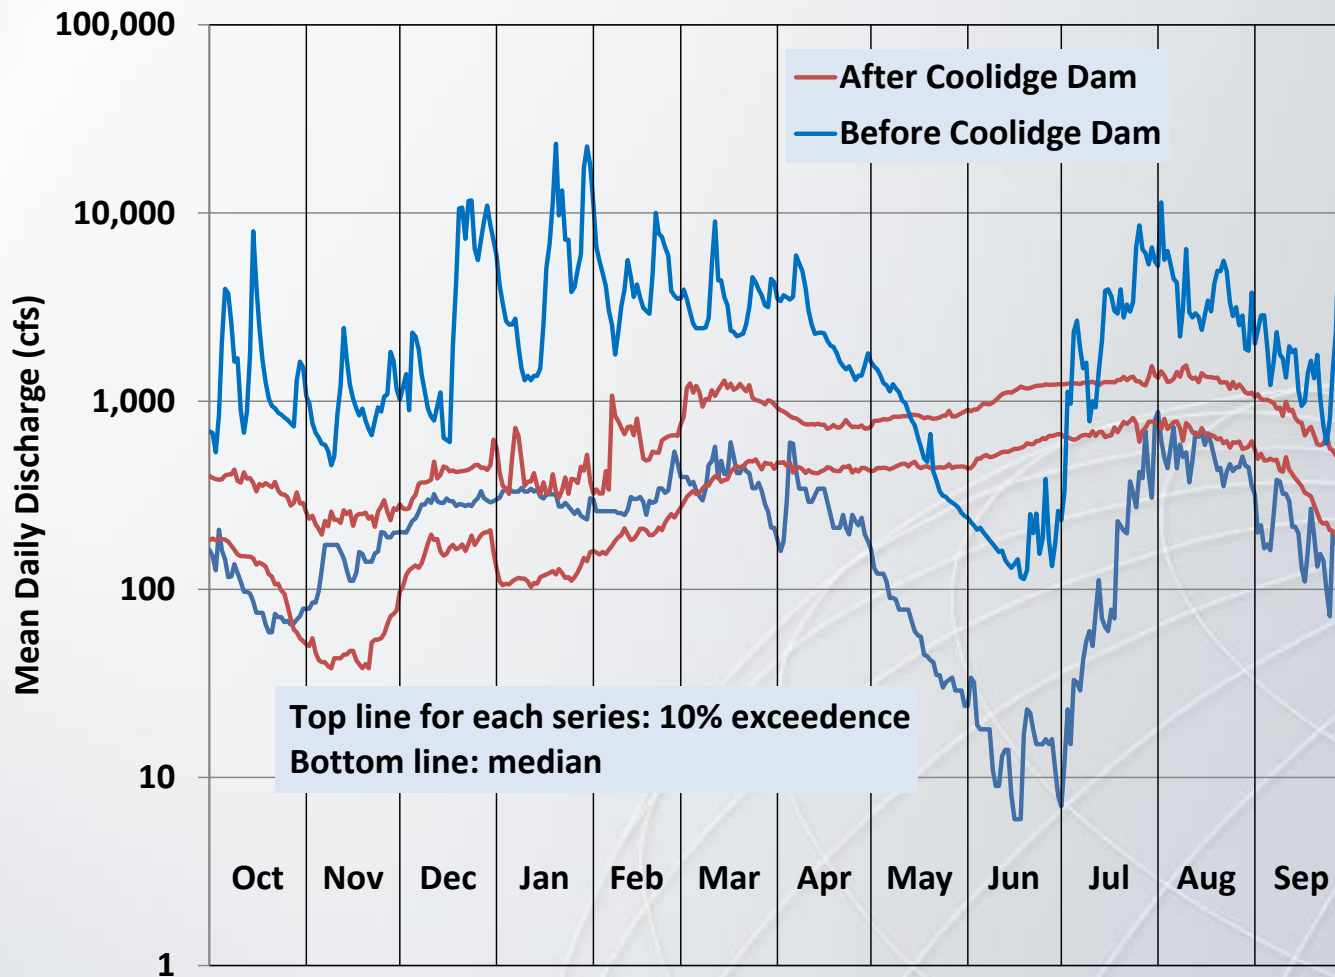
Gila River at Kelvin Flows
