Final Report SMALL & MINOR WATERCOURSES ANALYSIS for Santa Cruz County, Arizona

Contract No. AD 990205

ARIZONA STATE LAND DEPARTMENT

**SMALL AND MINOR WATERCOURSES ANALYSIS
for Santa Cruz County, Arizona**

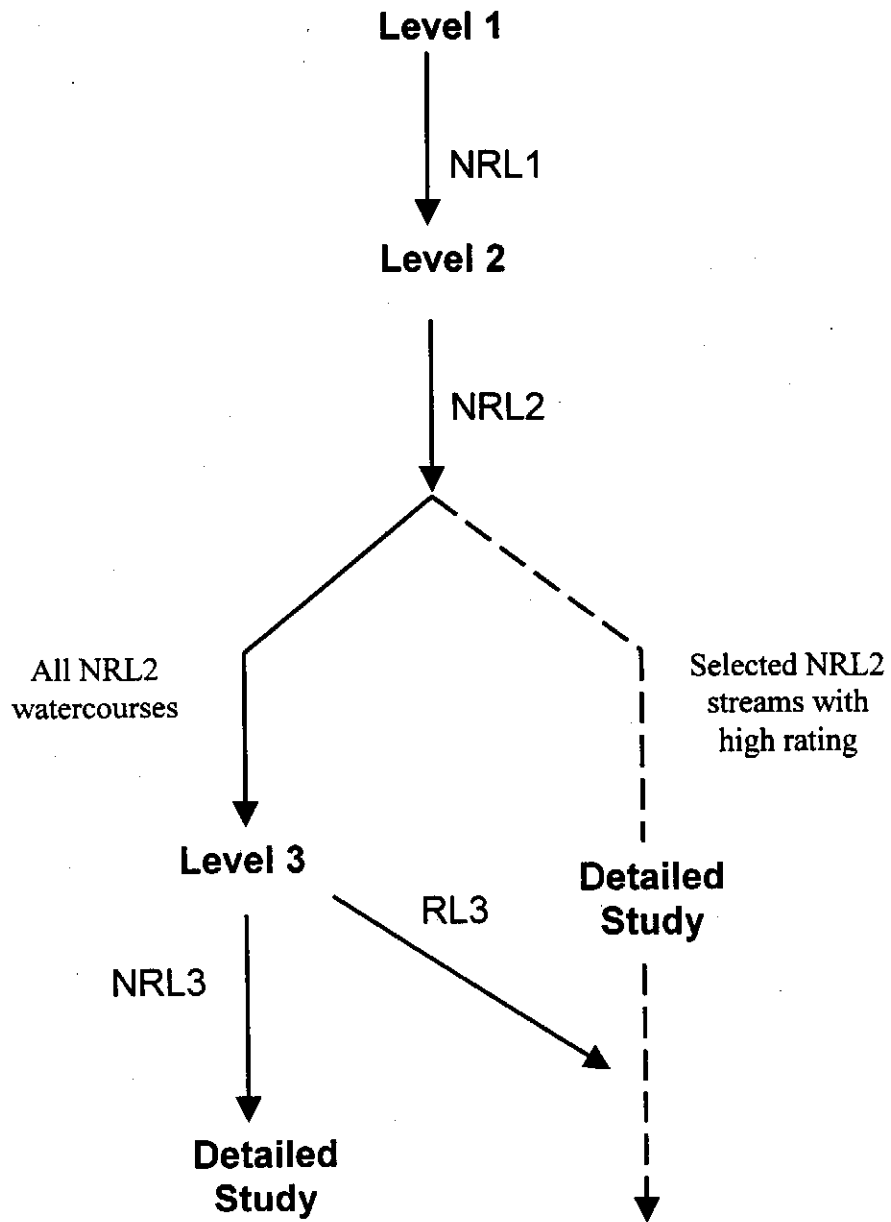
Figure 7 shows the schematics of the procedure adopted to evaluate the small and minor watercourses that have passed the Level 2 analysis. This approach was used by the project team to meet the accelerated schedule set by ANSAC for public hearings. It was not possible to meet the ANSAC schedule and wait for the outcome of the Level 3 screening prior to knowing which watercourse would proceed to detailed studies. Since the Level 3 analysis takes significant effort (and time) to complete, and detailed studies take an even greater effort, the completion dates of the detailed studies would extend beyond the scheduled ANSAC hearings. Therefore, the need to complete all analyses for every watercourse prior to the hearing dates requires that the Level 3 analysis and the detailed studies be conducted simultaneously or in parallel track (see Figure 7). This, however, does not require every NRL2 watercourse to be studied in detail but only those that had the highest ratings in the ranking system. Although this approach effectively eliminates the scheduling problem presented above, this entails some extra cost for the engineering and analysis. It is most likely that some of the watercourses that have been studied in detail would turn up in the RL3 (rejected data set in Level 3) list after the Level 3 analysis. This RL3 data set comprises those watercourses that merit no further evaluation and study after Level 3.

Figure 7
 Schematics showing simultaneous analysis of
 selected NRL2 watercourses in Level 3 and Detailed Study

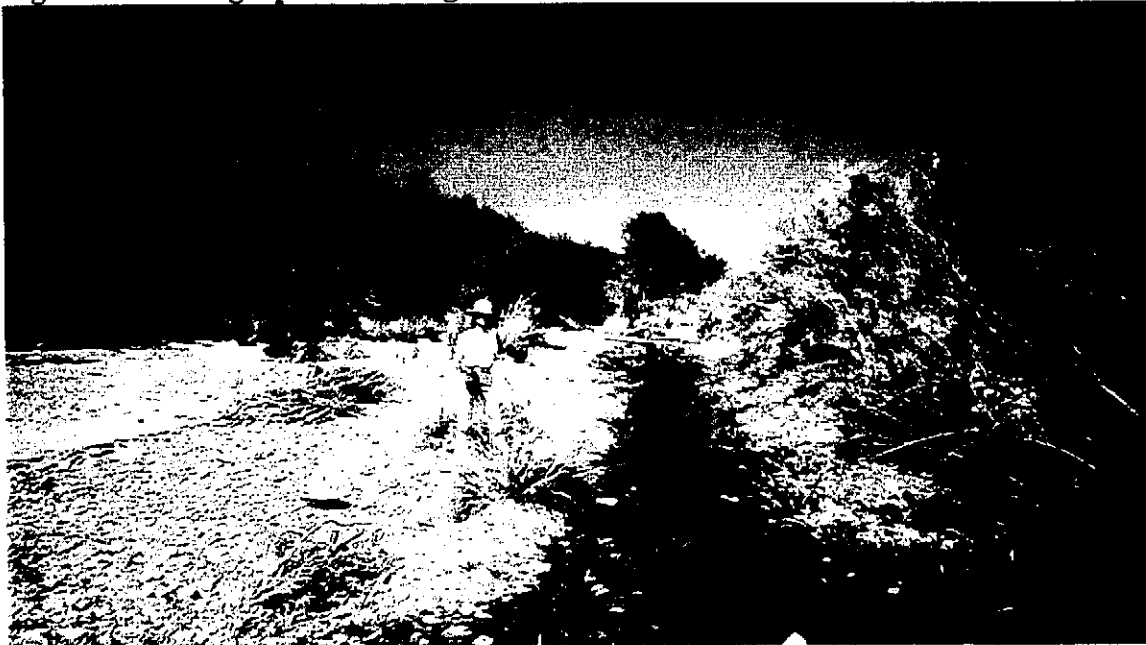
Figure 11. Photographs of Cienega Creek

Looking downstream from just downstream of Marsh Station Road.

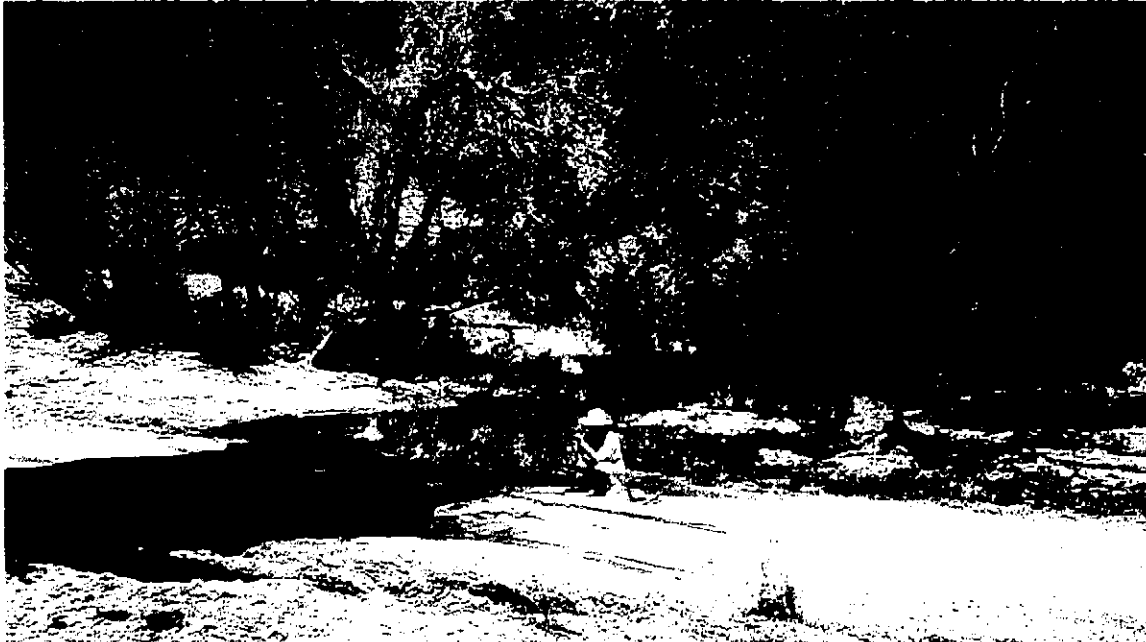
Figure 13. Photographs of Cienega Creek

Looking downstream from near Cienega Ranch (Lat. 31° 49.3', Long. 110° 35.3')

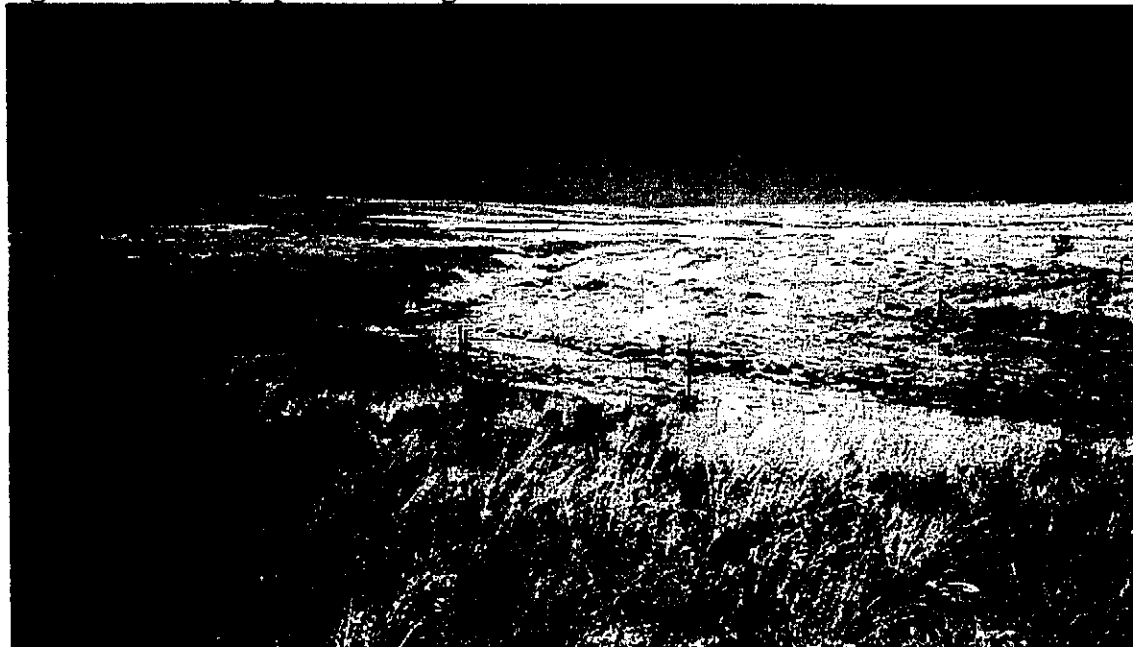
Figure 15. Photographs of Cienega Creek

Looking downstream from State Route 82.

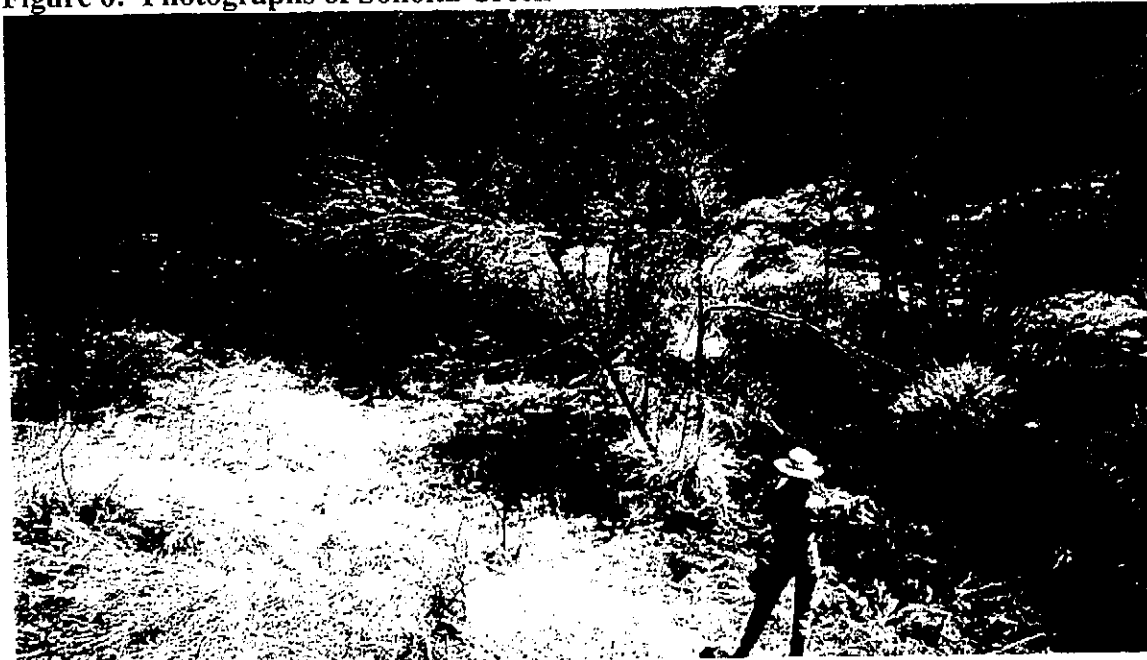
Figure 6: Photographs of Sonoita Creek

Looking upstream at Cottonwood Spring near the historic site of Fort Buchanan.

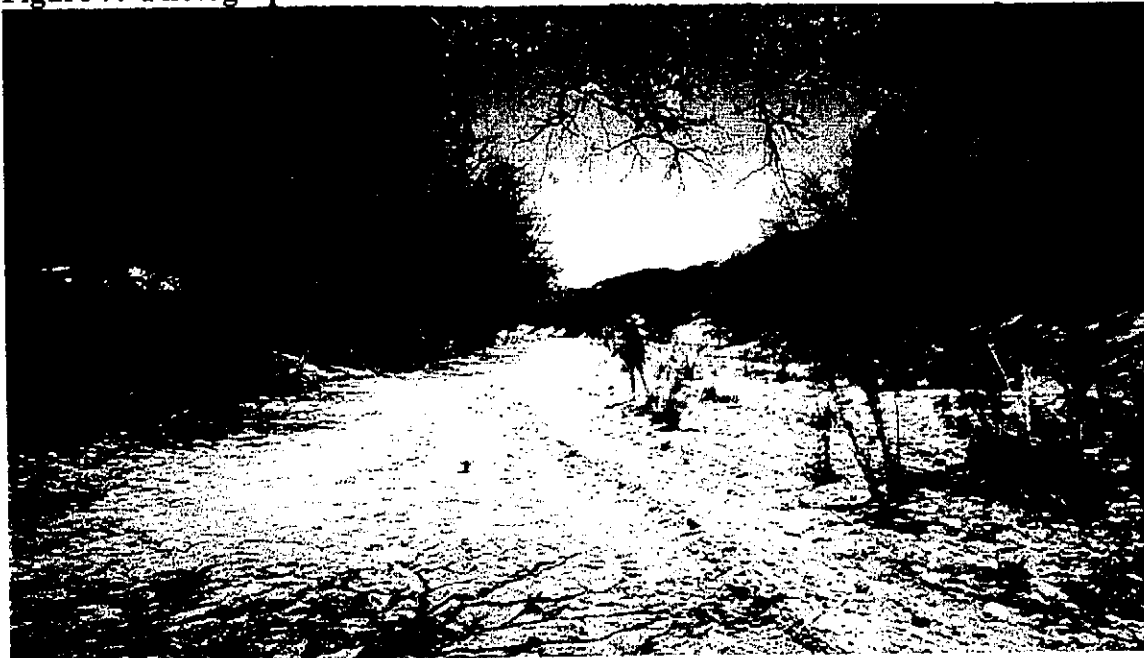
Figure 7: Photographs of Sonoita Creek

Looking downstream from Milepost 25 on State Route 82.

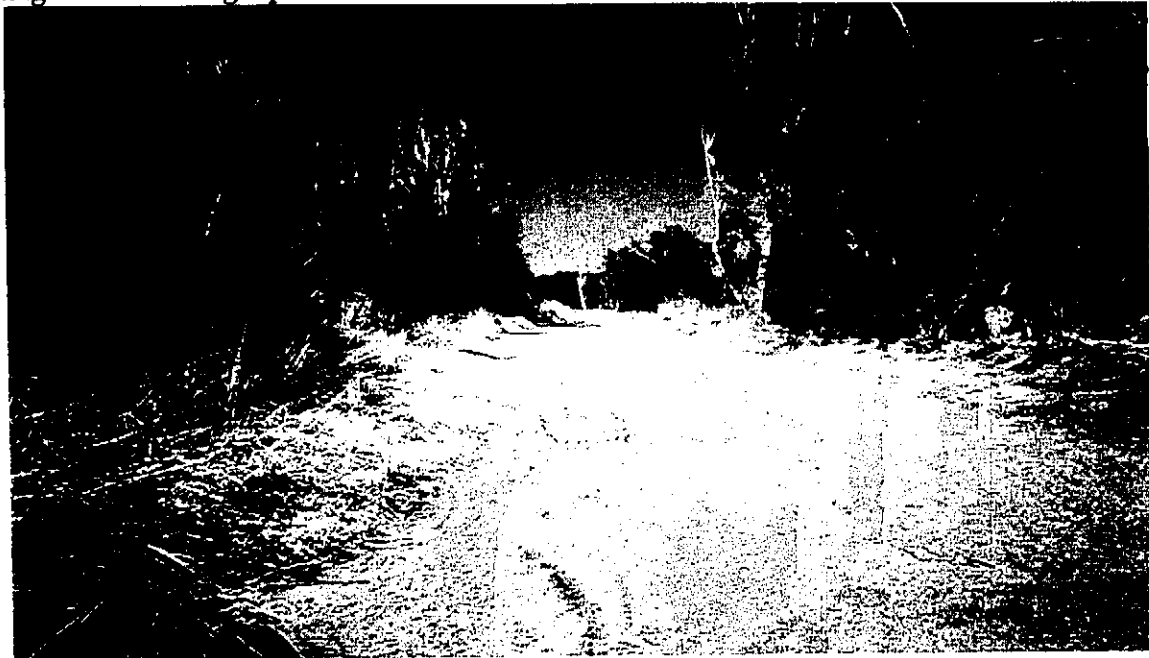
Figure 9: Photographs of Sonoita Creek

Looking upstream from within the Town of Patagonia.

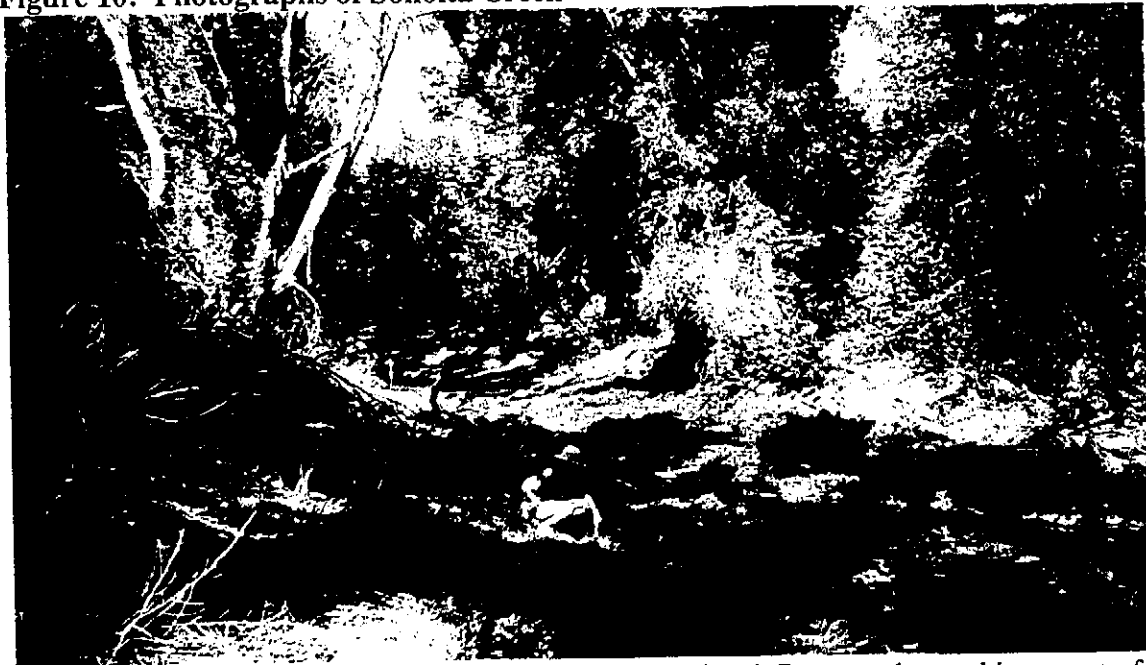
Figure 10: Photographs of Sonoita Creek

Looking upstream from within the Patagonia Sonoita-Creek Preserve located just west of Patagonia.

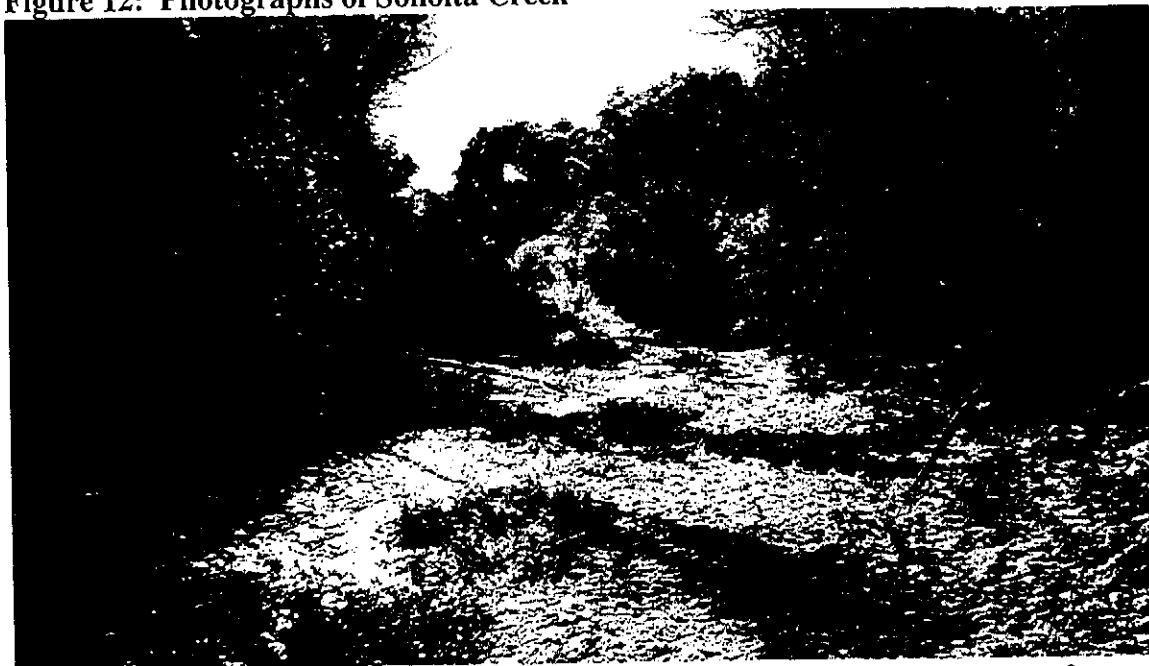
Figure 12: Photographs of Sonoita Creek

Looking downstream from the Salero Road crossing approximately 3 miles west of Patagonia.
