# THE SALT AND GILA RIVERS IN CENTRAL ARIZONA

A GEOGRAPHIC FIELD TRIP GUIDE

EDITED BY  
WILLIAM L. GRAF

DEPARTMENT OF GEOGRAPHY PUBLICATION 3  
ARIZONA STATE UNIVERSITY

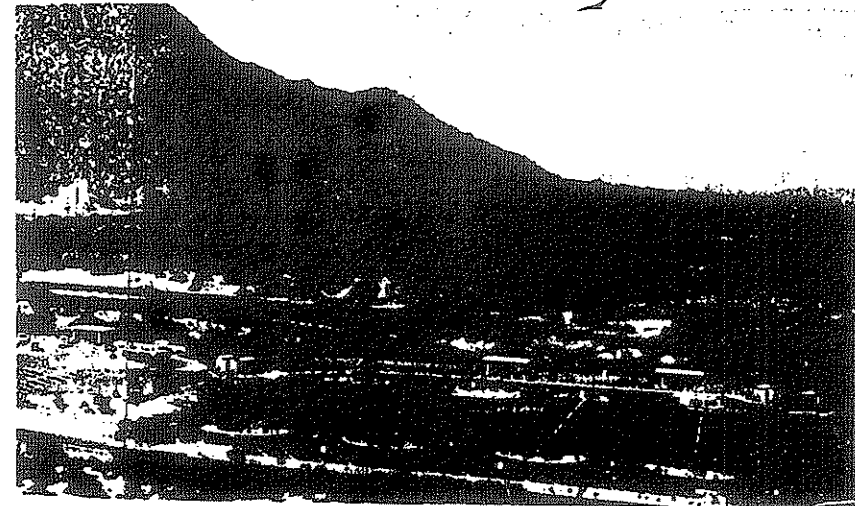
Figure 3.6 Salt and Verde Rivers confluence, 1986 (Photo by author).

flows collide at the confluence (Mosley, 1976). Historic flooding has caused changes in the location and geomorphology of the Salt and Verde rivers confluence. The confluence has migrated 152 m (500 ft) downstream since 1949 (Figs. 3.5 and 3.6). This is illustrated by the changing relative location of the tuff bedrock knobs protruding from the channel bed. The change most likely occurred between the 1966 and 1980 storms. The storms of 1980 caused the Verde River to slightly alter its meandering course by creating a larger sweeping bend upstream of the confluence. This was due to the higher velocities associated with flood flows which resulted in increased bank cutting (Heinert, 1986).

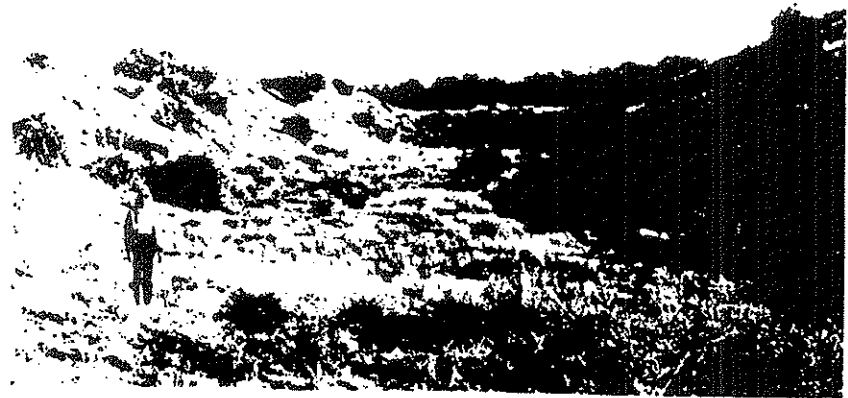
Figure 5.5 Remains of a section of the 1893 Consolidated Canal at the McDowell Crossing site, looking northeast (photograph by author).

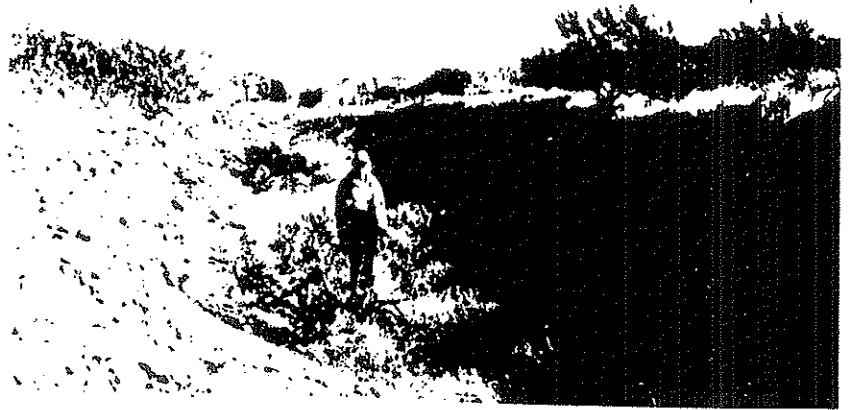
Figure 5.6 Remains of the never-used Spite Ditch, built in 1912, looking northeast (photograph by author).

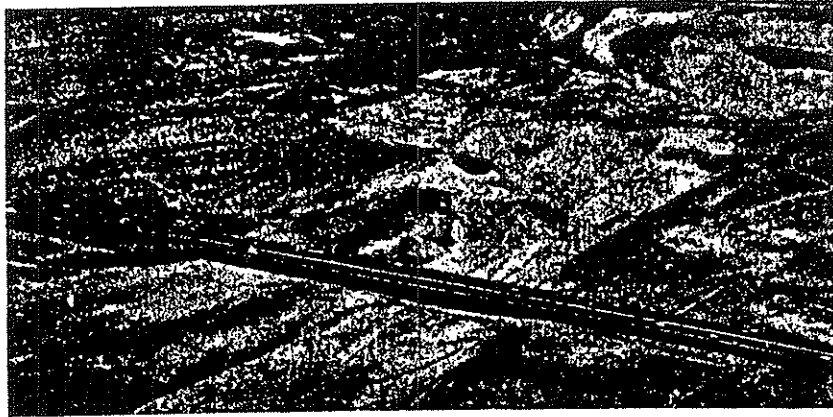
Figure 9.8 Interstate-10 Bridge, August, 1980 (Dames and Moore archives, Phoenix).

a braided one. Some vegetation still remains in the flood plain, although the trees in the lower portion of the 1965 photograph are gone in the 1973 photograph, probably the result of earth-moving and construction activities. Major flooding in 1978, 1979, and 1980 resulted in widespread scouring of the channel (Fig. 9.8). Most vegetation was removed from the flood plain and the low flow channel was deeply scoured. Figure 9.4 shows the change in channel configuration caused by the 1979 flood.

meters downstream of the bridge to prevent upstream cutting. Complete aggradation behind the walls has occurred in the last several years, but they are still effective in preventing upstream erosion toward the bridge (Briscoe, 1986).

Presently, the bridge is being completely replaced. Designed to pass a flow of  $5,660 \text{ m}^3/\text{s}$  ( $200,000 \text{ ft}^3/\text{s}$ ), the new 11-lane bridge is being built on caisson foundations that are set in the alluvium bed at a depth of 30.5 m (100 ft) (Hawthorne, 1983; Briscoe, 1986). New features of construction include a new sand and gravel pit with dike, as well as the new 32nd Street Tempe storm sewer outflow channel, all of which are located on the left bank on the upstream side of the bridge (Fig. 9.3).

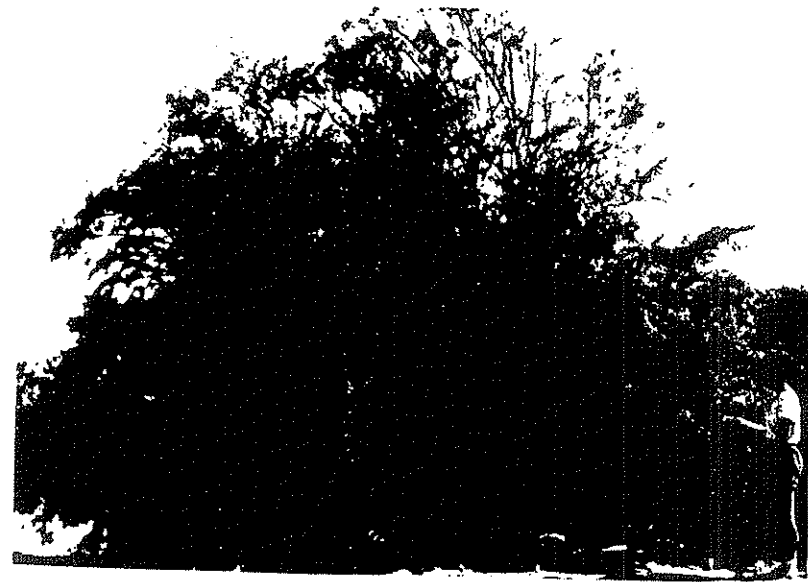
Figure 10.4 Tamarisk along the Gila River west of Phoenix, 1987  
(photo by Anne Chin).

Riparian vegetation communities play an important role in dryland river behavior. Tamarisk, an artificially introduced phreatophyte, has become a dominant component of the riparian community (Fig. 10.4). Tamarisk, with heights up to 12 m (39.4 ft) and trunks as great as 0.5 m (1.6 ft) in diameter, has the ability to densely populate an area creating jungle-like thickets (Robinson, 1958). Tamarisk competes successfully with native vegetation for several reasons. A mature tree produces as many as 0.5 million seeds per year. The optimal seedling locations for tamarisk are surfaces of moist sand and silt. When natural riparian vegetation is destroyed by floods or reservoir water levels fluctuate, new moist bed areas are exposed. Tamarisk seedlings grow rapidly and can quickly colonize the disturbed area. The penetrating taproot system of tamarisk, which extends 3 to 4 times the root depth of native phreatophytes, provides a needed water supply and an anchoring mechanism for flood event stability. Tamarisk can resprout from roots and branches buried by sediment during flooding events.

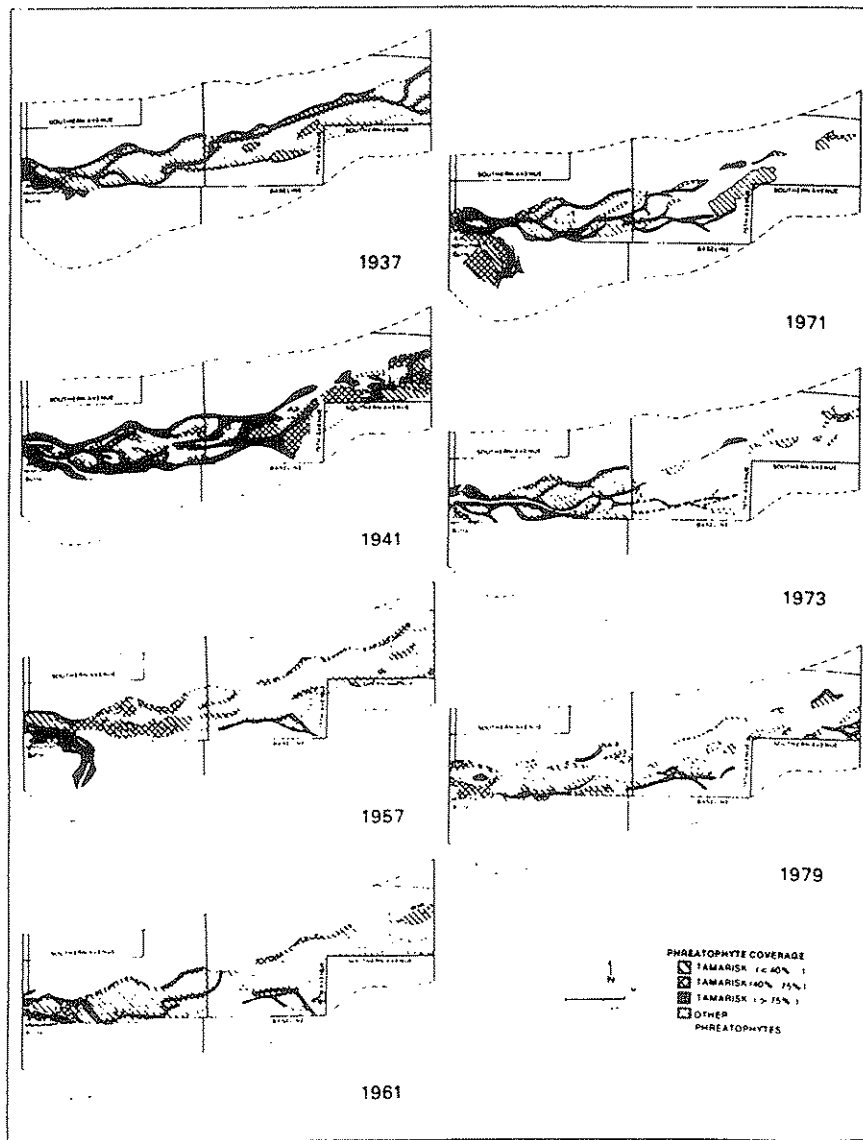
**Figure 10.5** The distribution and density of phreatophytes between 59th Street and Monument Hill (Graf, 1980b).

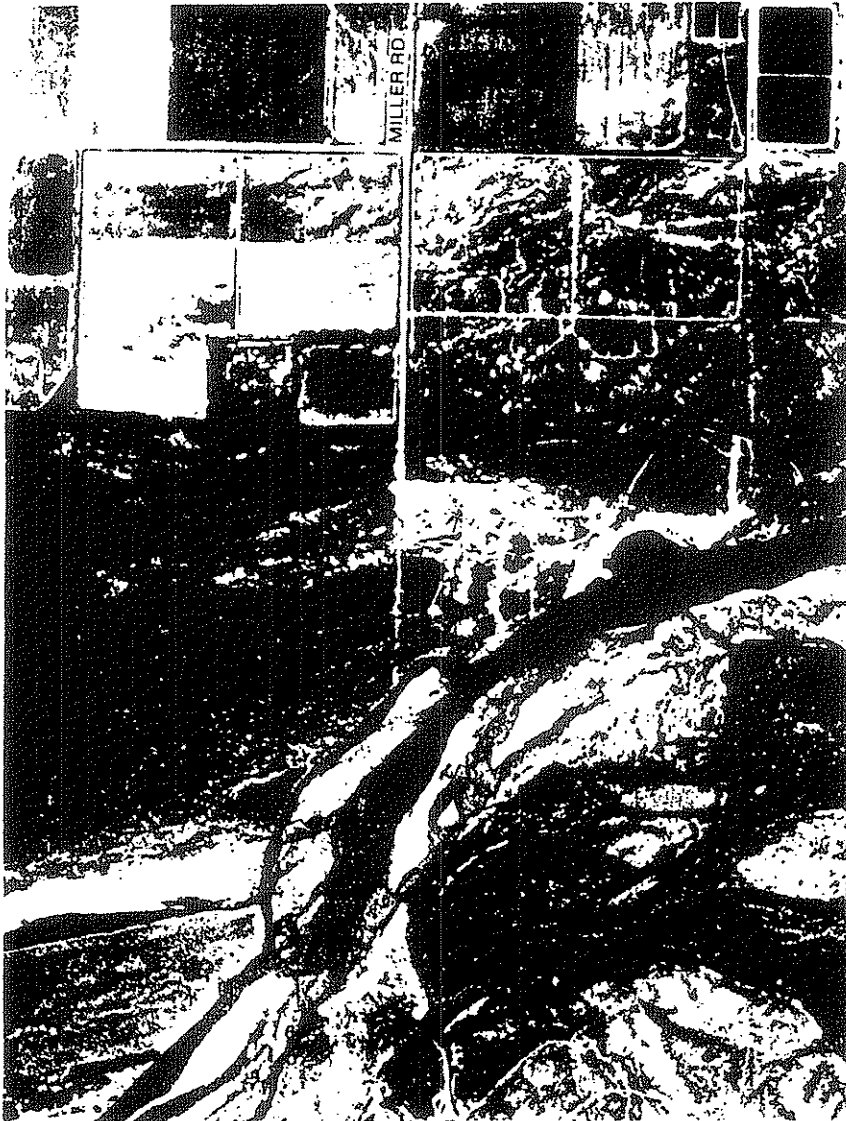
Figure 11.12 Buckeye Crossing, December 29, 1986, showing Miller Road buried by sediment with dense tamarisk thickets. The abandoned channel is at the end of the buried Miller Road, separated from the main channel by a sand bar. (Landis Aerial Survey, 1986, Photo # P-8).

cause major changes (Figs. 11.4, 11.5), southward migration of the channel at this location continued an additional 0.8 km (0.5 mi) during the large floods of the late 1970s (Fig. 11.10c). During the February 1980 flood, locational adjustment again occurred, when the channel moved northward at the Miller Road crossing while just downstream, it meandered radically to the south. Although this configuration was generally reflected in the early 1984 channel (Fig. 11.11), floods later that year caused the Gila River to abandon the outer portion of the bend just upstream of the buried Miller Road where it intersects the channel (Landis, 1985). This abandoned channel is now separated from the main channel by a bar, depicted as a lighter patch of sand in the most recent aerial photograph (Figs. 11.2, 11.12). The 1984 floods also caused the river to abandon its southern braid at this location, resulting in the single low flow channel observed at present.

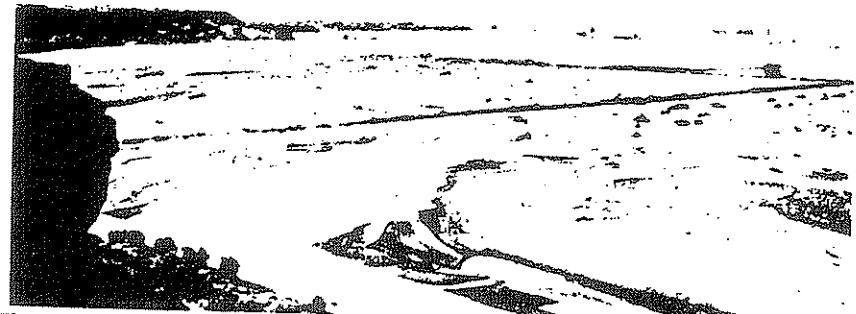
**Figure 12.6** May 1980, same view as Figure 12.3, 12.4, and 12.5. Main channel has moved to the west side of the valley following the February 1980 flood, destroying the agricultural land shown in Figure 12.4 (photo by W.L. Graf).

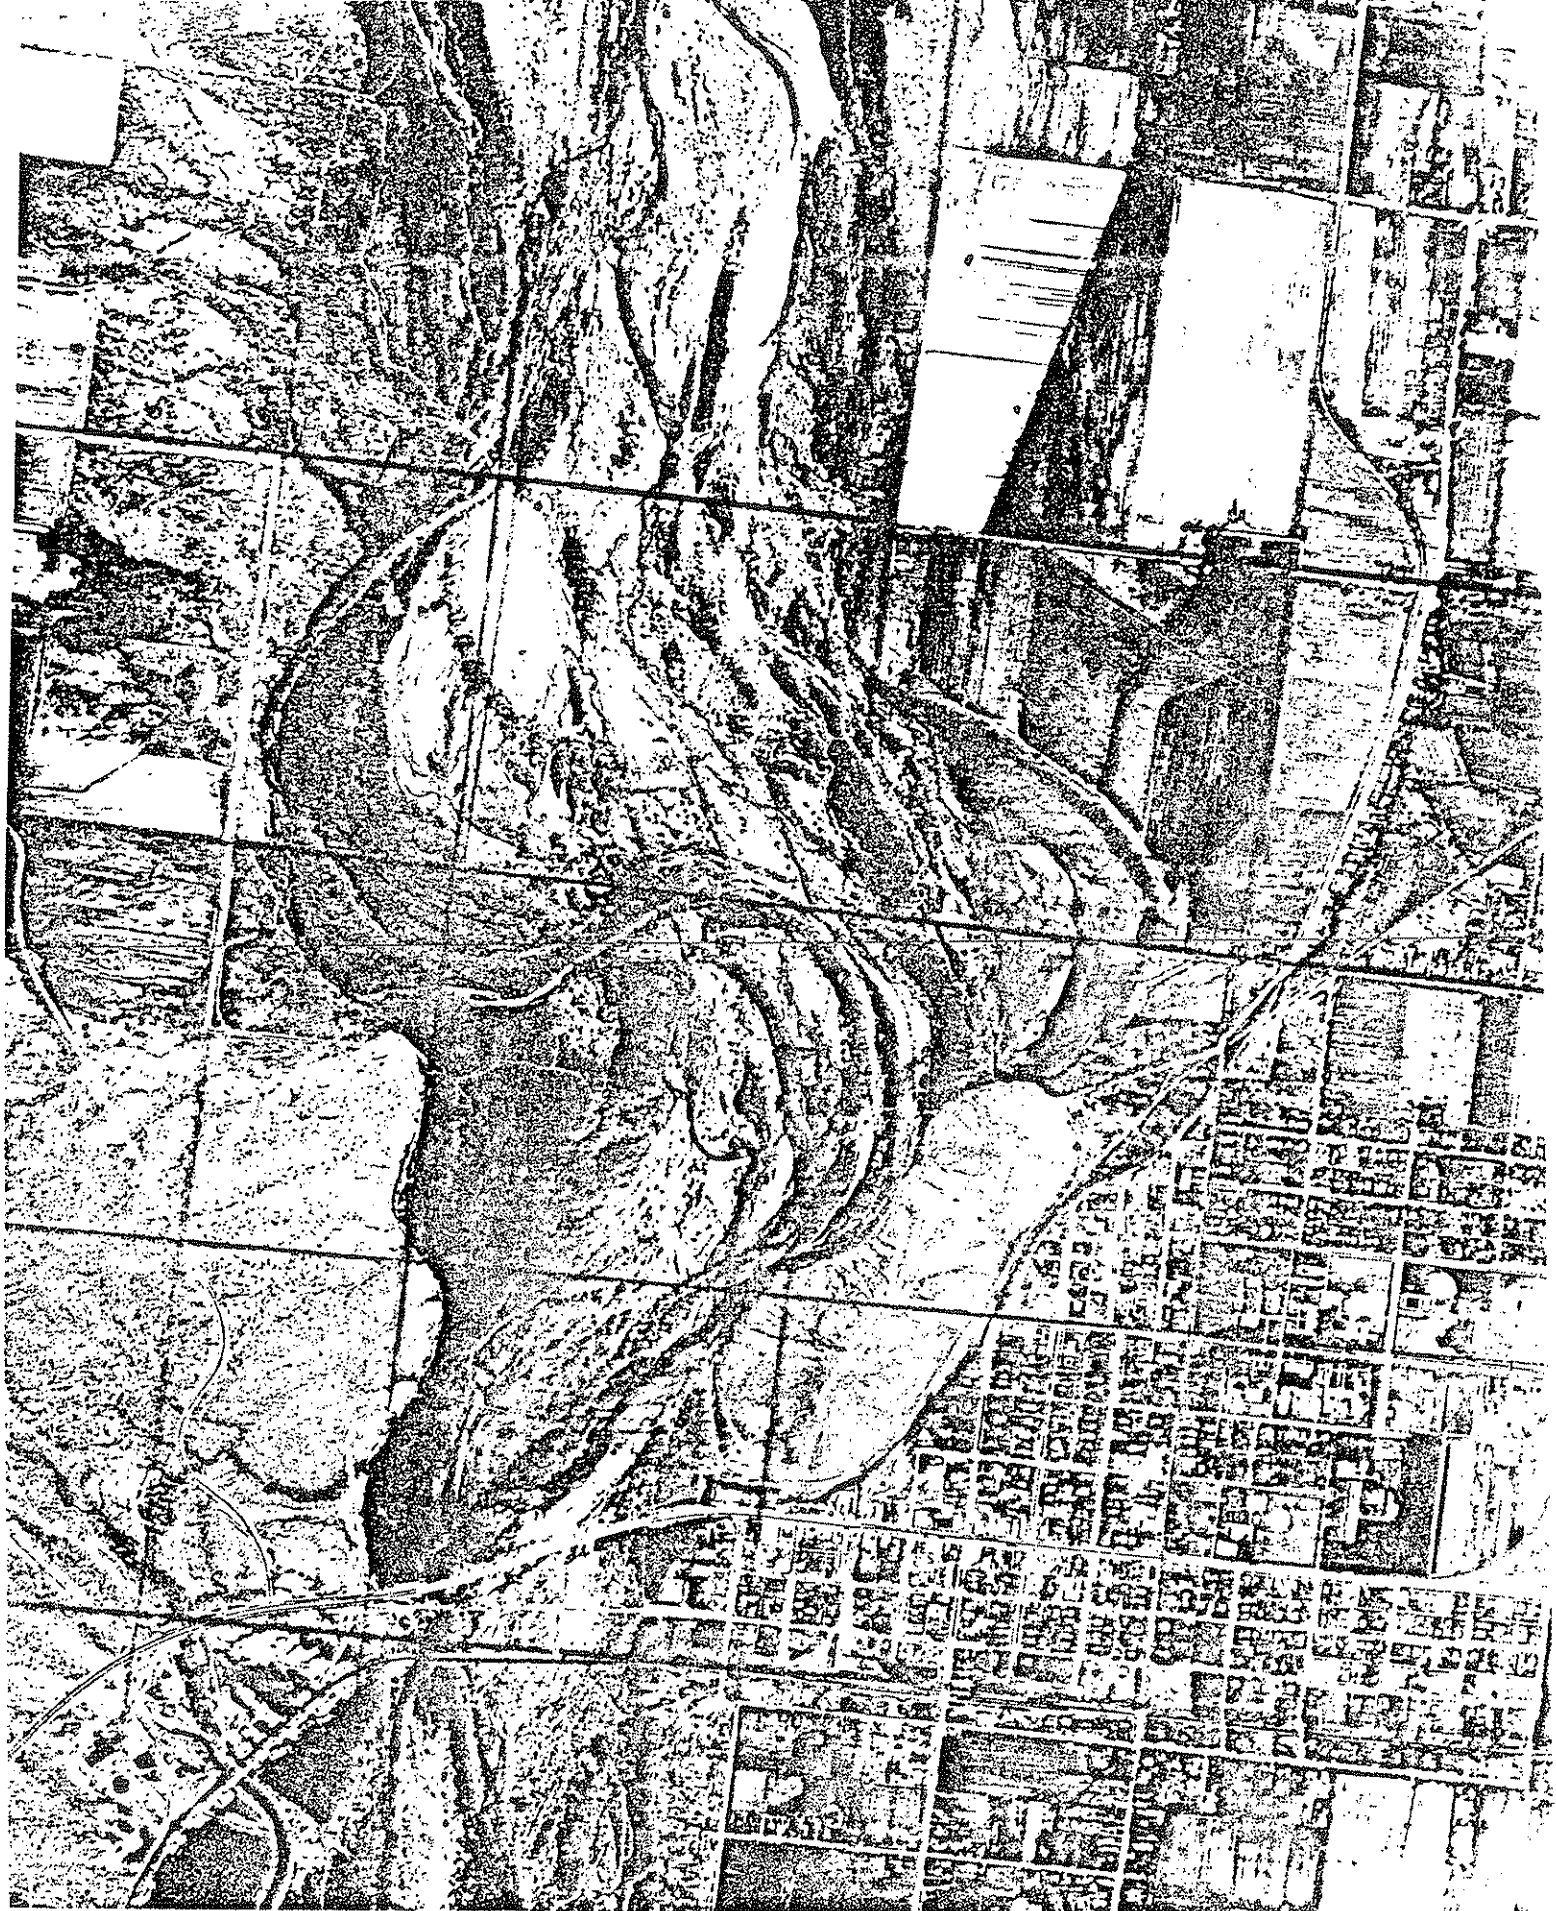
PLATE 2

A wide and shallow river course is typical of channels that are in a process of filling or aggradation. During this process the channel(s) continually shift and move to lower adjacent topography. Each small channel potentially represents the flow channel for a particular discharge. Large discharges, however, move in a relatively straight path down the valley.

The operations and developments that have been noted previously continue to further expand in the channel. A sewage treatment plant lagoon and the accompanying outfall appurtenances have been constructed immediately east of the confluence of the Indian Bend Wash and the Salt River. A comparison of Plates 2 and 6 clearly shows that the treatment plant does indeed lie in the Salt River channel. Reference: Plate 6.

A study of Plates 2 through 7 shows the high rate of urban and industrial encroachment and occupancy of the Salt River channel. The Salt River Valley as well as the channel itself are being urbanized and industrialized. The sewage treatment plant facility observed in 1964 has been greatly enlarged and now occupies approximately 50 percent of the area normal to the flow of the entire river channel. This facility also completely blocks any possible flows of the river in its (north) meandering channel. Reference: Plate 7.

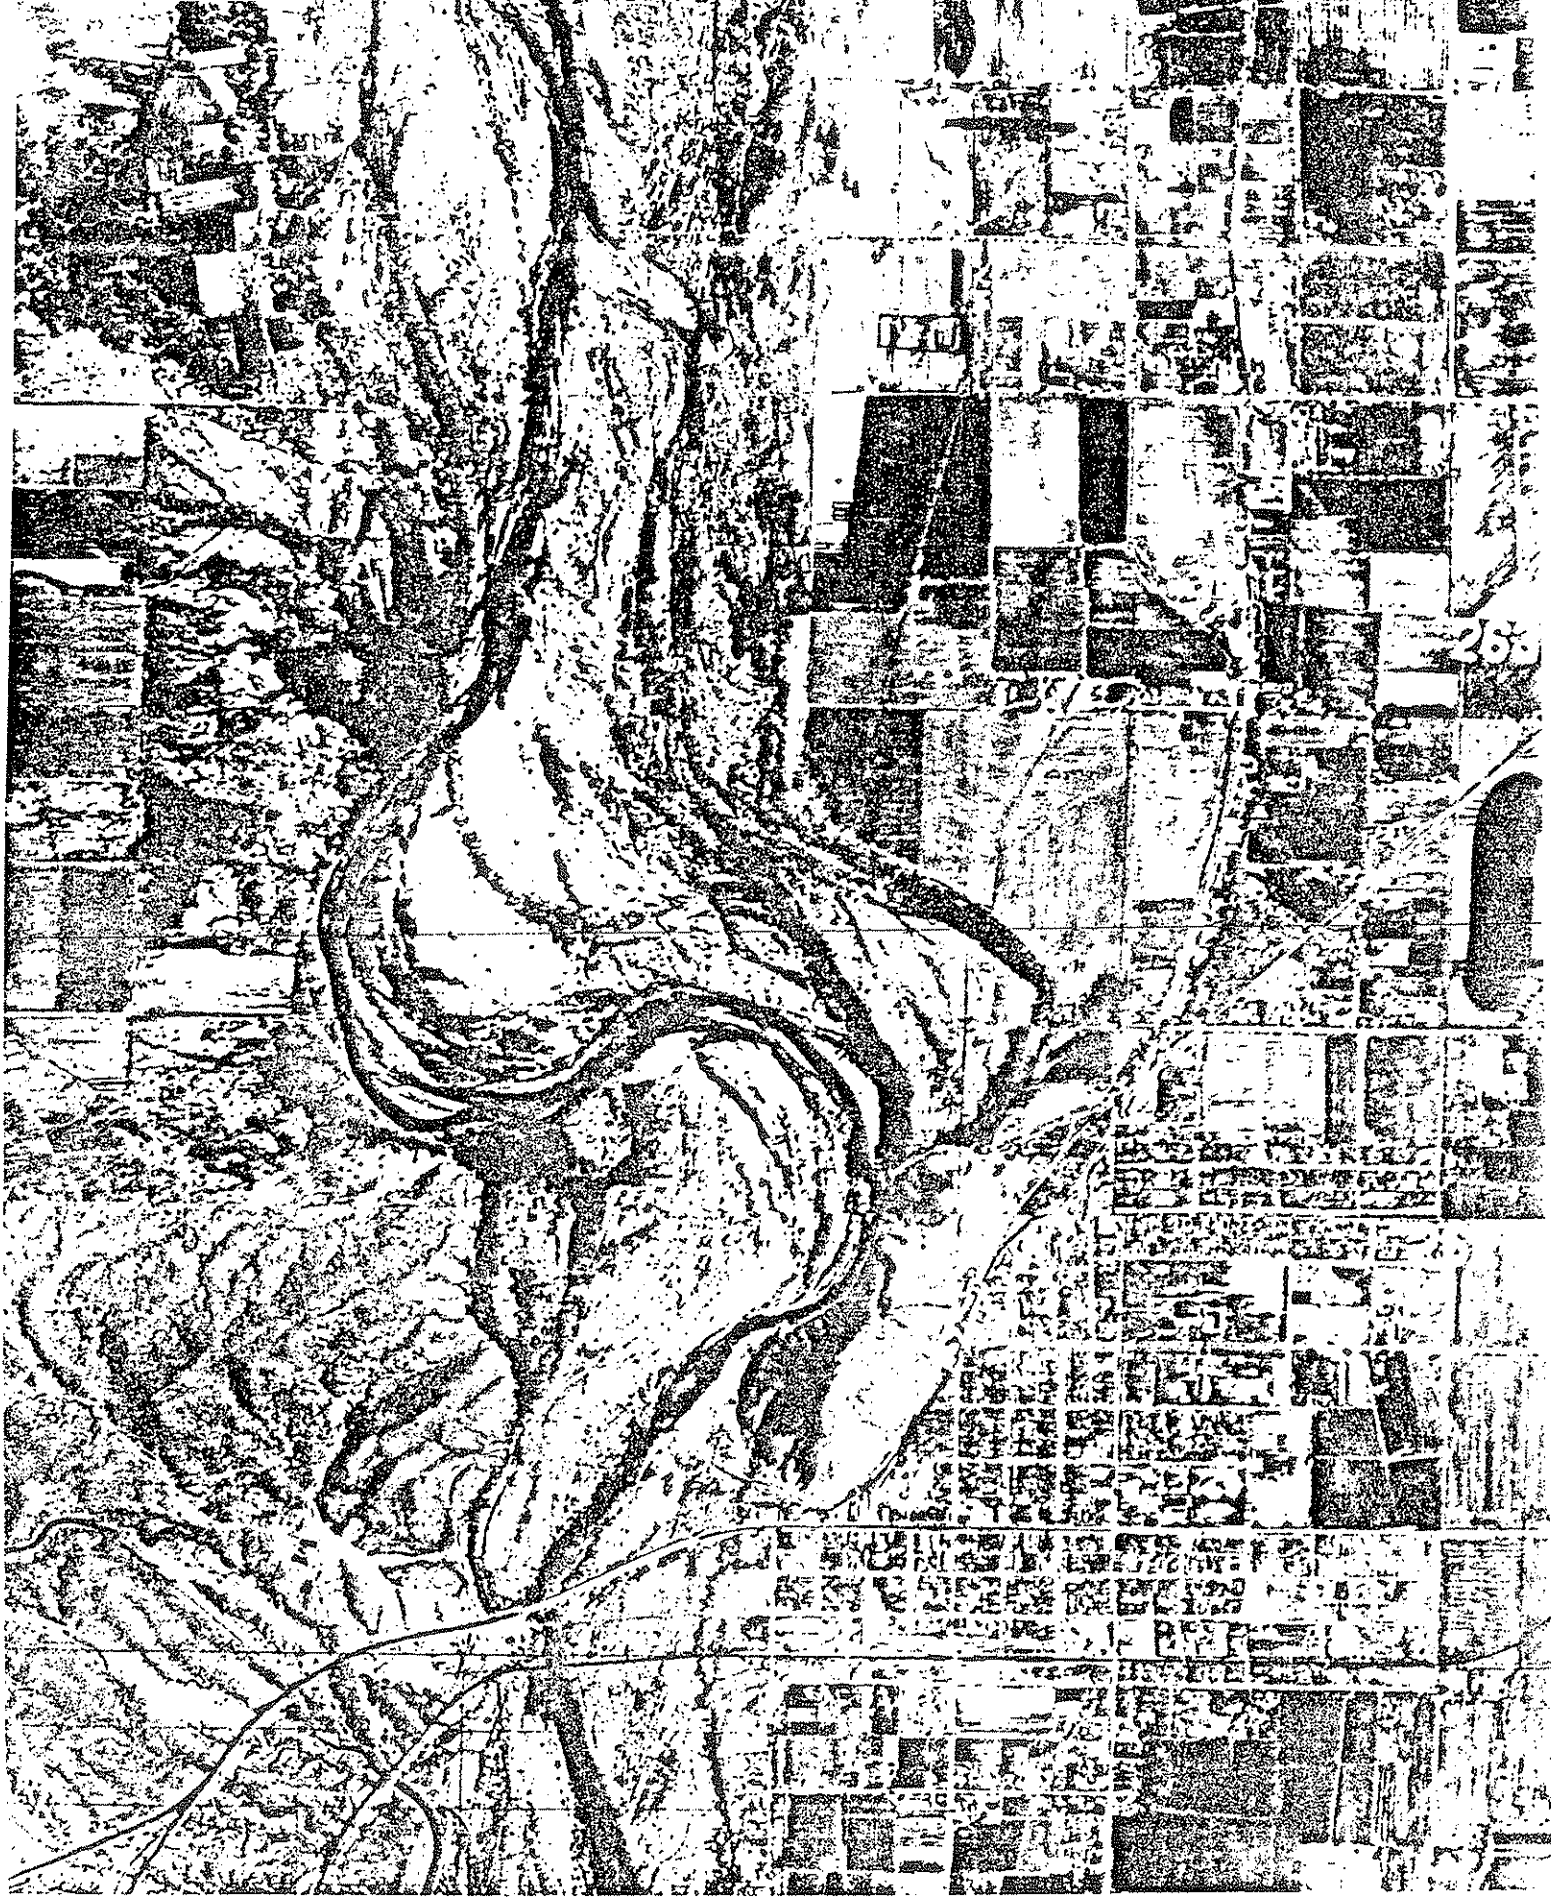
The water that once flowed continually and unrestrained in the Salt River is now stored in the upstream dams. Periodically, overland flow resulting from local precipitation does enter the river course, but it soon deposits its sediment load as the water infiltrates the already sediment-filled channel bed. The presence of the dike system located north and east of the Tempe bridges significantly reduces the flow passage area of the Tempe constriction.

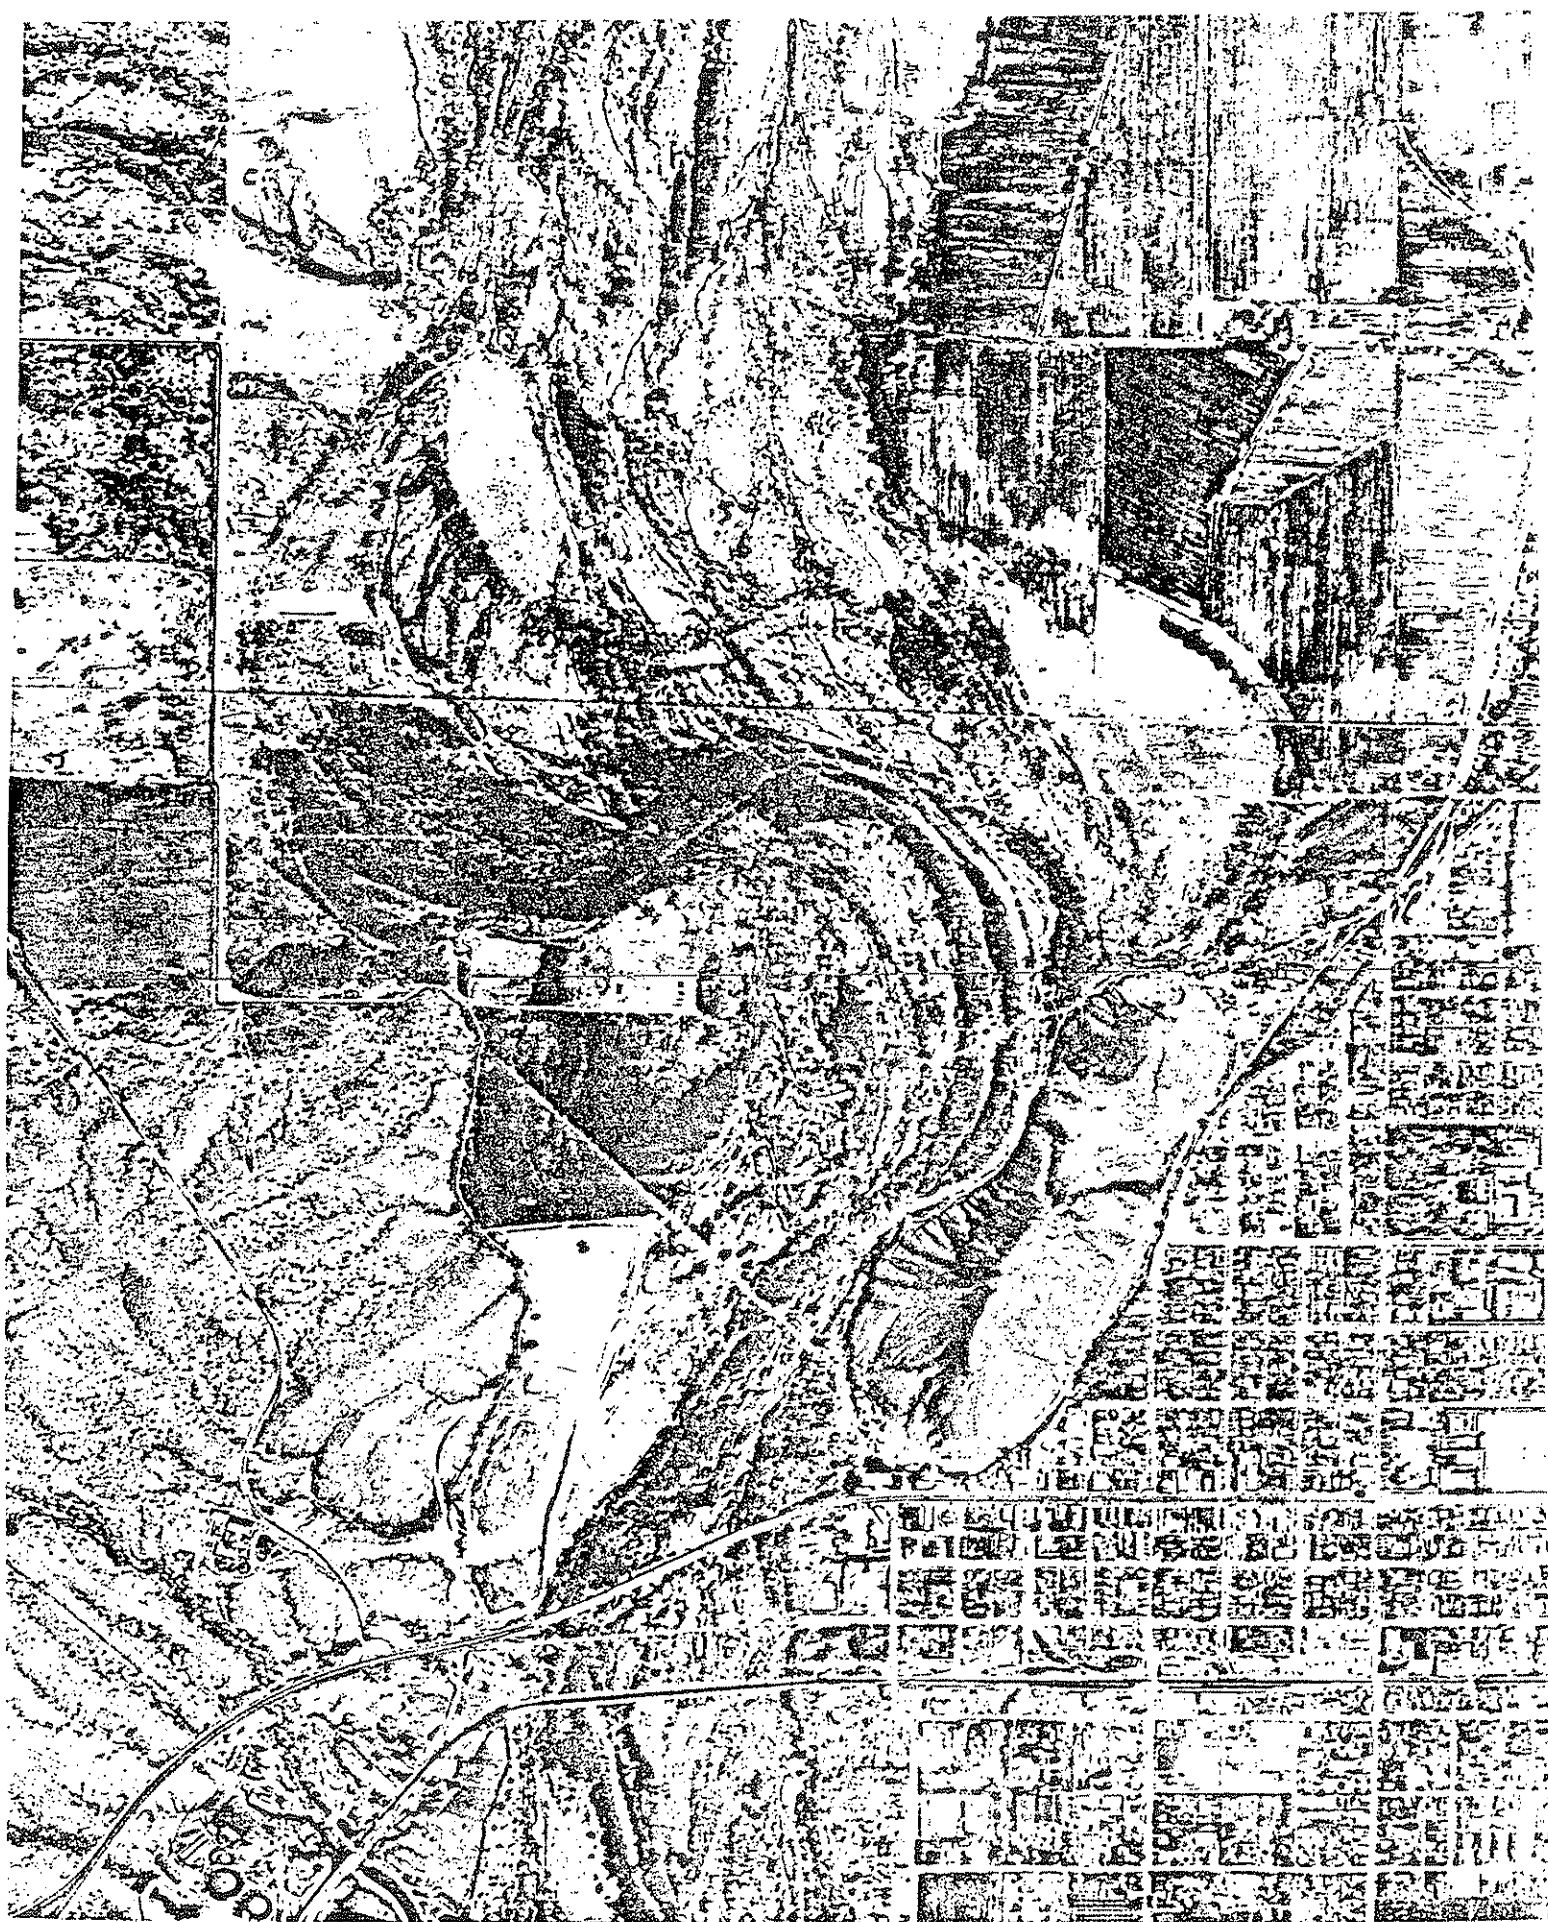
PLATE 5

The geometry and the location of a river course changes slowly and in an erratic manner. This change is of little concern to anyone until a large flow assumes possession of its channel, and help is needed to keep the water from the doors of the channel's intruders.

December 30, 1957

Urban, industrial, gravel, and roadway developments continue to increase and occupy the river channel. Reference: Plate 5.

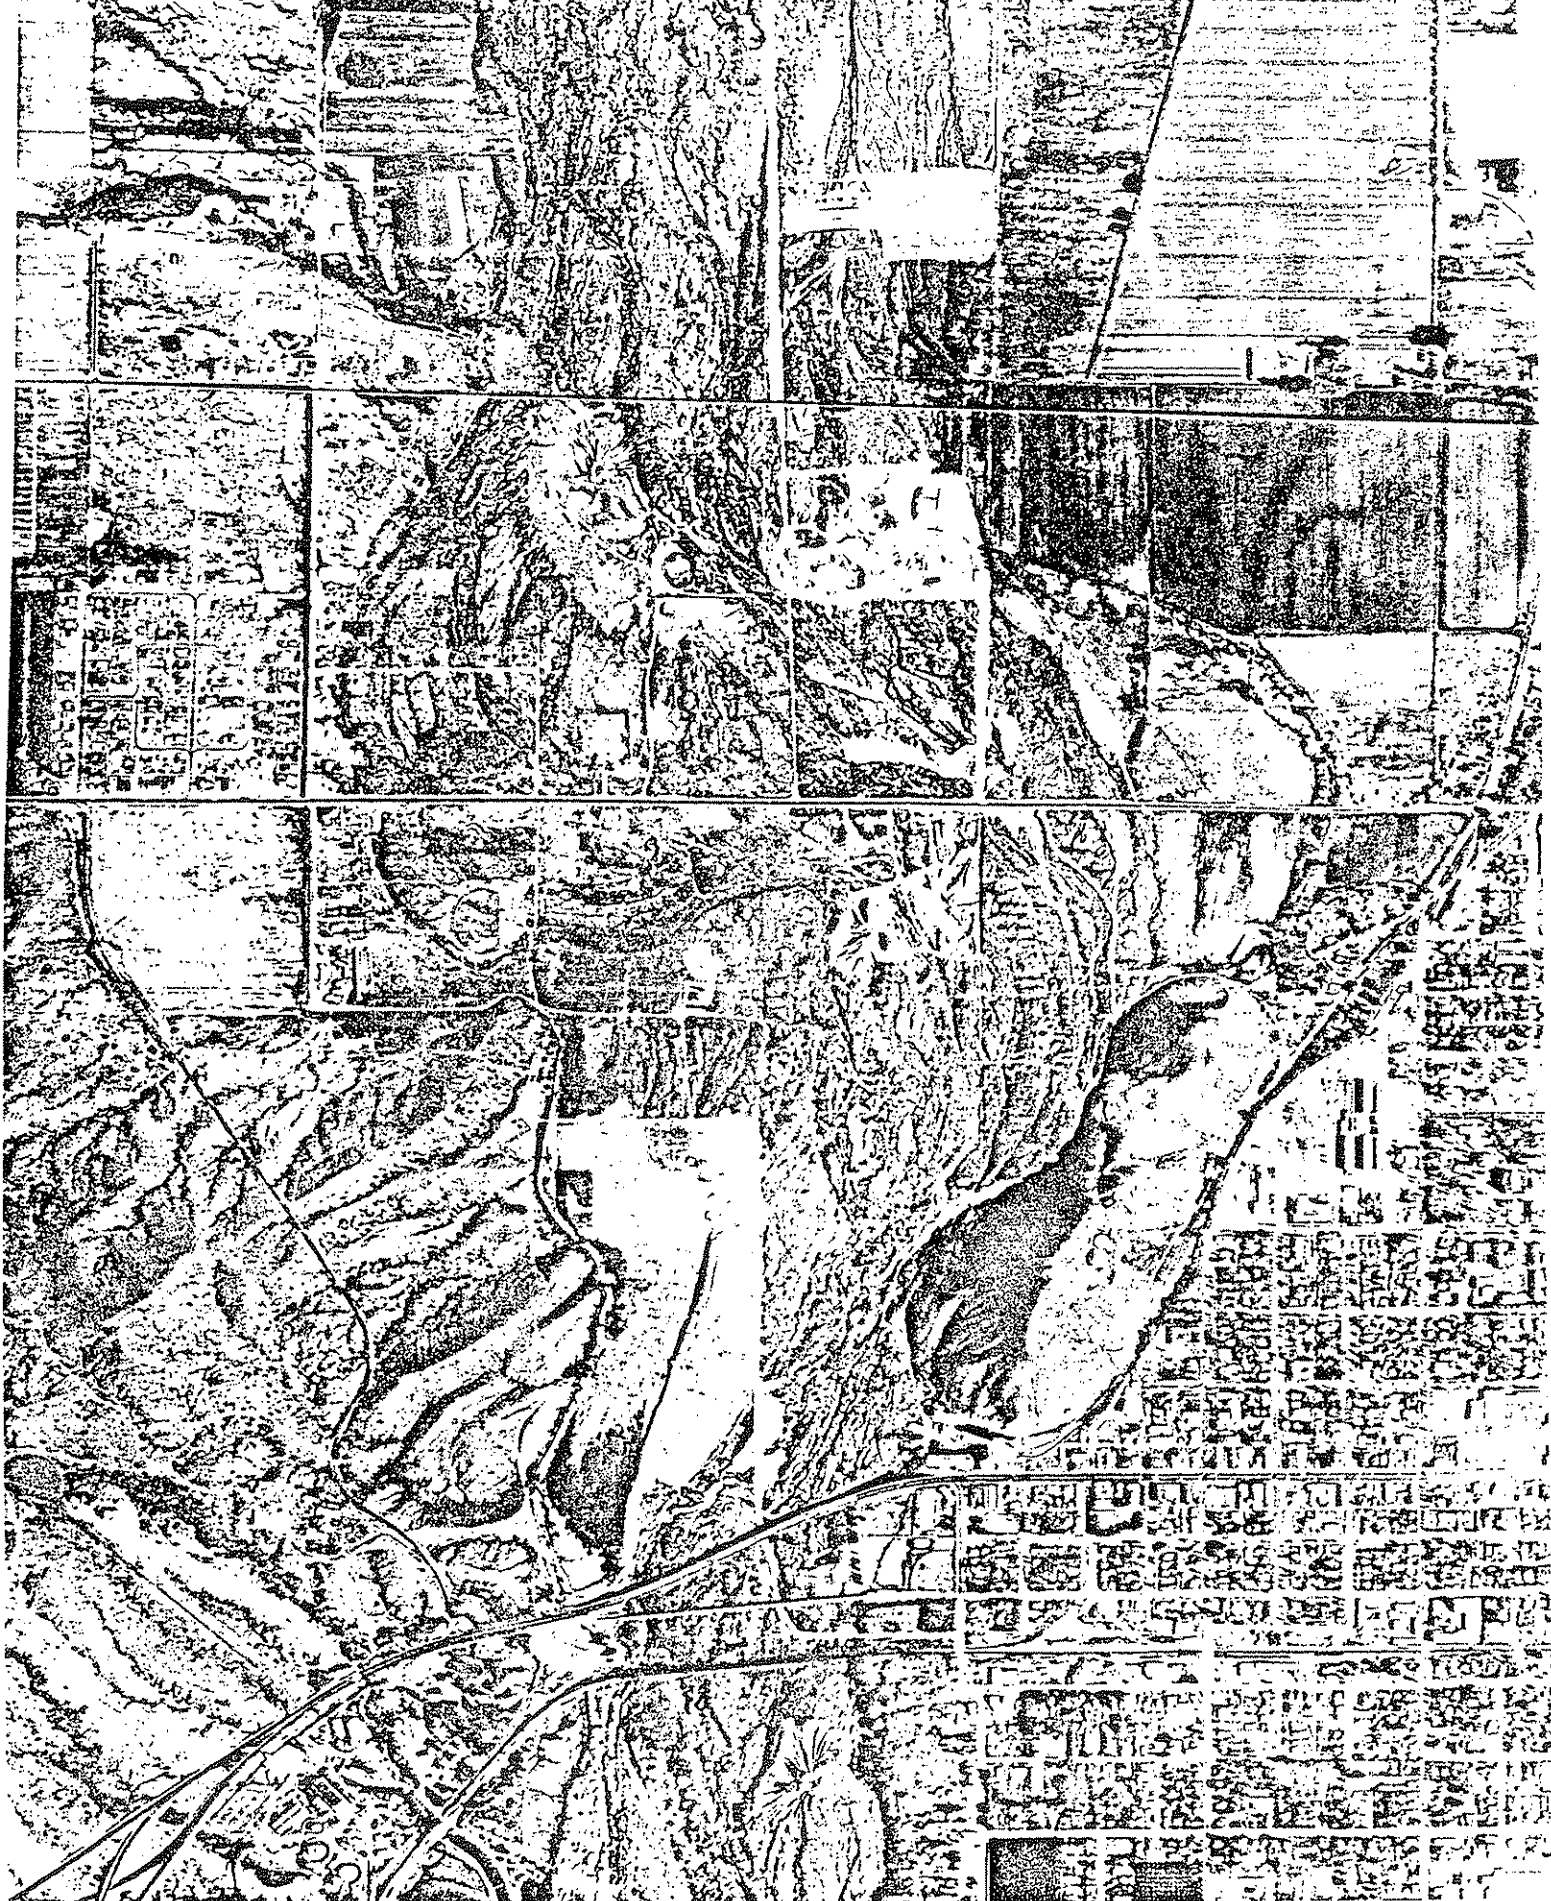
PLATE 7

The potentially active flow areas of the river continue to be occupied; a sewage treatment plant facility now partially occupies the river channel. The natural and historically defined flow channels are being obliterated.

January 12, 1965

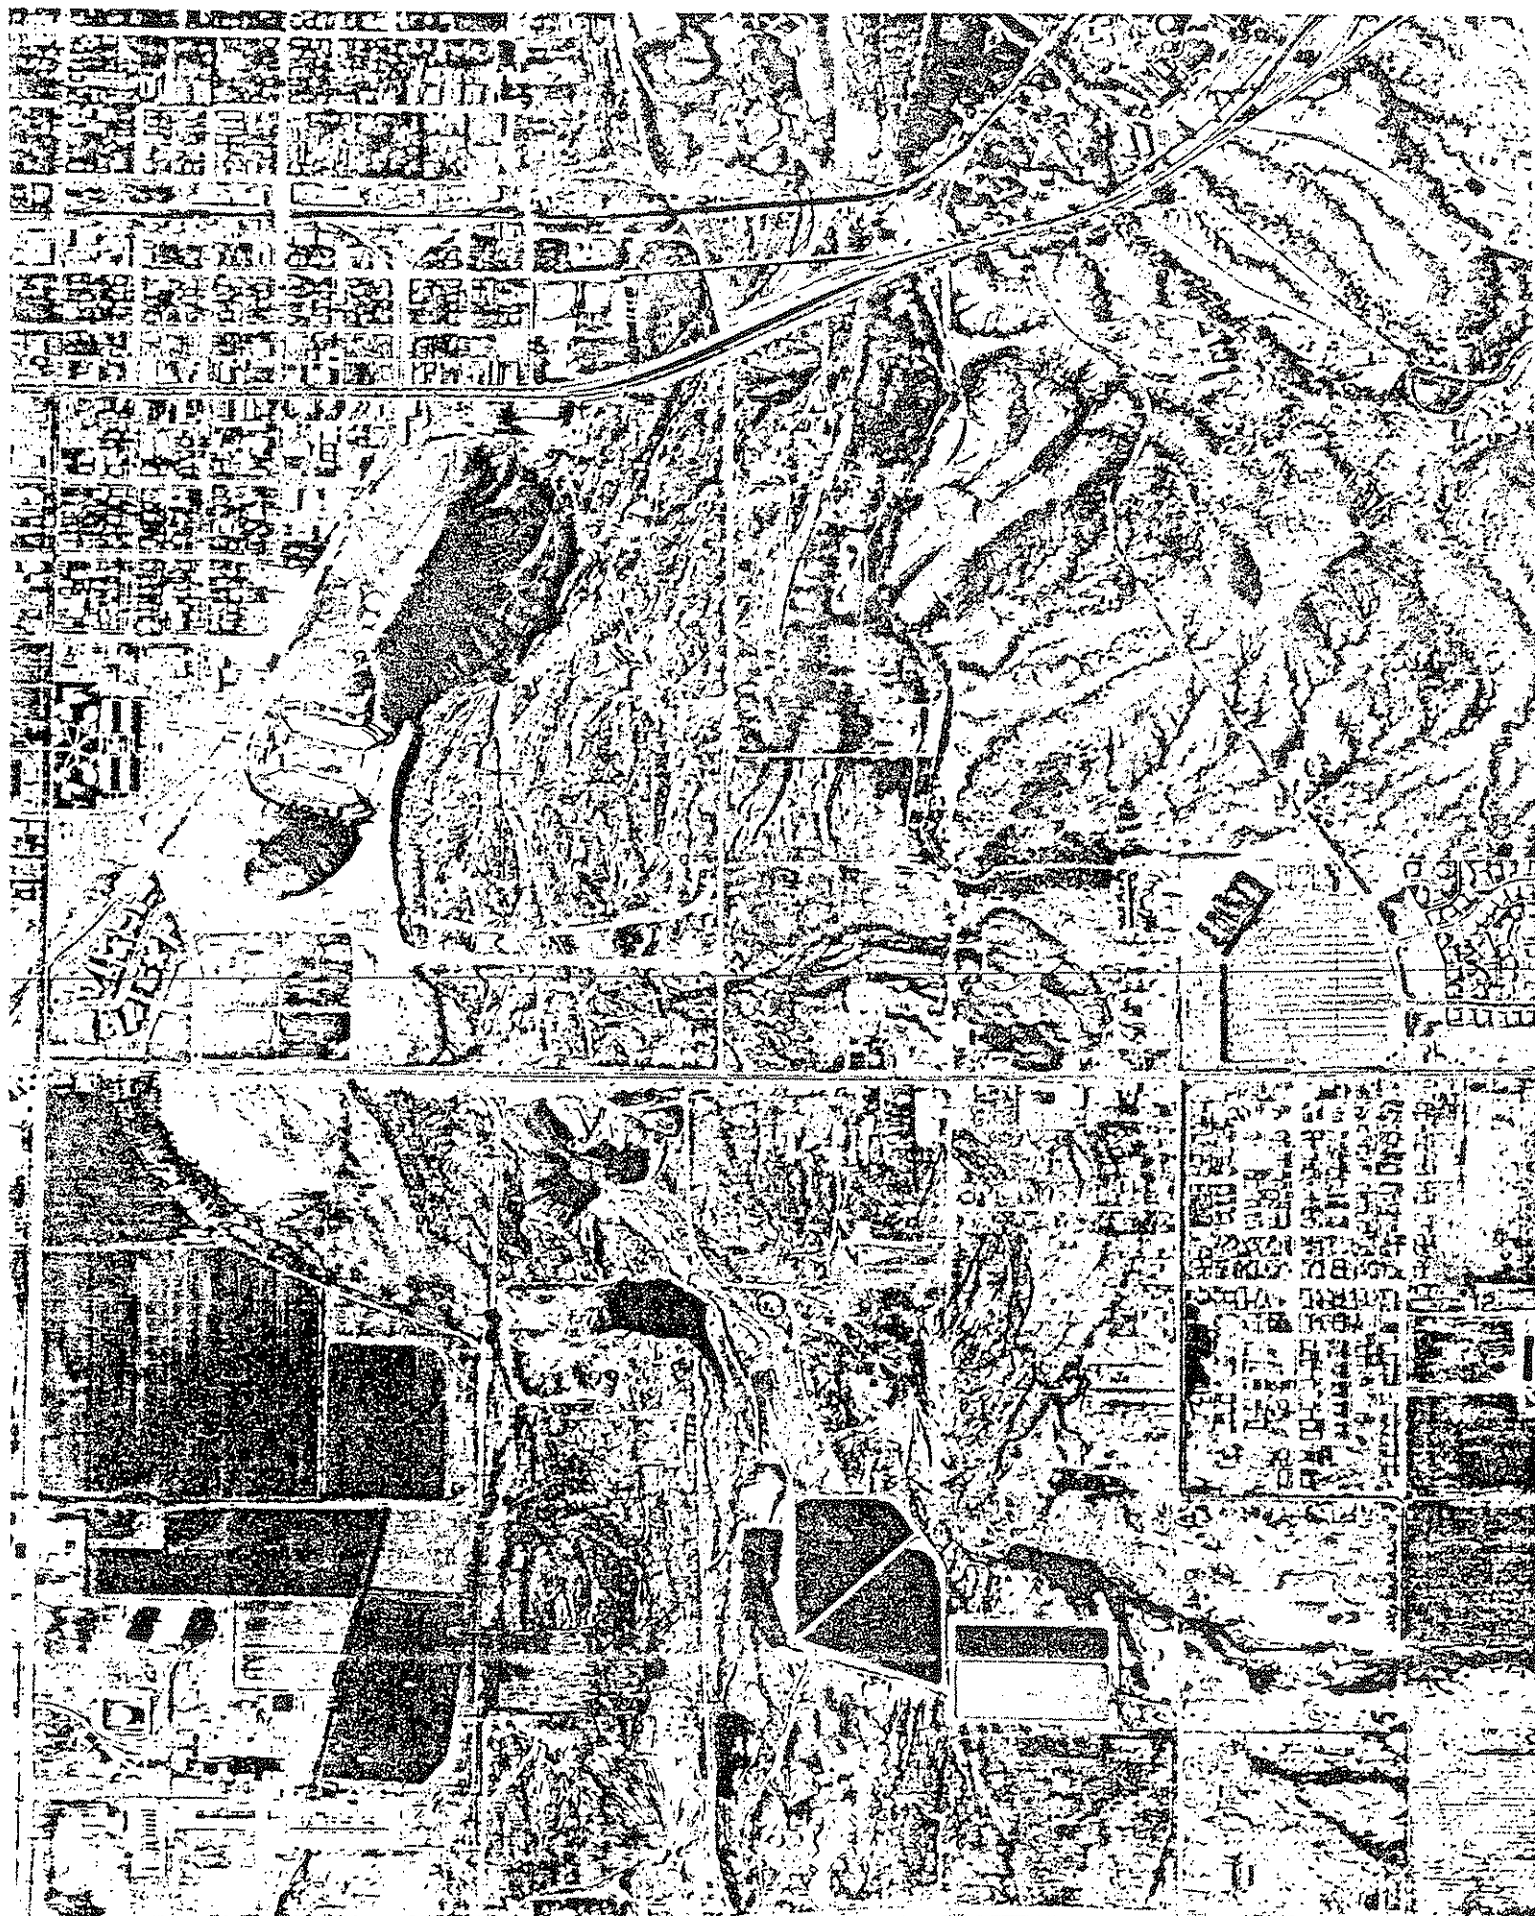
PLATE 9

When man occupies a river channel and the area immediately adjacent to it, he can expect that the river, at certain times, will contest his occupancy. This flow of 65,000 cfs can be expected to occur, on the average, once every 12 years. The high flow channel of a river usually does not coincide with the low flow channel(s); during a large discharge the main flow path is in a relatively straight line down the valley. All of the obstructions to the flow of this river in its natural channel, which have been developed over the years, now direct the flow southward. Observe the position of the dike system east of the Tempe bridges and the water that is ponded.

December 31, 1965

flow during this large discharge is in a channel that lies north of the Tempe Butte and the existing transmission towers. The retarding and inhibiting influence of the developments along Scottsdale Road and the north part of the channel are clearly evident in Plates 8 and 9. The large degree of development--for example, houses, fences, major structures, and so forth--that deflected, in part, the normal course of the flow is shown in Plate 9. Also of interest in this photograph is the geometry of the flow, and the tortuous path it is caused to assume by the developments. These developments are partly responsible for the relatively static body of water that exists in the north part of Section 15. It appears that this area would have been a major flow channel if the discharge had not been diverted to the south as already noted, if this channel area had not been blocked to the east by the sewage treatment plant lagoons and appurtenances. References: Figure A-6; Plates 8 through 12; Plate E-3.
