# THE SALT AND GILA RIVERS IN CENTRAL ARIZONA

A GEOGRAPHIC FIELD TRIP GUIDE

EDITED BY  
WILLIAM L. GRAF

DEPARTMENT OF GEOGRAPHY PUBLICATION 3  
ARIZONA STATE UNIVERSITY

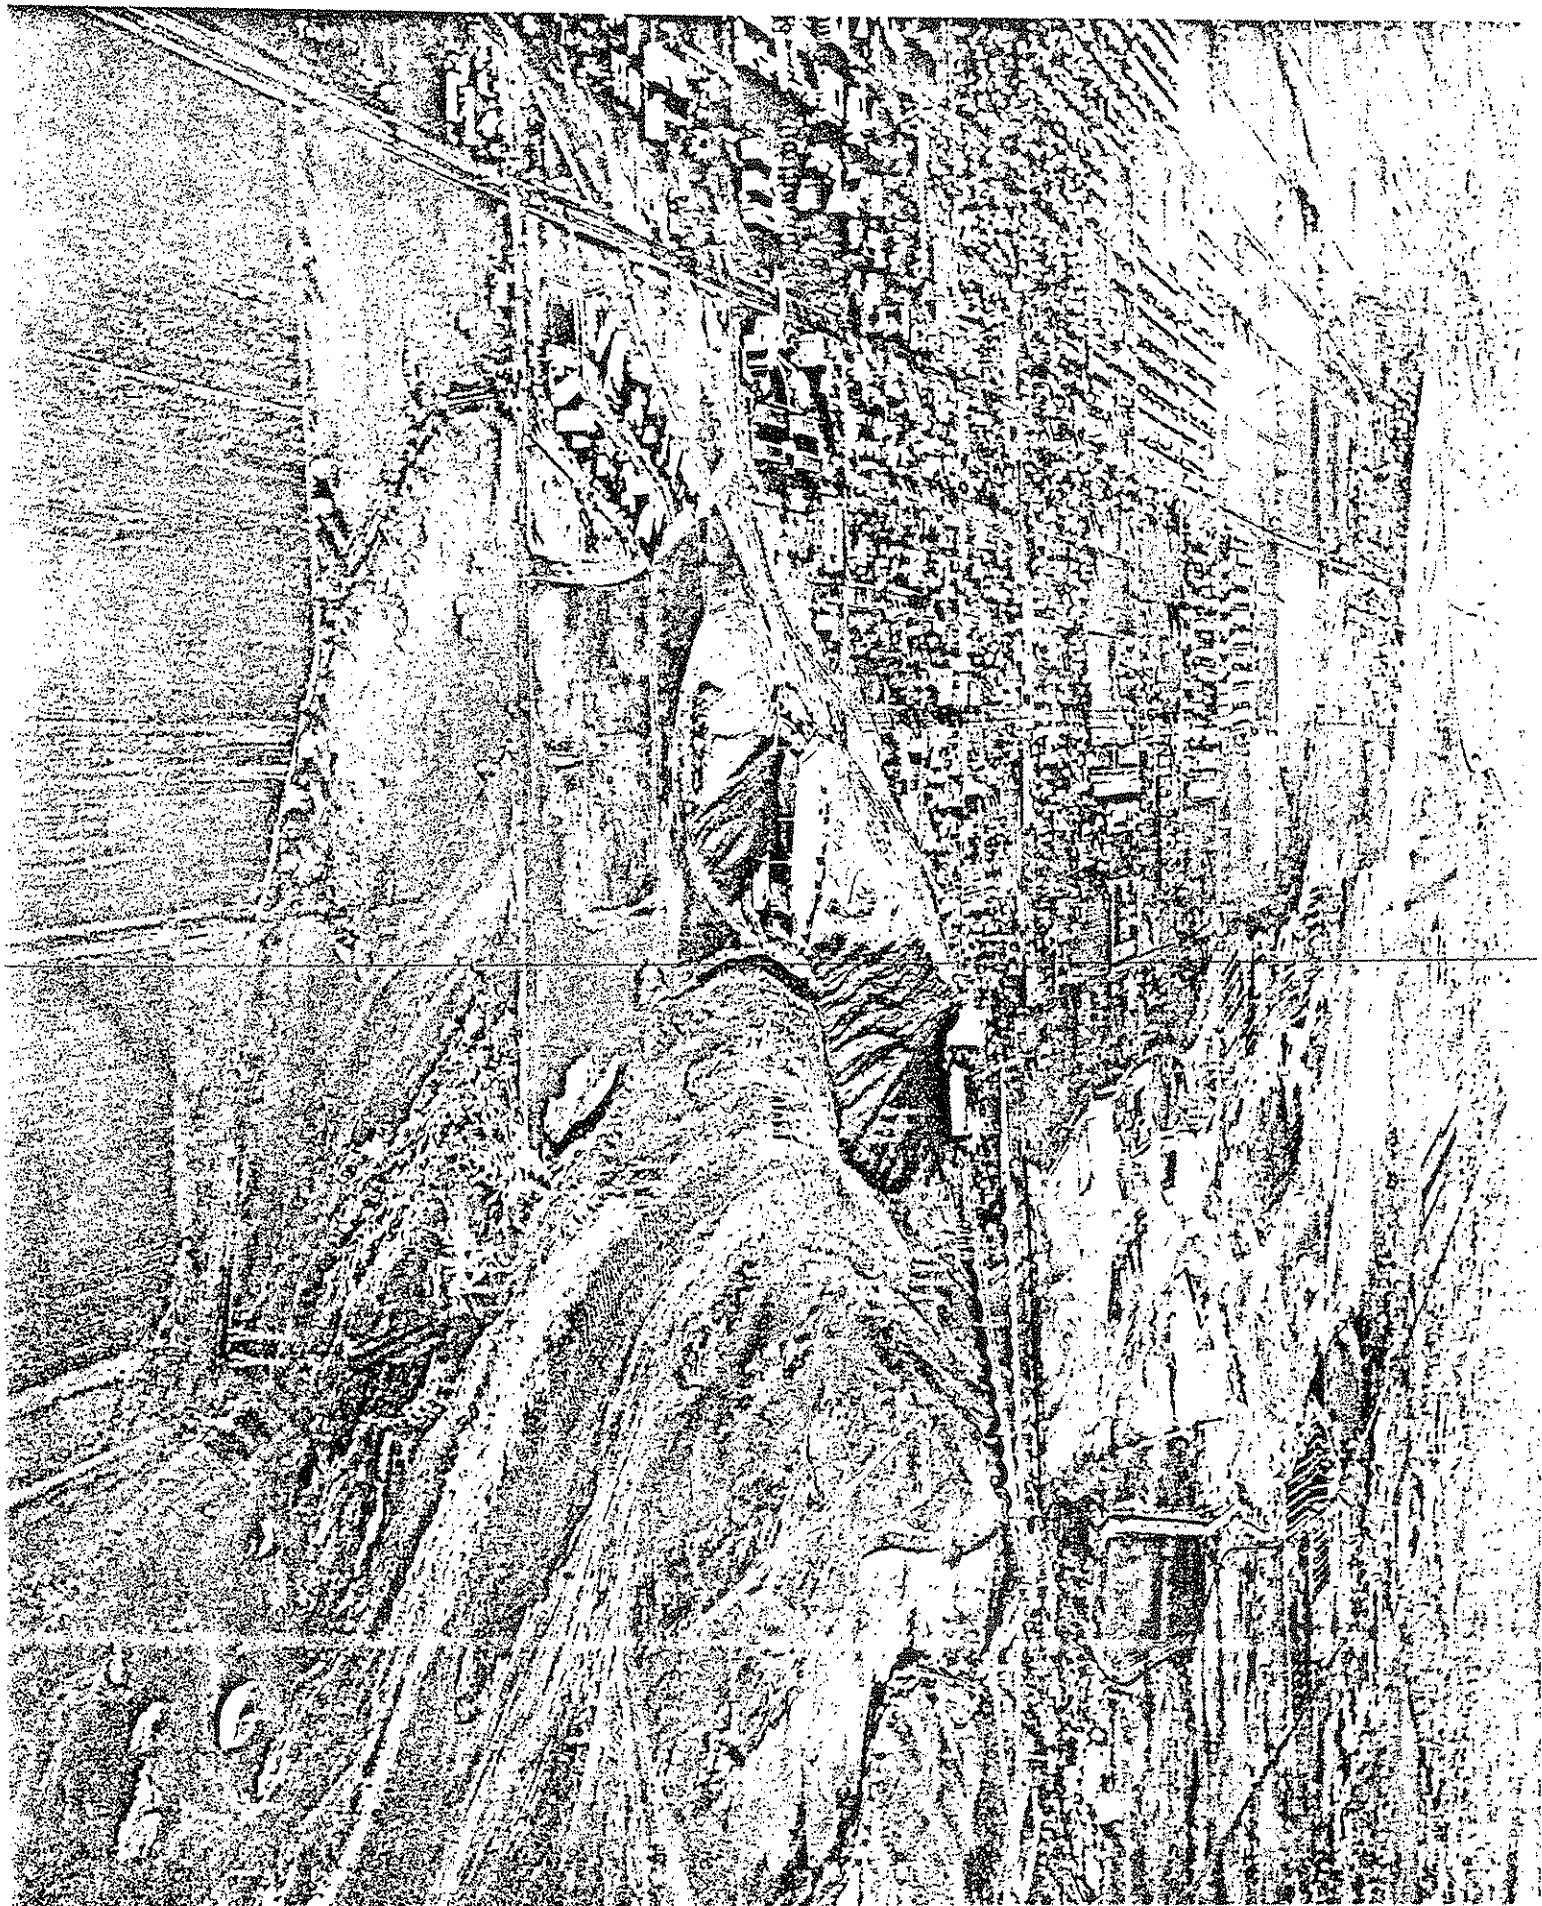
PLATE 13

January 13, 1966

The channel immediately after the 65,000 cfs flow bears slight resemblance to the channel of, say, 1941. Little water has been allowed to flow in its historic channel. It is of interest to note that a large part of Scottsdale Road, north of the channel, was not removed by the discharge but remained an obstruction throughout the flow. A comparison of Plate 7, of the poorly defined channel before the large flow, and Plate 13, of the channel cut by the flow, afford a good study of the man-made encroachments on a stream channel region and the results of the stream's efforts to reclaim its channel. Reference: Plate 13.

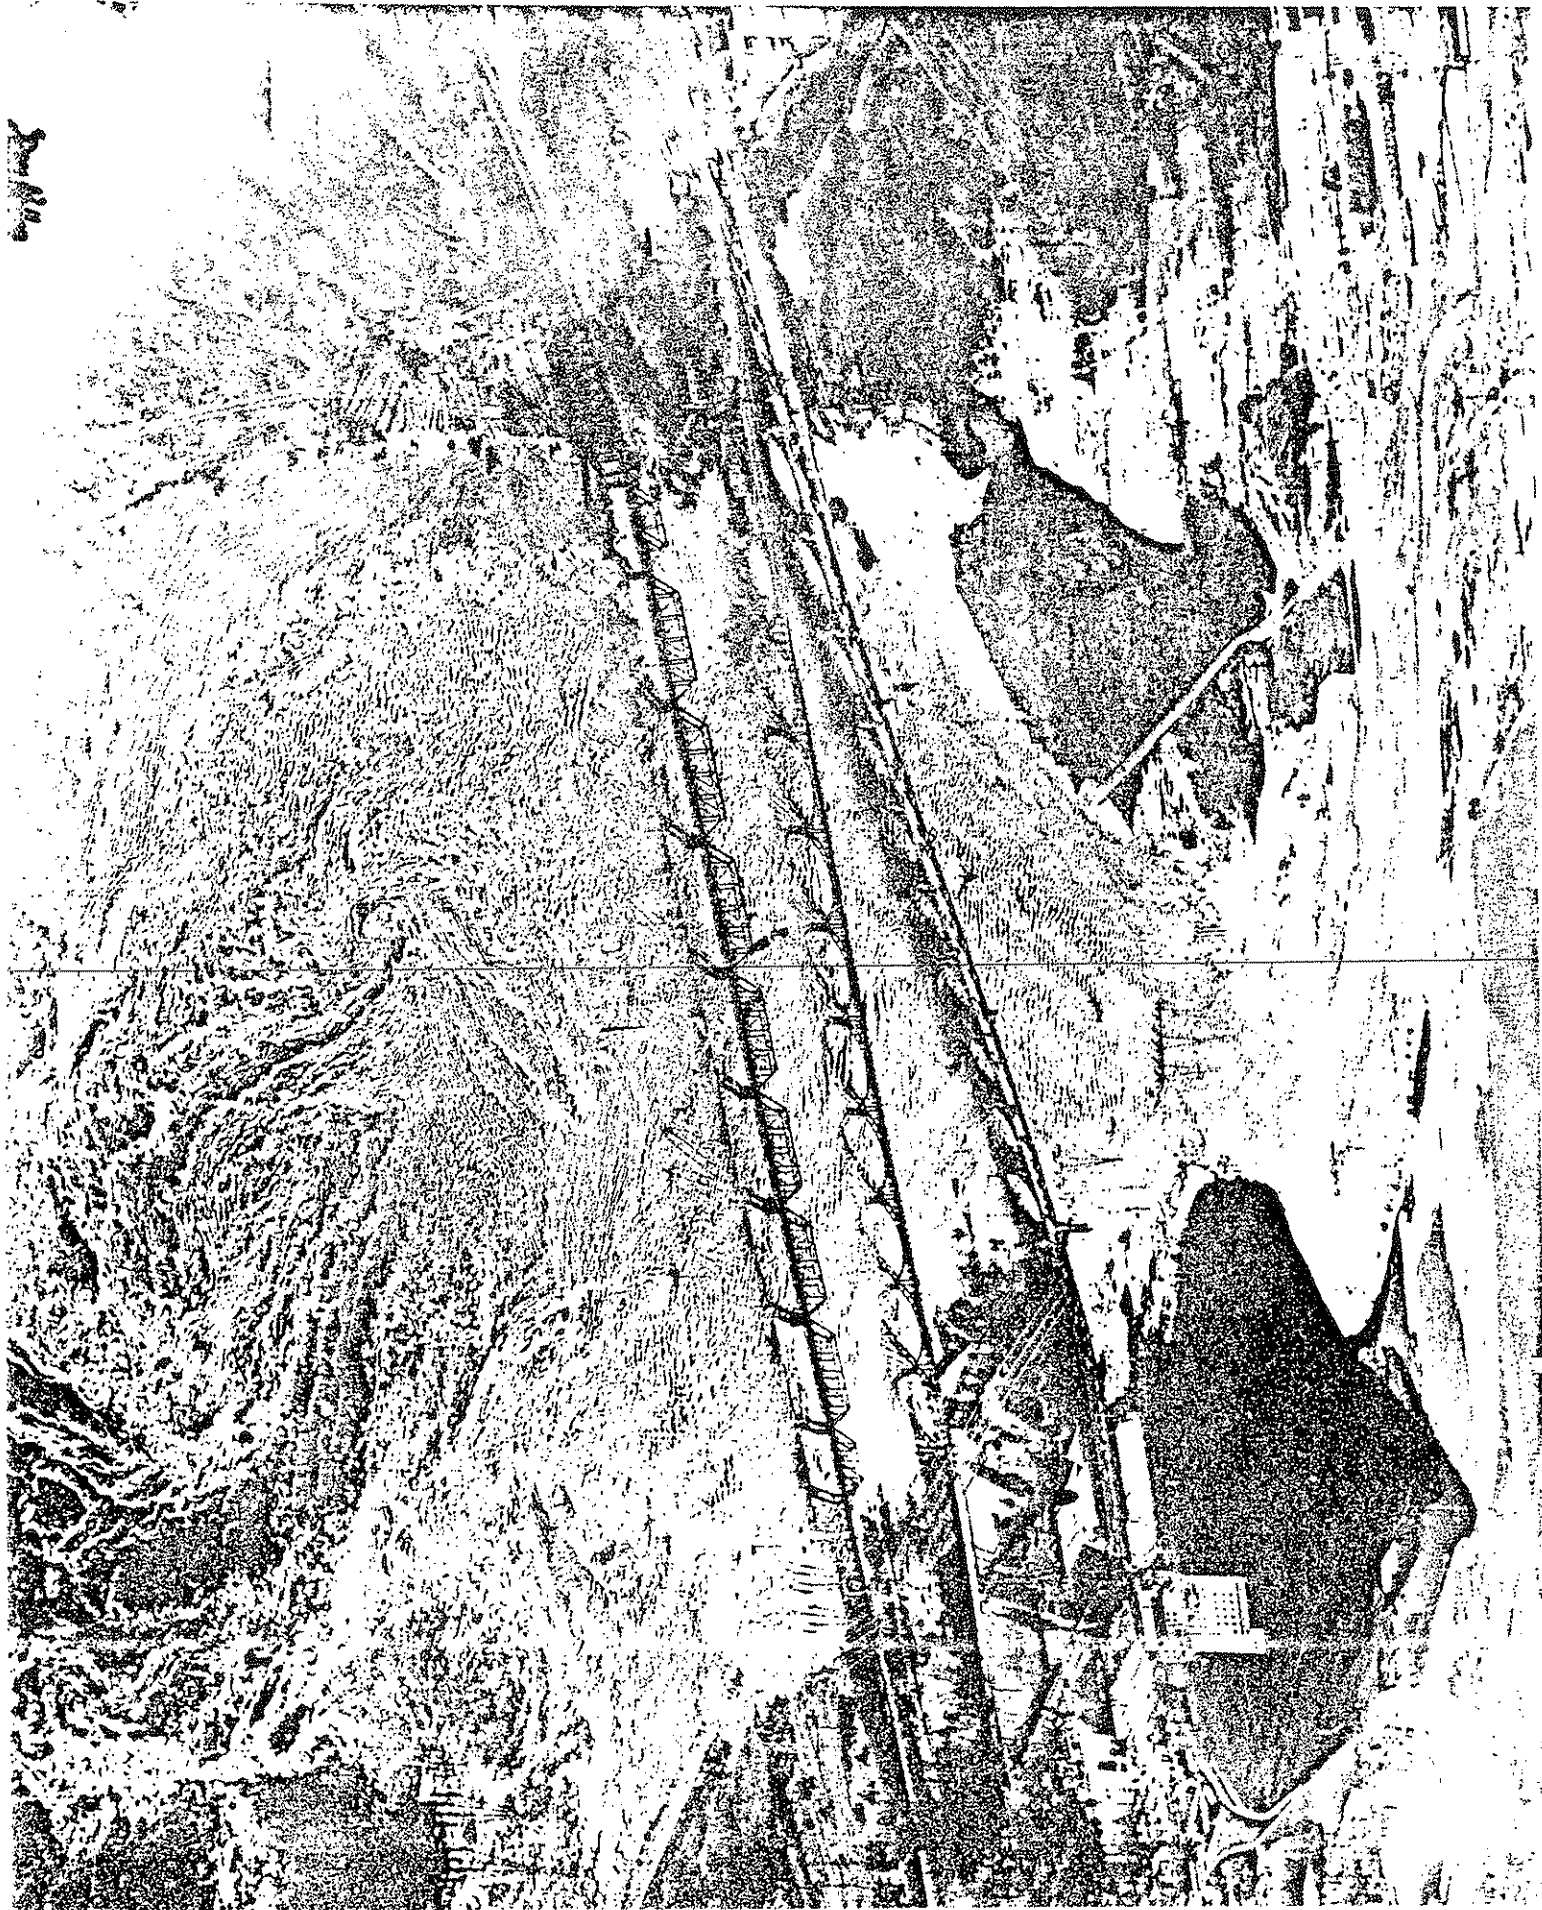
PLATE 14

January 2, 1969

north of the Arizona State University stadium. The model study of this work has indicated that this material can increase the hydraulic efficiency of the river channel. An increased efficiency is caused by the flow being directed in a straighter path than has previously been possible through the Tempe constriction. References: Plate 14; Plate E-4.

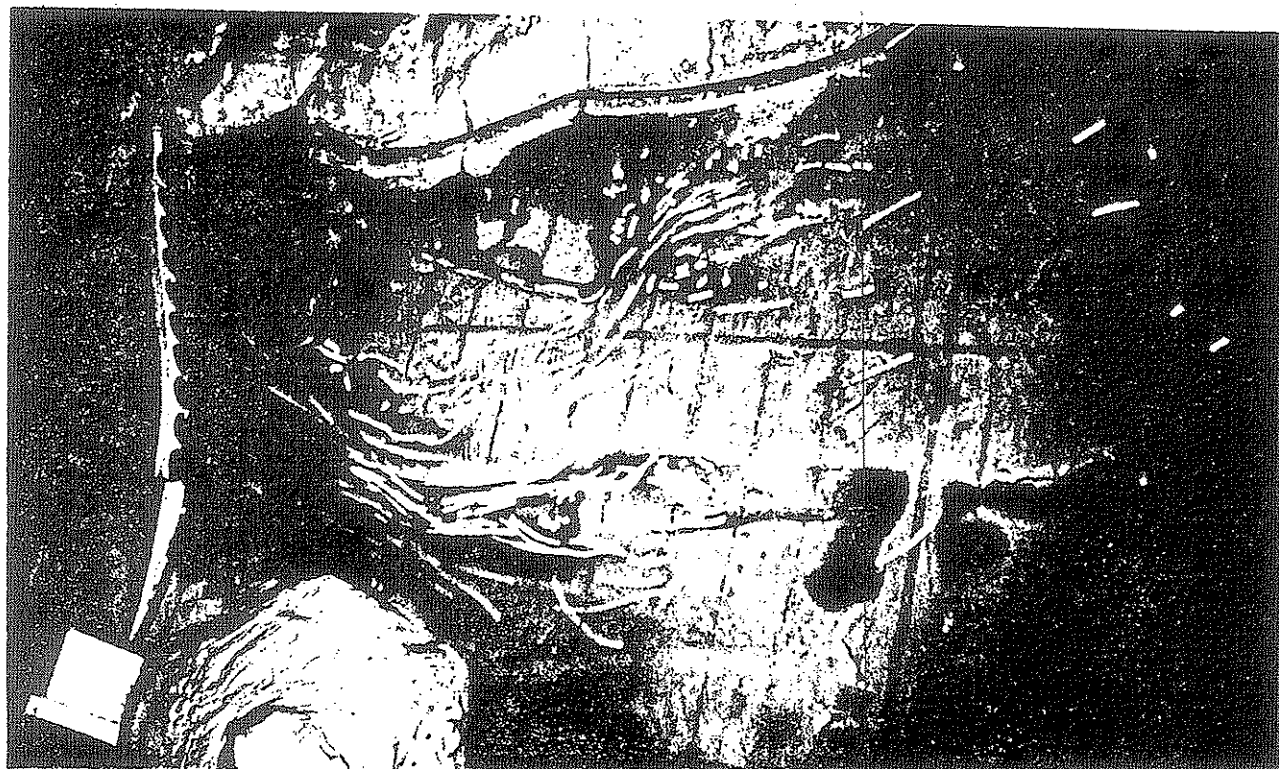
PLATE E-2  
Model Study of the Salt River  
Dike System East of  
Tempe Bridges

Direction of  
Flow
