Arizona State Land Department
September, 2014

Presentation to ANSAC: Verde River Navigability

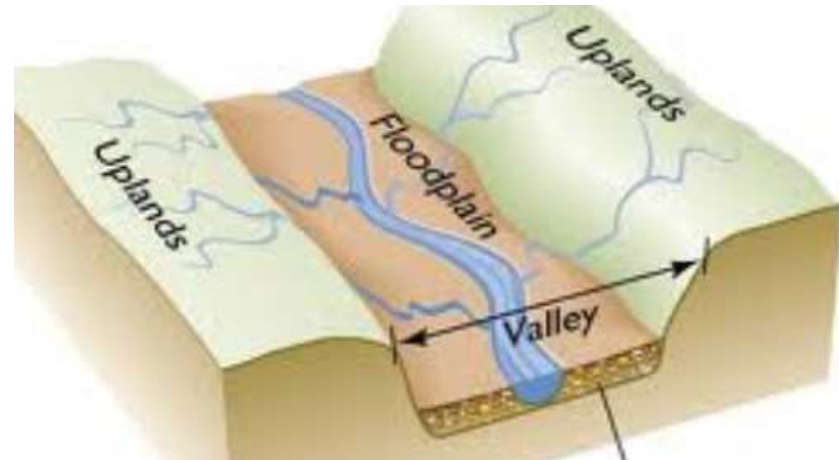
- Floodplain *
 - Areas in a watercourse which have been or may be covered partially or wholly by flood water (See A.R.S. § 48-3601).
 - Includes a low flow or main channel that is ordinarily inundated, and elevated areas that are less frequently inundated.

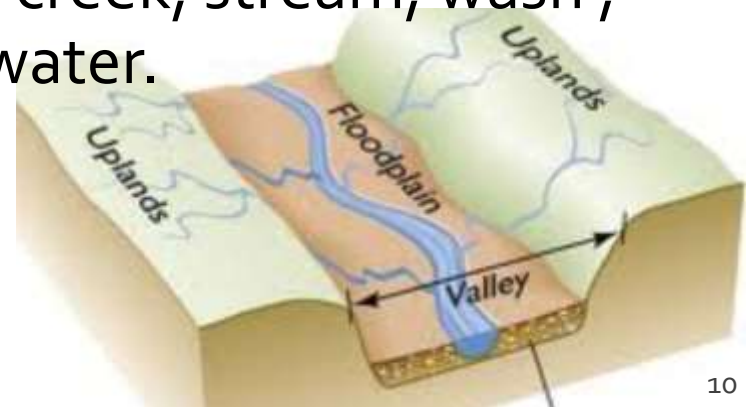
- Channel *
 - An open conveyance of surface water having a bottom and sides in a linear configuration.
 - Low Flow (Main) Channel. A channel within a larger channel which typically carries low and/or normal flows. The area within the ordinary high watermark.
 - Watercourse (ARS A.R.S. § 37-1101.11) – the main body or portion or reach of any lake, river, creek, stream, wash, arroyo, channel or other body of water.

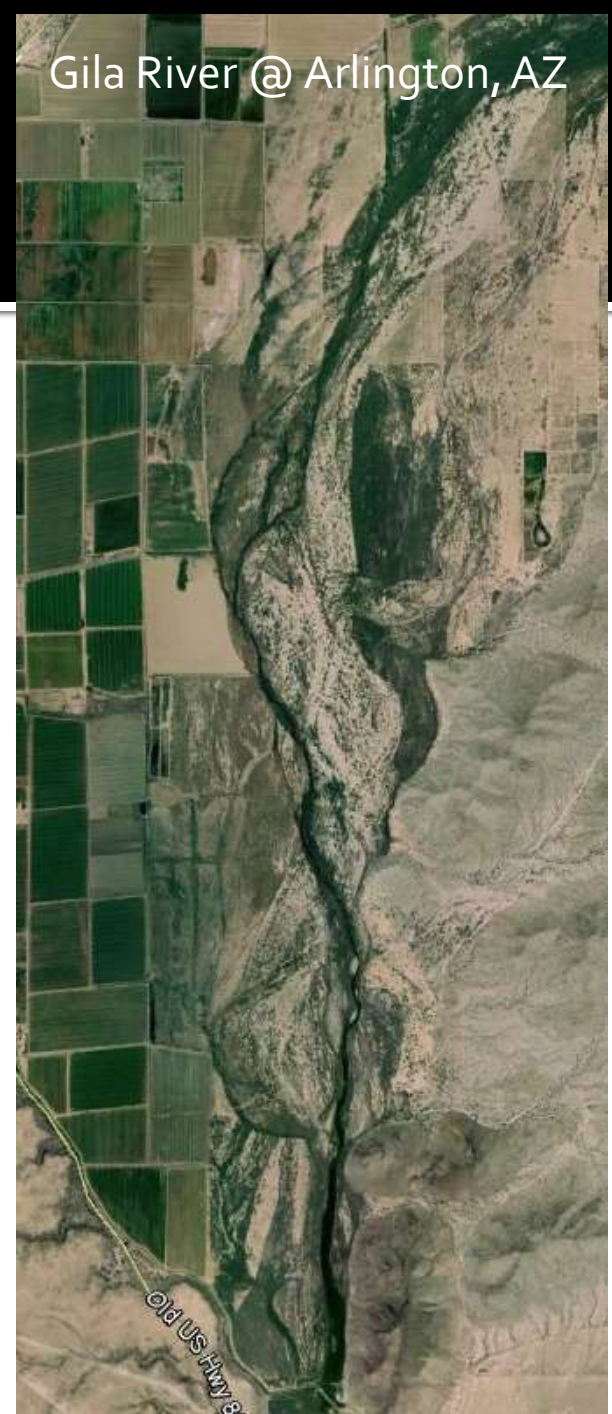
Gila River @ Arlington, AZ

Compound Channels

<< Braided Flood Channel

Non-braided main channel >>

Boating occurs on ordinary flows in the main channel, not on the flood channel.

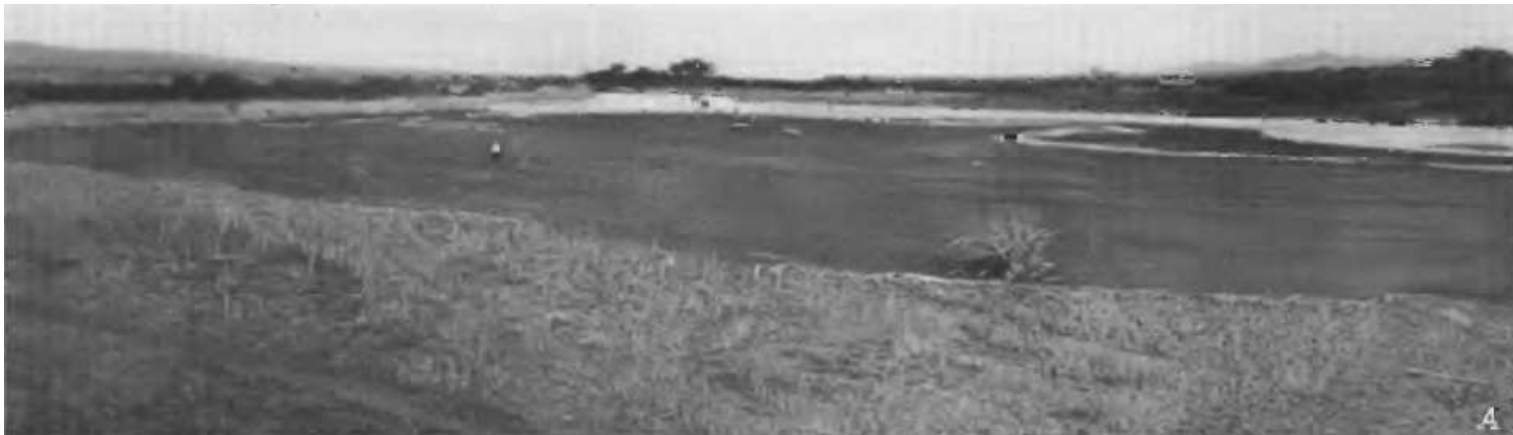
- Example: Burkham, 1972 Study of Gila
 - Phreatophyte study – water use by floodplain vegetation
 - “Stream channel” = area devoid of vegetation
 - Not = boating channel, except in high flow
 - “Active channel” – recent erosion, deposition, water flow
 - “Bottom land” = 1914 flood channel (inclusive)
 - “Flood plain” = outside stream channel, inside bottom land, densely vegetated

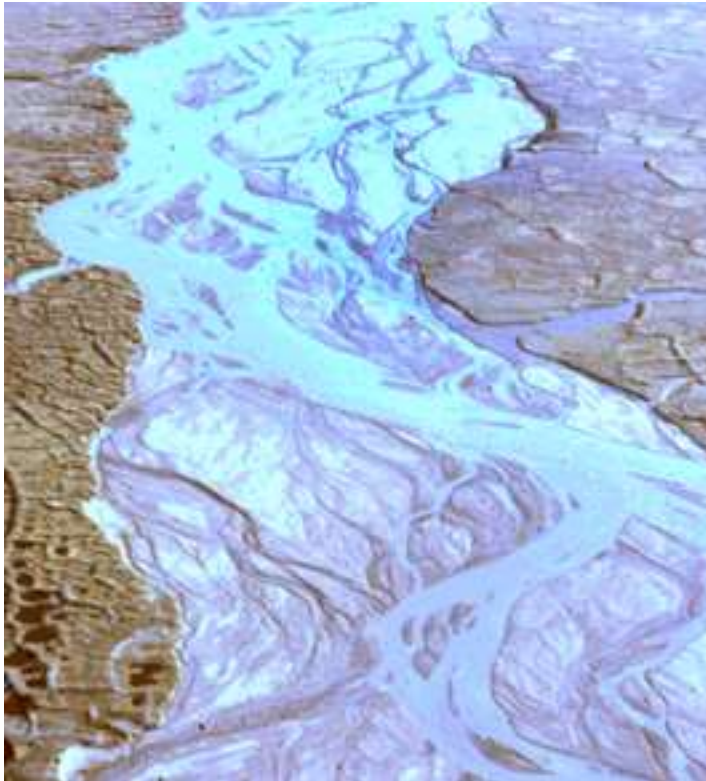
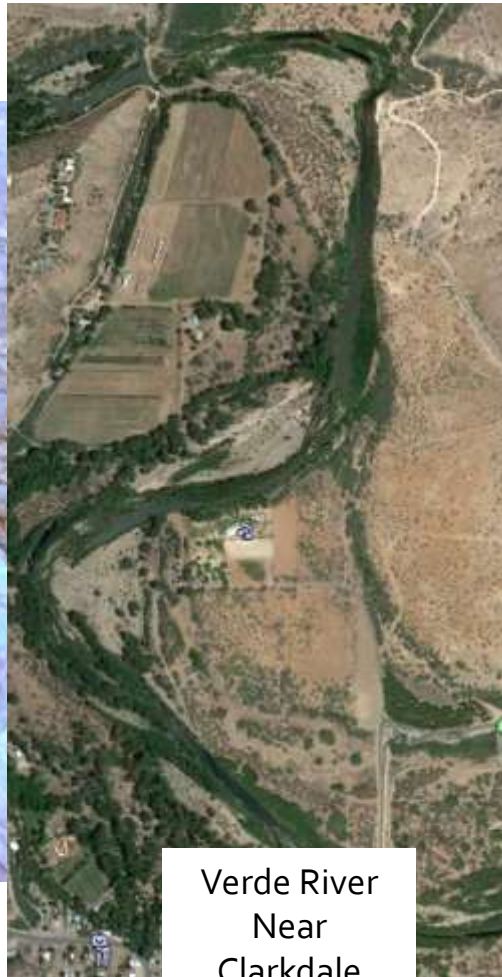
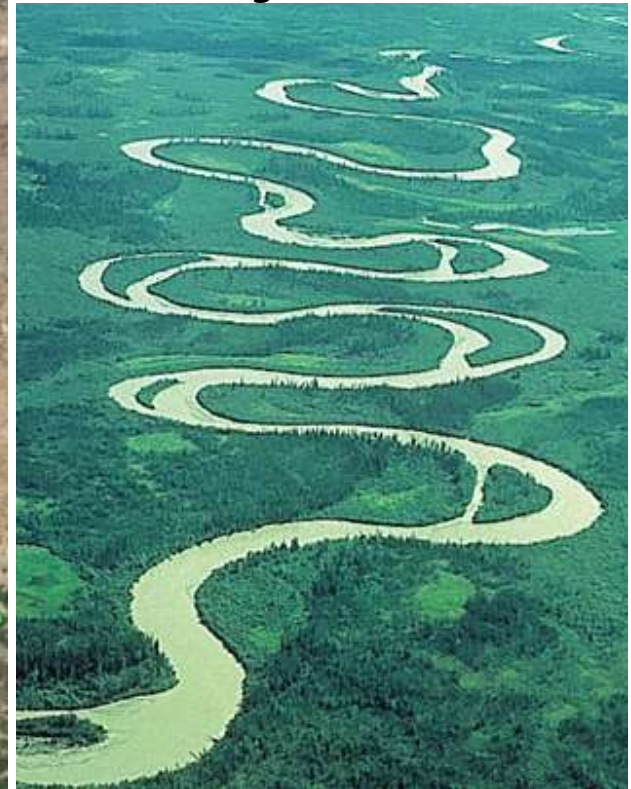
Verde River
Near
Clarkdale

Braided

Meandering

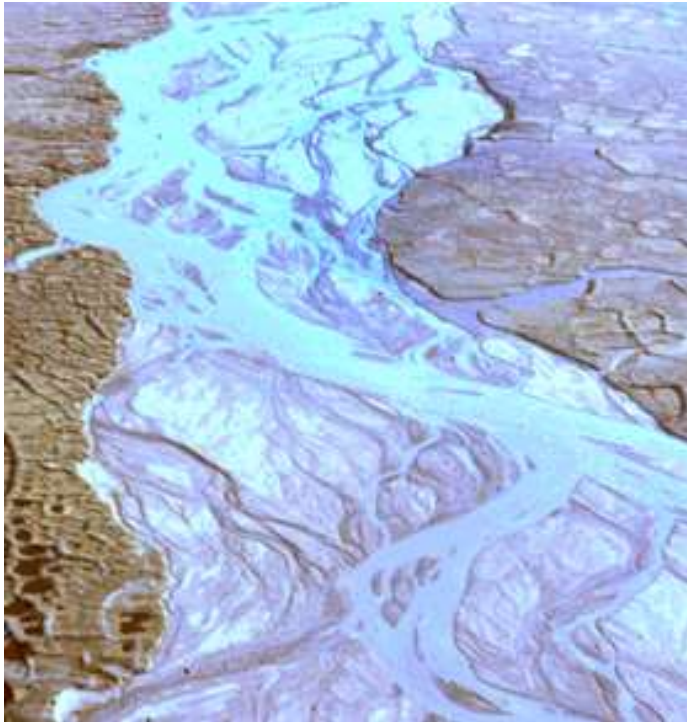
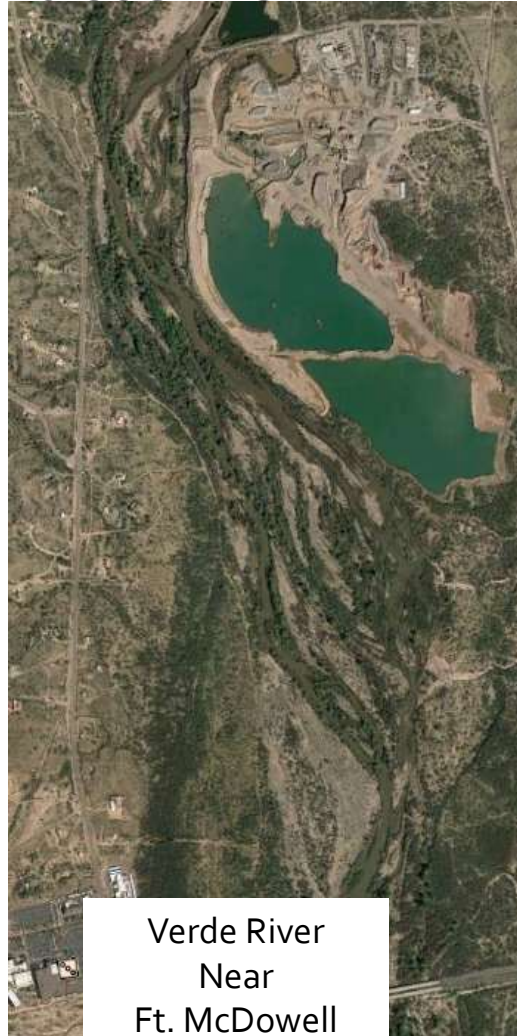
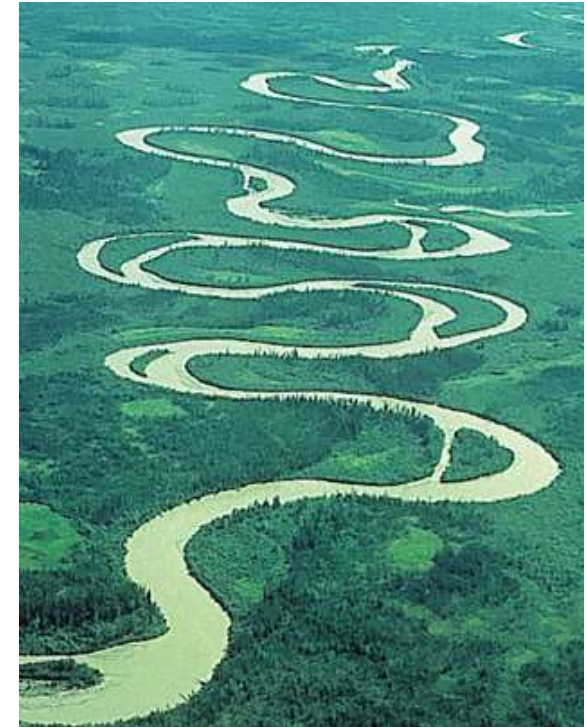
Verde River
Near
Ft. McDowell

Braided

Meandering

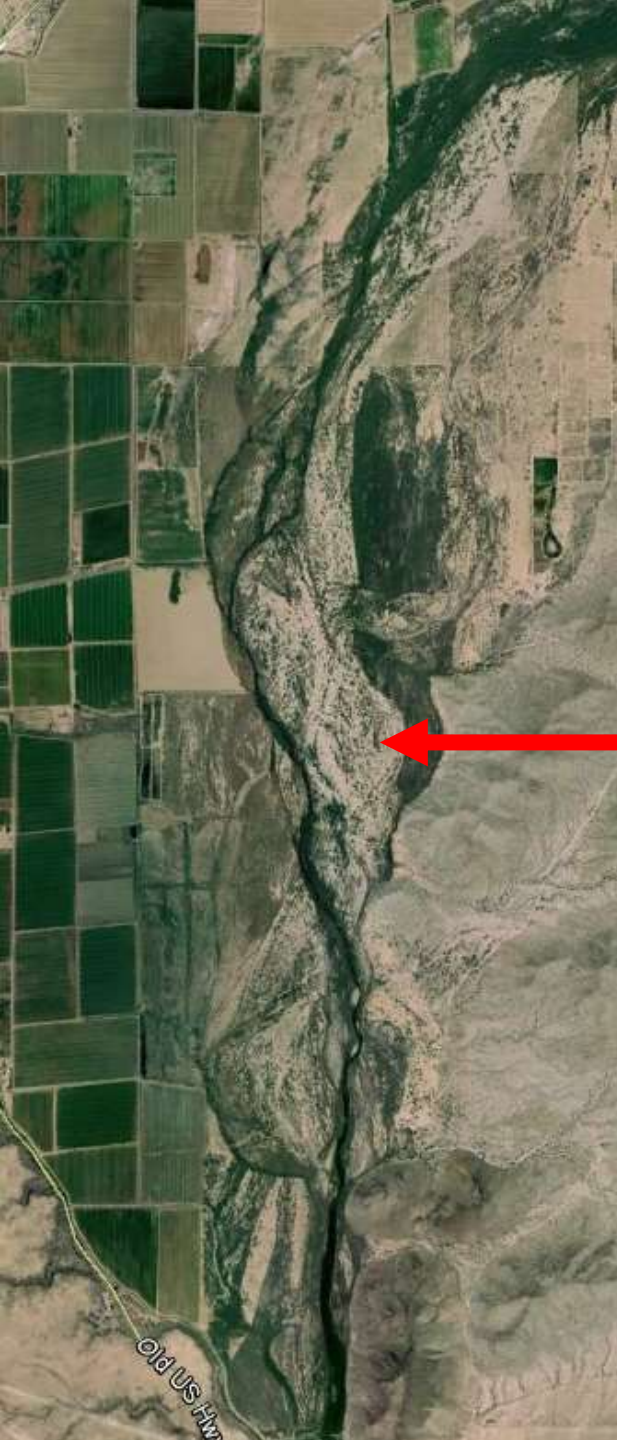
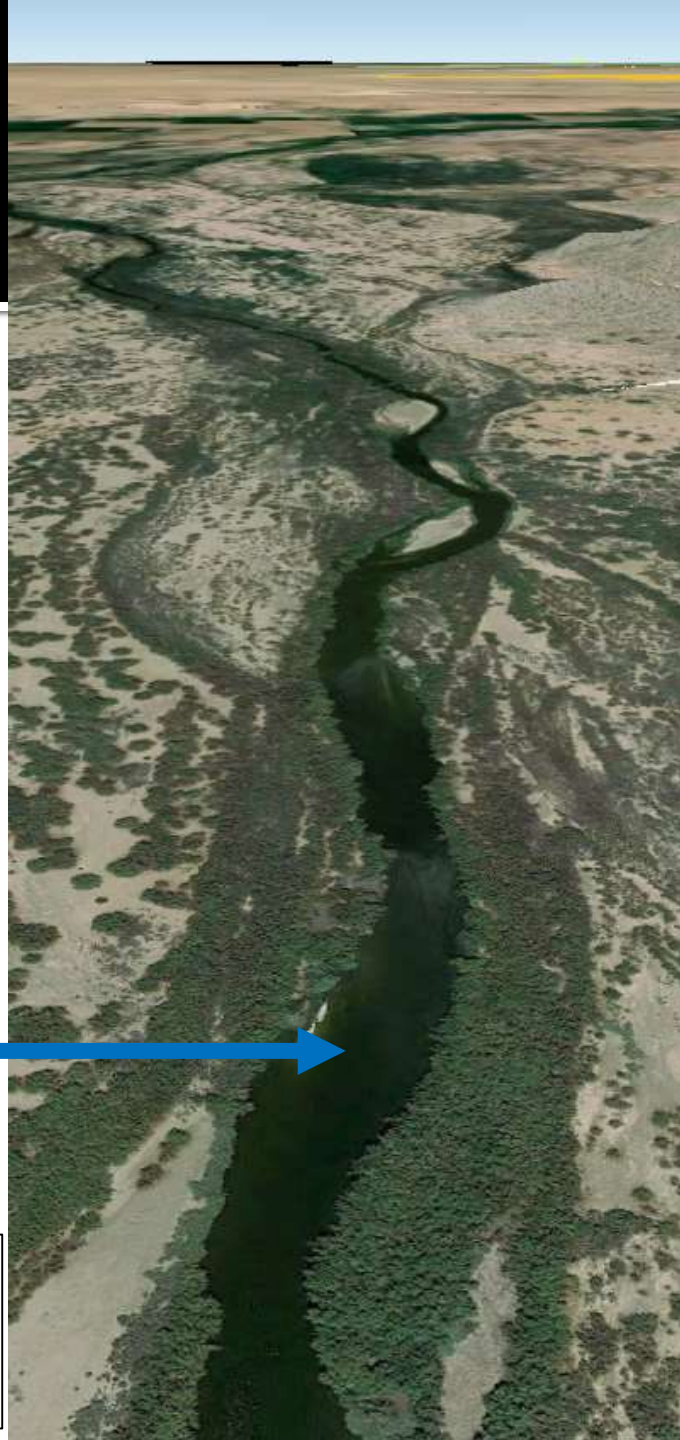
Braided or Meandering

Gila River @ Arlington, AZ

<< Braided Flood Channel

Non-braided main channel >>

Boating occurs on ordinary flows in the main channel, not on the flood channel.

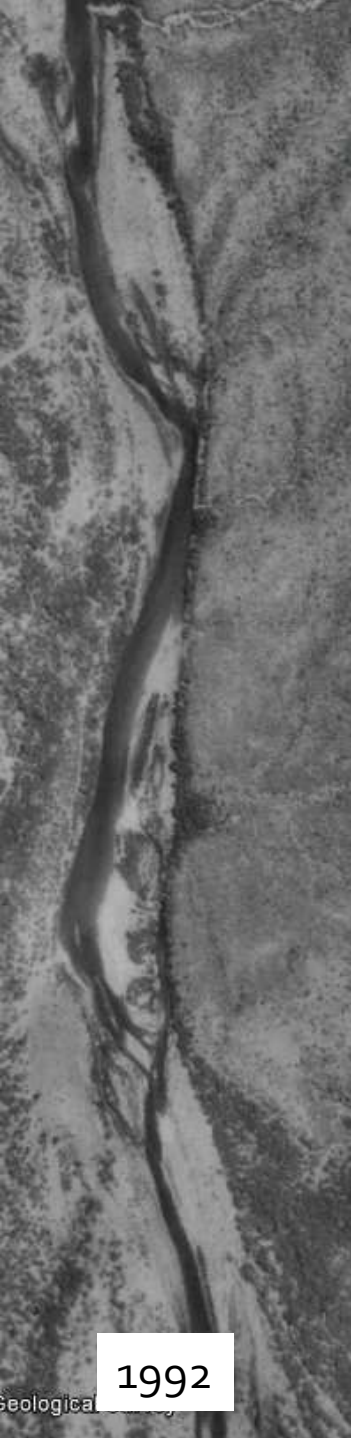
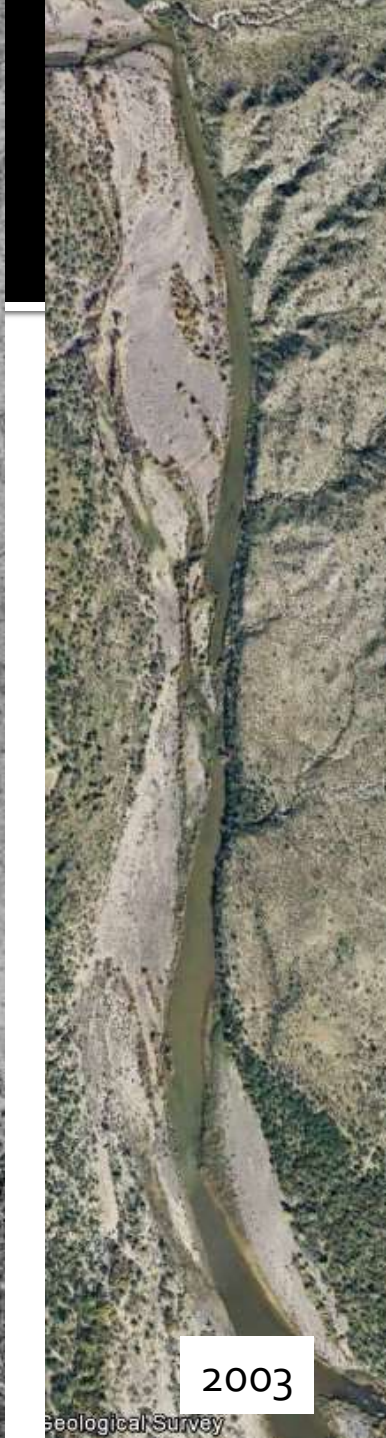
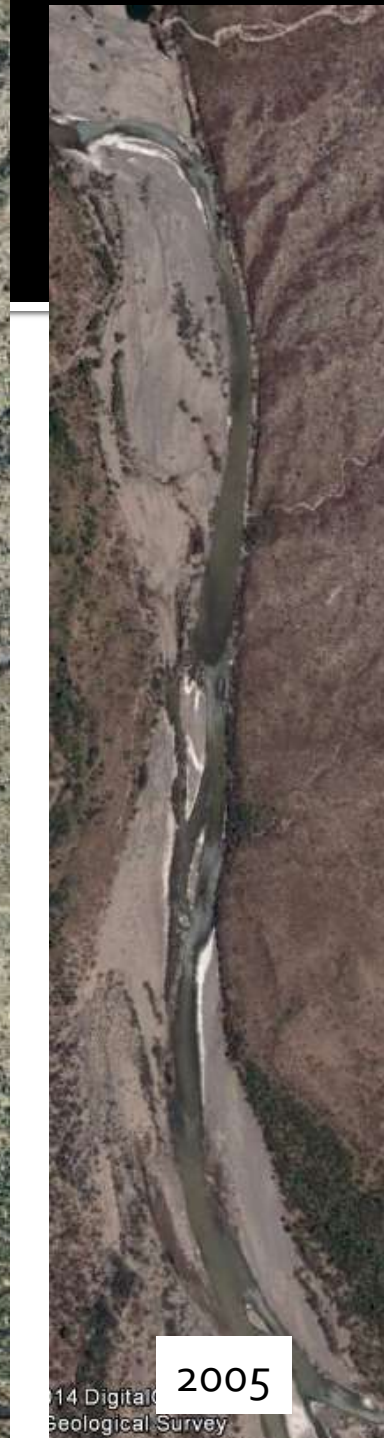
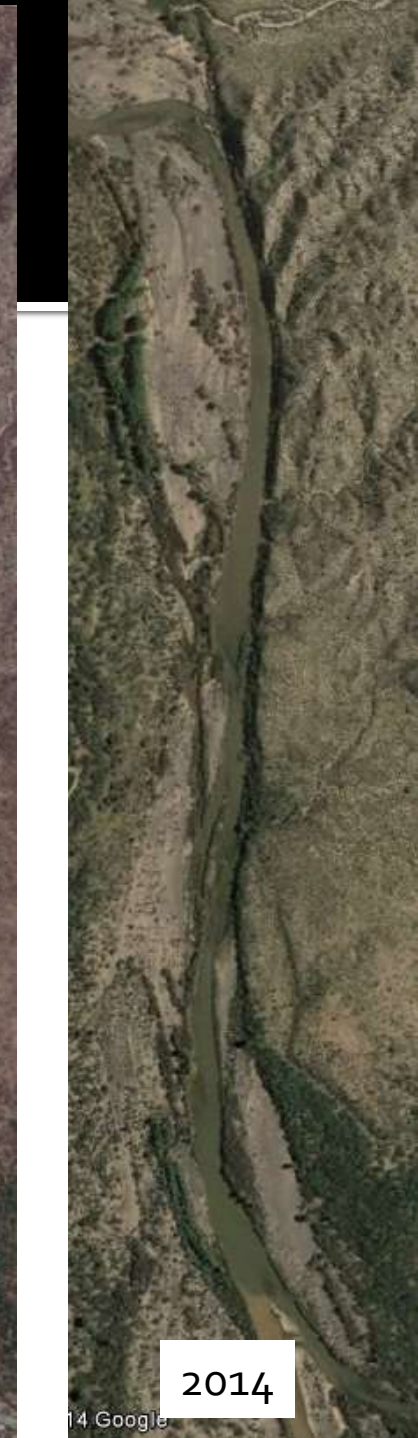
- Channel Response to Flooding
 - Flood dominated arid region streams
 - Floods leave a persistent mark on the floodplain
 - Widening
 - Erosion of flood channel
 - Remove vegetation
 - Special case: Geomorphic Thresholds
 - Ordinary flows shape the low flow channel
 - Low flow channel returns after floods recede
 - May be relocated within floodplain

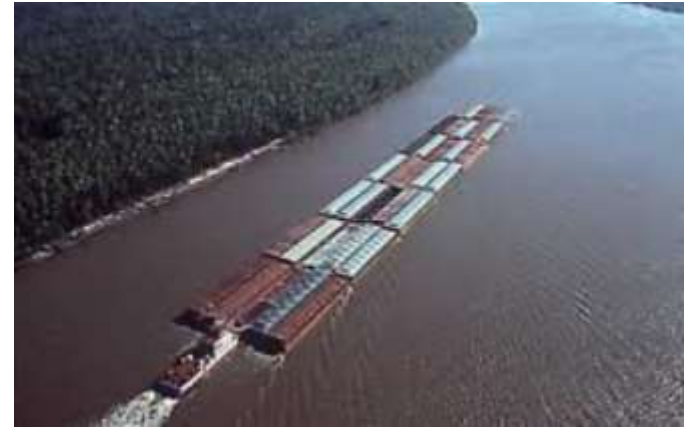
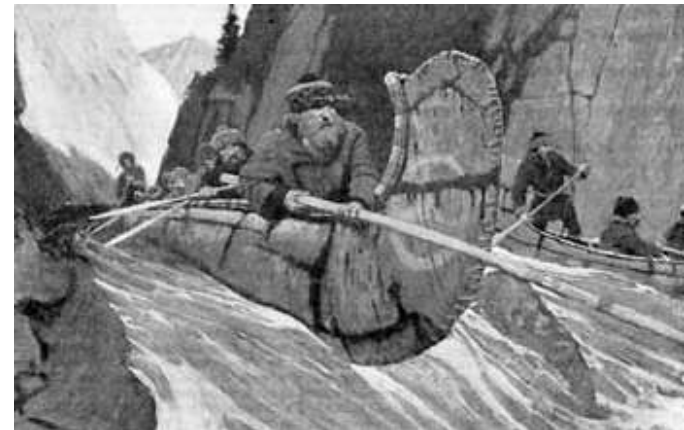
- Obstructions (to Navigability)
 - Not Defined in ANSAC statutes
 - Depends on the Type of Boat
 - River Barges vs. Trapper Canoes
 - Depends on Boater's Experience
 - Depends on Flow Rate
 - Obstruction ≠ Obstacle, Challenge

Obstruction?	Barges	Canoes
Sand Bars	Only if river wide	No
Rapids	Yes	No (I-V)
Waterfalls	Yes	Some
Beaver Dams	No	No
Shallow Flow	< 10 ft.	< 0.5 ft.

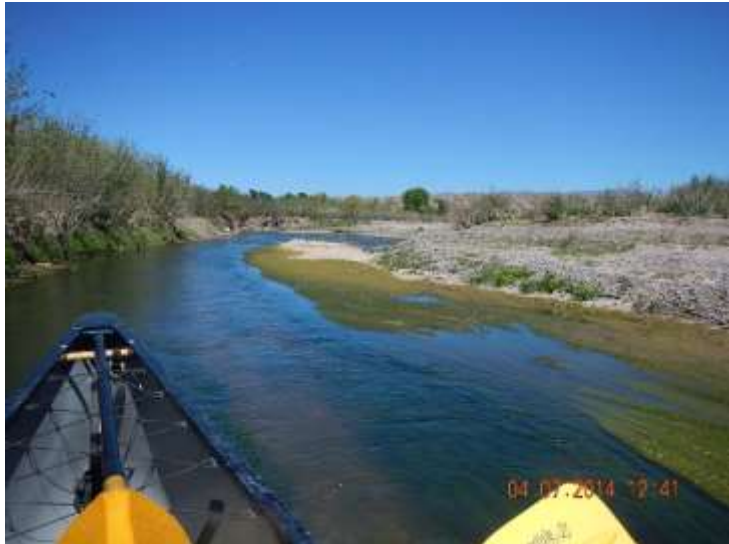
Gila River
near Apache Grove

- Sand Bars
 - Raised area of sand at or near the water surface
 - Occupies part of the stream bed channel

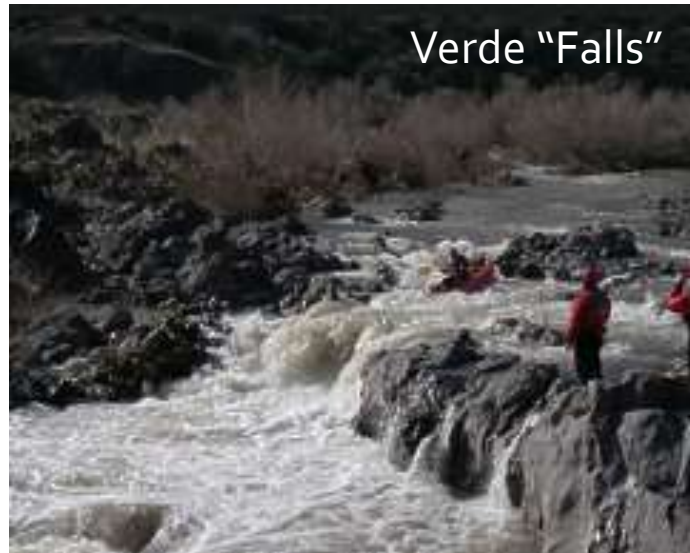
Verde "Falls"

- Waterfalls:
 - Definition: River flow over a vertical drop.
 - Not drowned out at high flow
 - Permanent feature
 - Rapids are less steep, may be drown out
 - None on Gila, Salt, or Verde River in AZ
 - Some Rapids are named "falls"

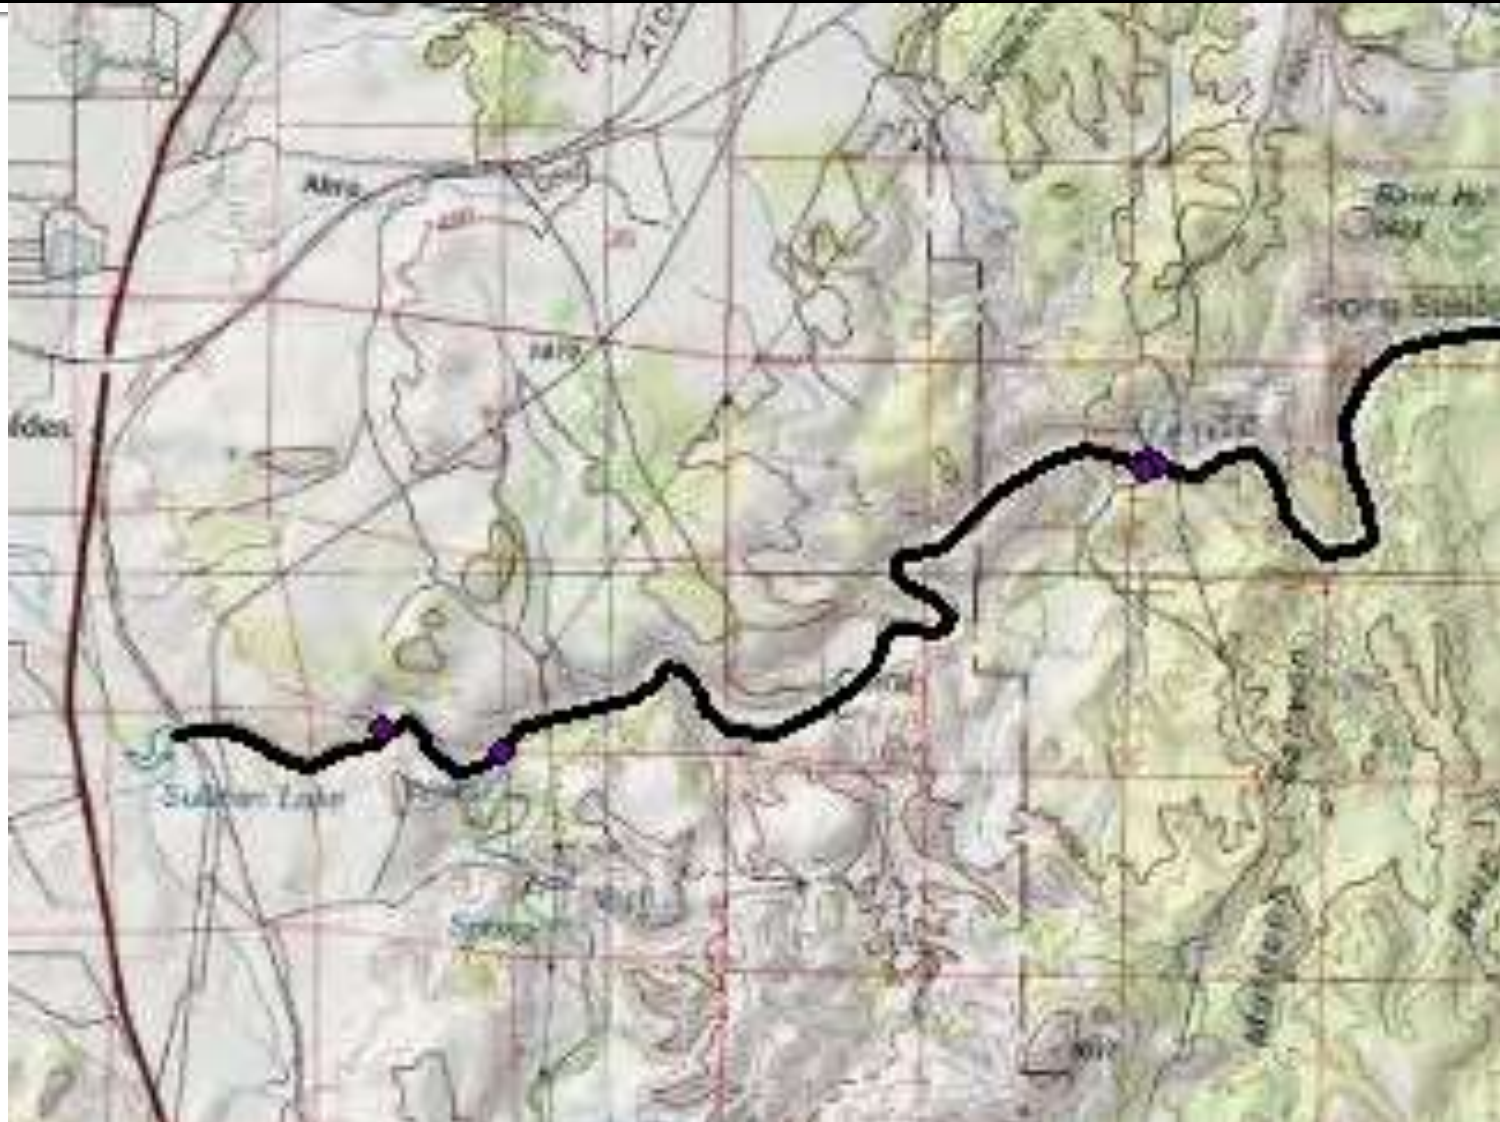
- Verde River Segment #0
 - Sullivan Lake to Forest Road 638
 - Perennial below Granite Creek
 - Channel Characteristics
 - Pool-Drop/Pool & Riffle Pattern
 - Bedrock Canyon
 - Depleted Base Flow Since & Prior to 1912
 - Minimal Other Human Impact
 - Flow Depletions from Ground Water Pumping
 - Not Normally Boated

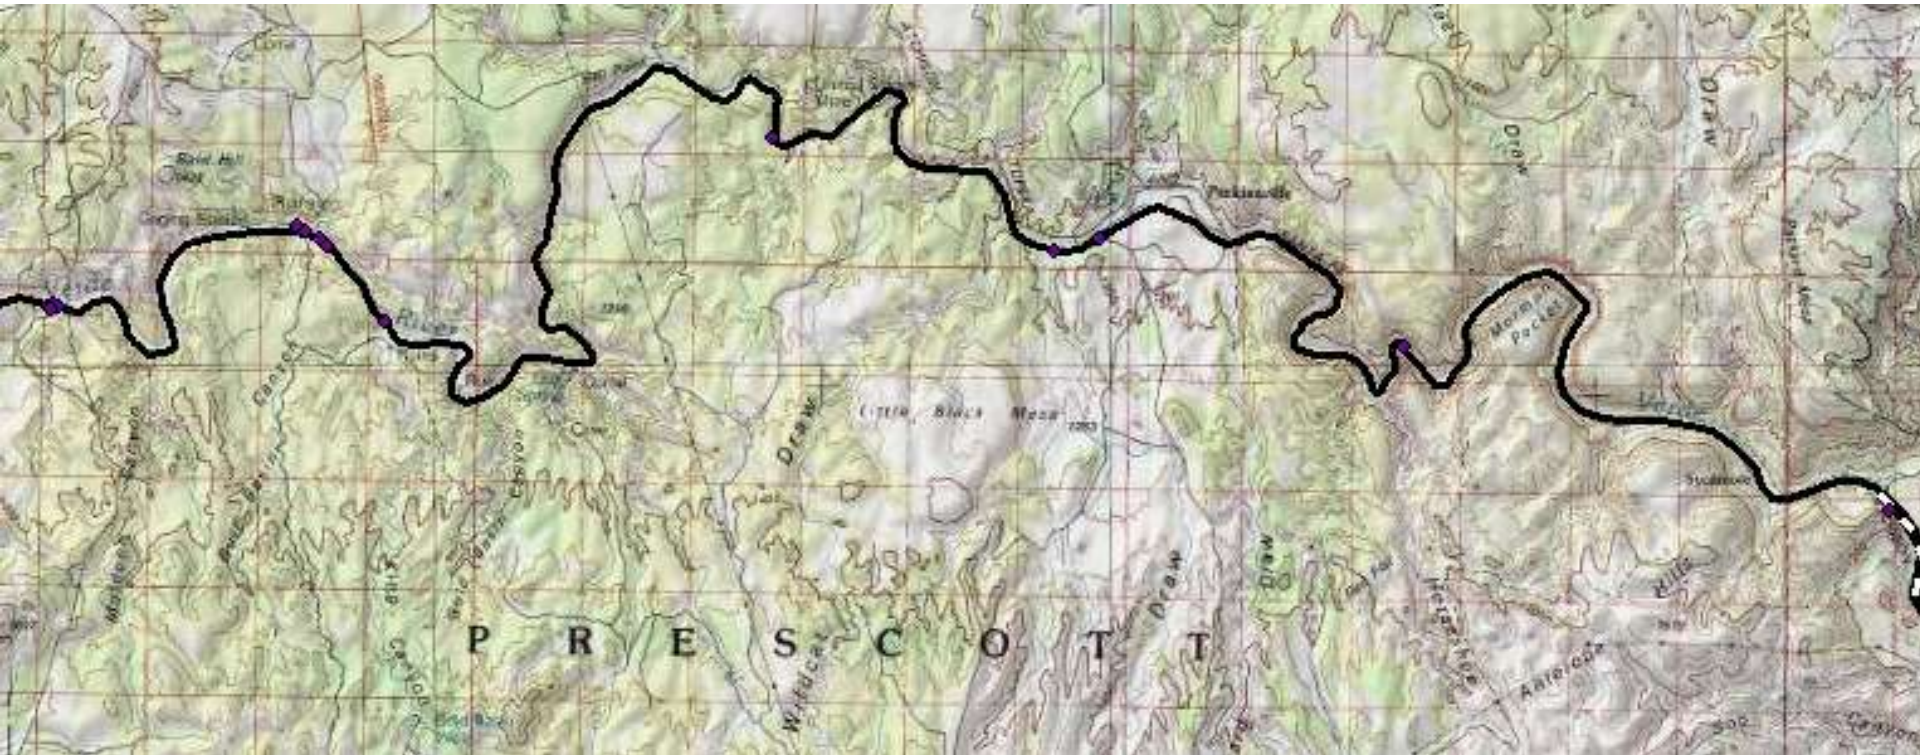
- Verde River Segment #1
 - Forest Road 638 to Sycamore Canyon
 - Perennial
 - Channel Characteristics
 - Pool & Riffle Pattern
 - Bedrock Canyon
 - Diminished Base Flow Since & Prior to 1912
 - Ground Water Pumping Depleting Natural Flow
 - Minimal Other Direct Human Impact to Channel
 - Boated for Recreation

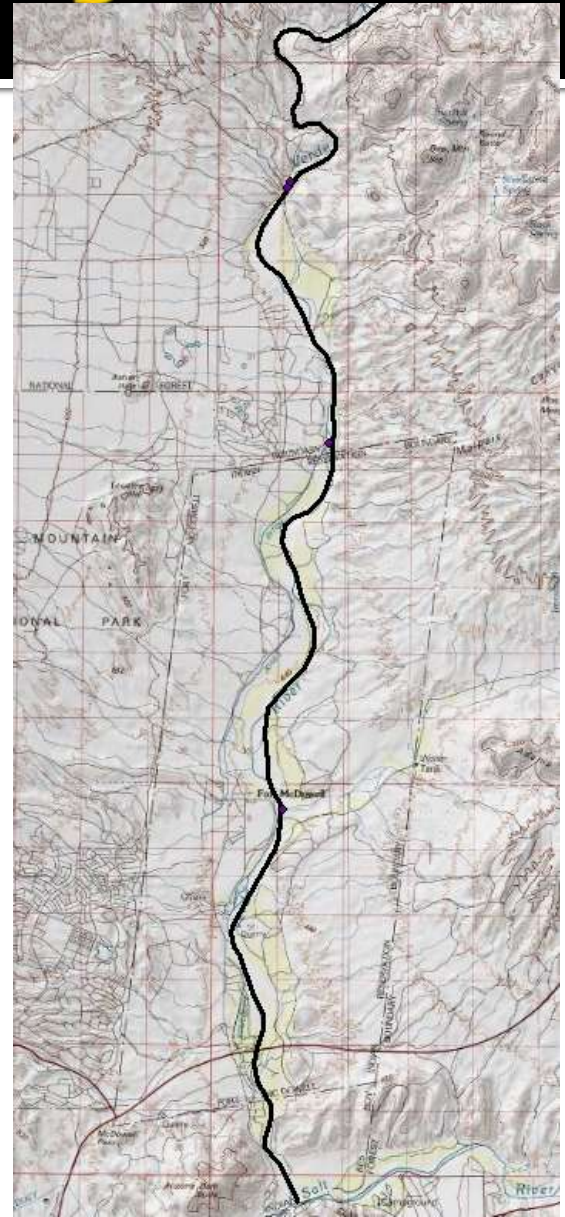
- Verde River Segment #5
 - Needle Rock to Salt River
 - Perennial
 - Channel Characteristics
 - Pool & Riffle Pattern
 - Alluvial Valley
 - Diminished Base Flow Since & Prior to 1912
 - Two Major Dams Upstream (post-Statehood)
 - Boated for Recreation
 - Some commercial recreational trips

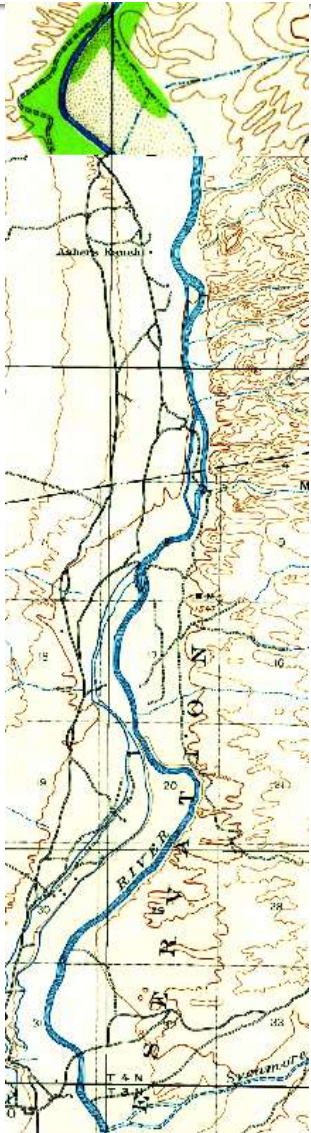
Ft. McDowell, AZ Quadrangle, 1904

- Verde River mostly shown as single channel
 - Some double channels
- Irrigation canals
- Main channel shift 1904 to 1930
- Main channel shifts 1904 to 2014
- No rapids listed on map
- Several ford crossings
- Communities:
 - Asher's Ranch
 - Ft. McDowell

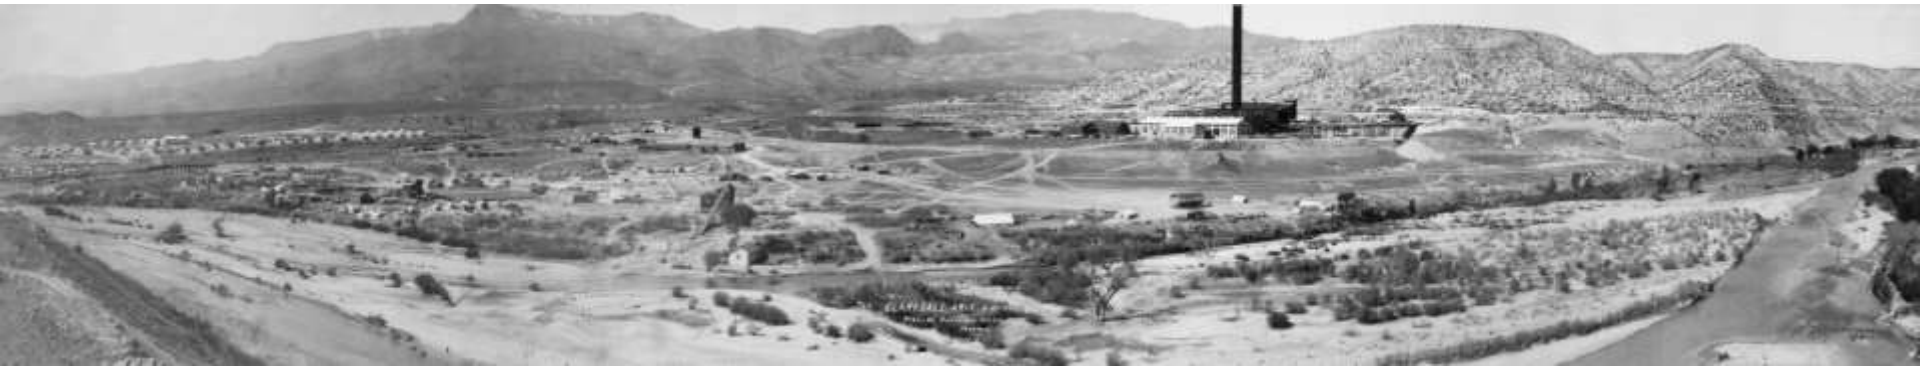
Verde River @ Clarkdale, March 1914
Source: Verde River Institute

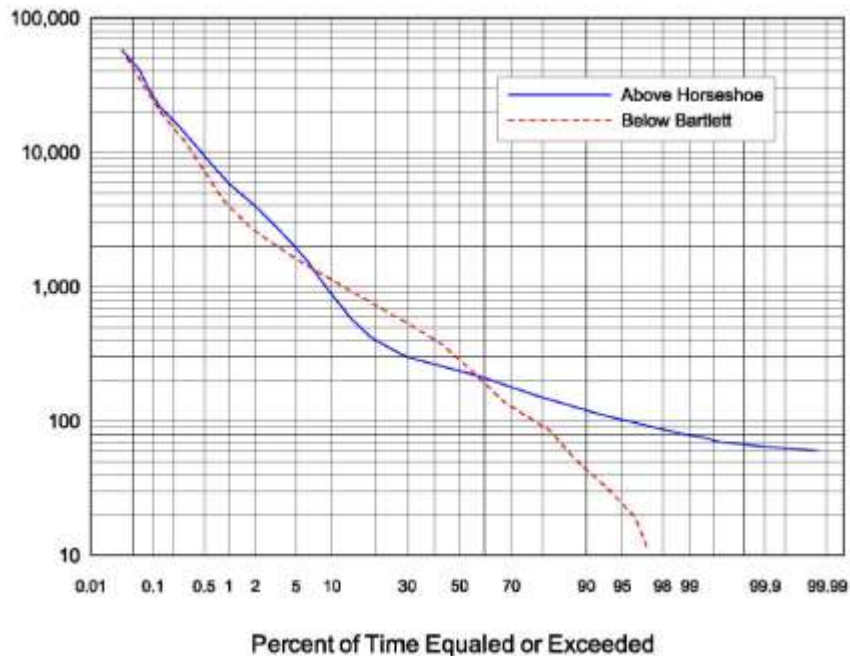
Change in Flow Duration Due to Dams

- Impacts of Dams & Diversions
 - Upstream of Major Reservoirs
 - Irrigation Diversions diminish ordinary low flows
 - Minimal impact on floods
 - Downstream of Major Reservoirs
 - Ordinary Flow Conditions
 - Decrease duration of low flows and high flow, increase mid-flows
 - Lower winter and spring flows (storage in reservoirs)
 - Higher late spring & summer flows (releases for water supply)
 - Minimal change to fall flows
 - Floods:
 - Decrease size of frequent floods (2- to 5-year)
 - Less impact on large floods (> 10-year)

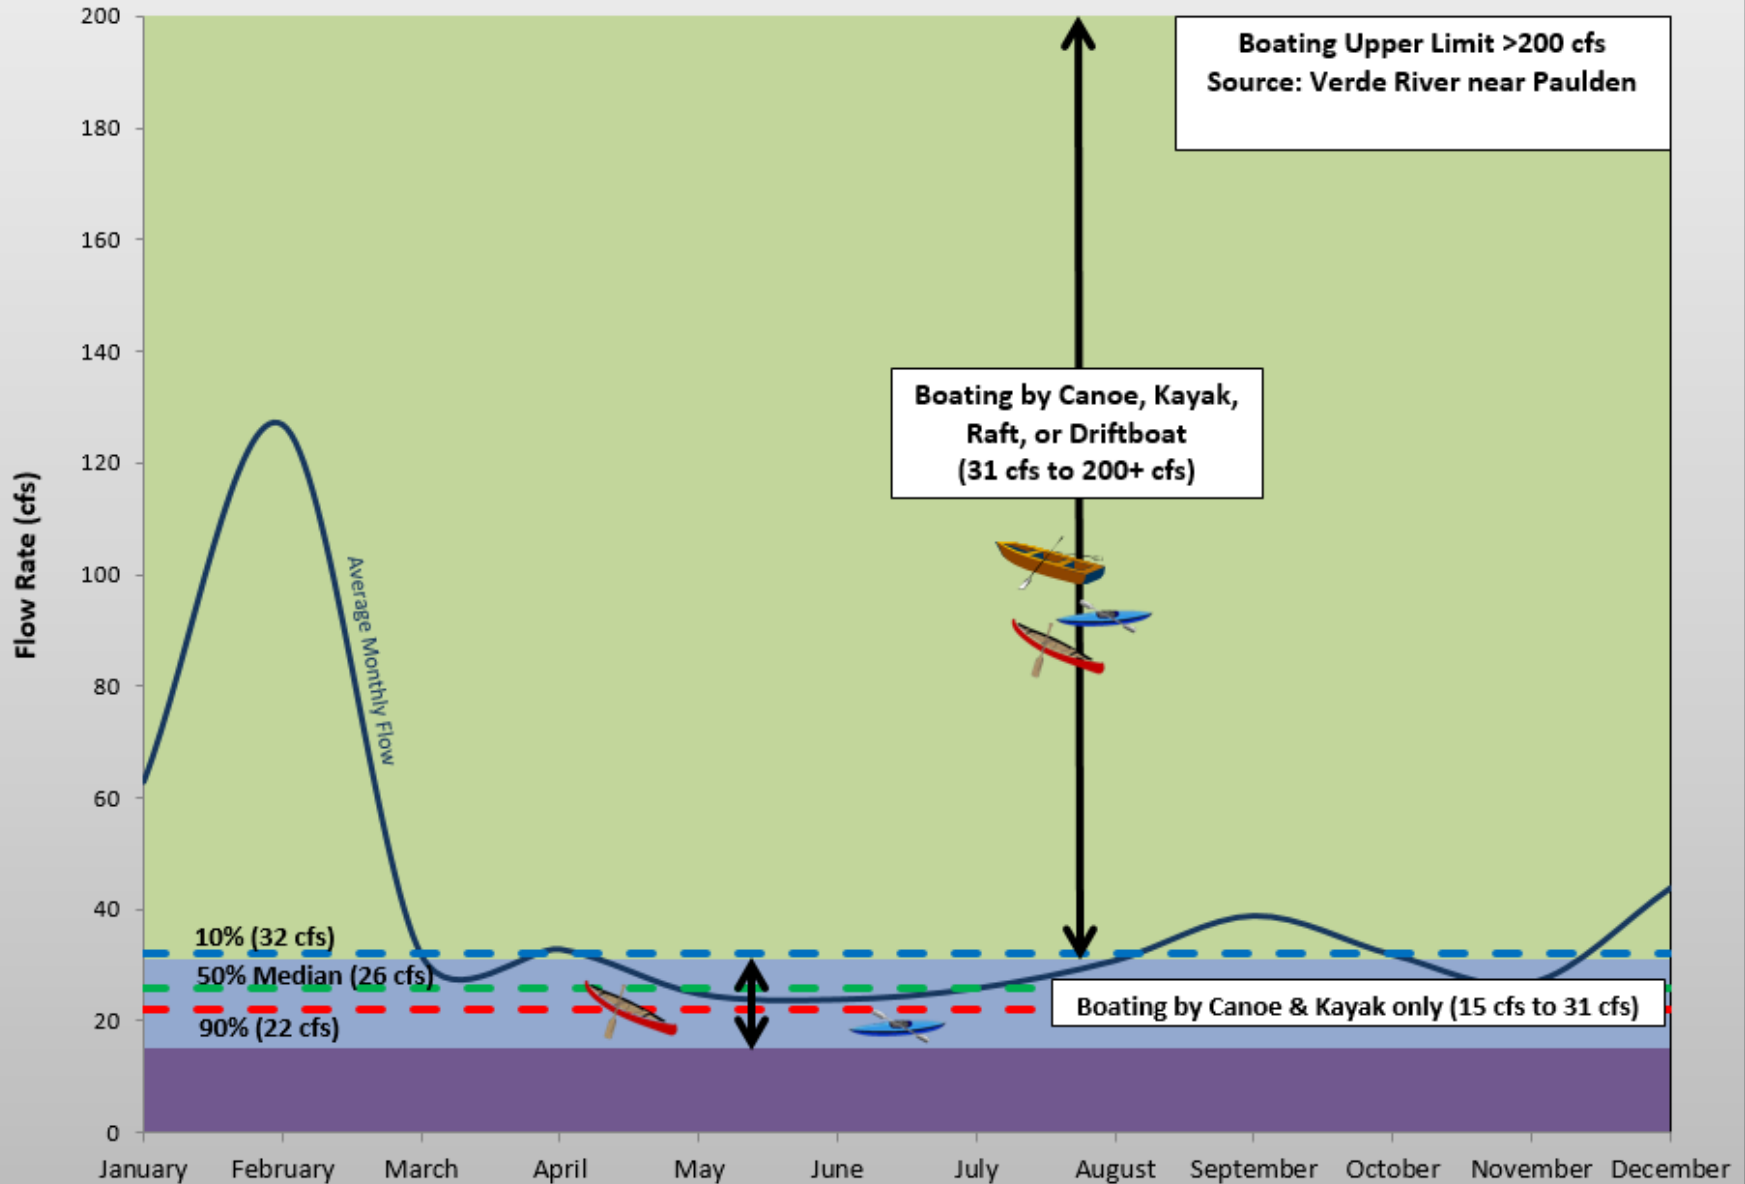
Verde River Segment 1 Historical Boatable Flow Range

- Boatable by canoes: ~99% of the time
 - Year Round (360 days/yr)
- Boatable by flatboats: ~30% of the time
 - Seasonally (Winter, Monsoon) (110 days/yr)
- Modern Boating
 - Recreational, low water boating
- Ordinary & Natural Condition
 - Similar to existing condition
 - Minor diversions, fences
