Final Report SMALL & MINOR WATERCOURSES ANALYSIS for Graham County, Arizona

Contract No. AD 990205

ARIZONA STATE LAND DEPARTMENT

April 2001

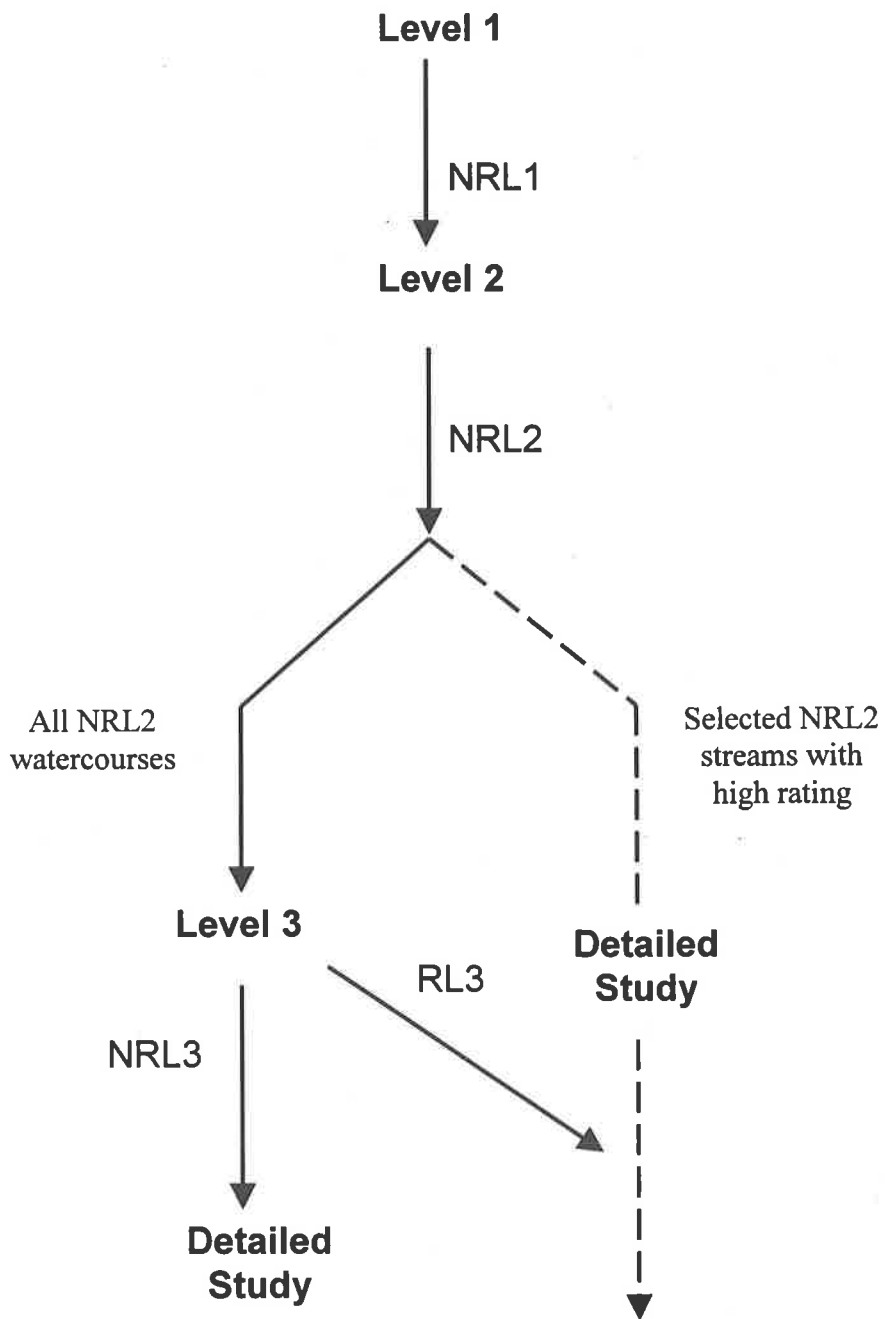
Figure 8
 Schematics showing simultaneous analysis of
 selected NRL2 watercourses in Level 3 and Detailed Study

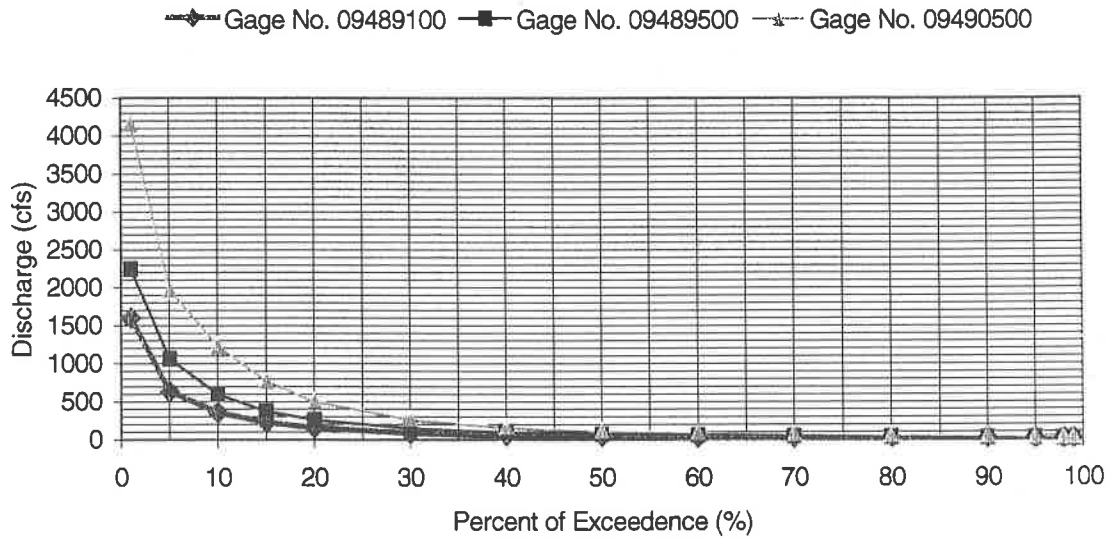
Figure 1
Black River - Flow Duration Curves
 [Data Source: Pope et al. (1998)]

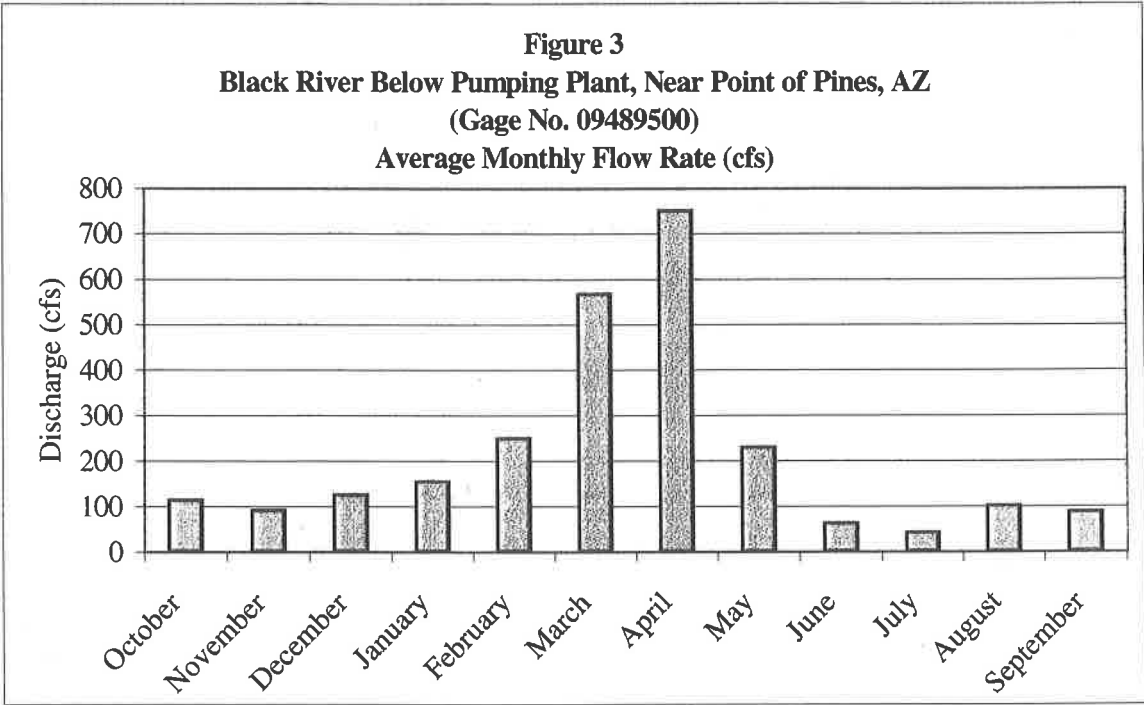
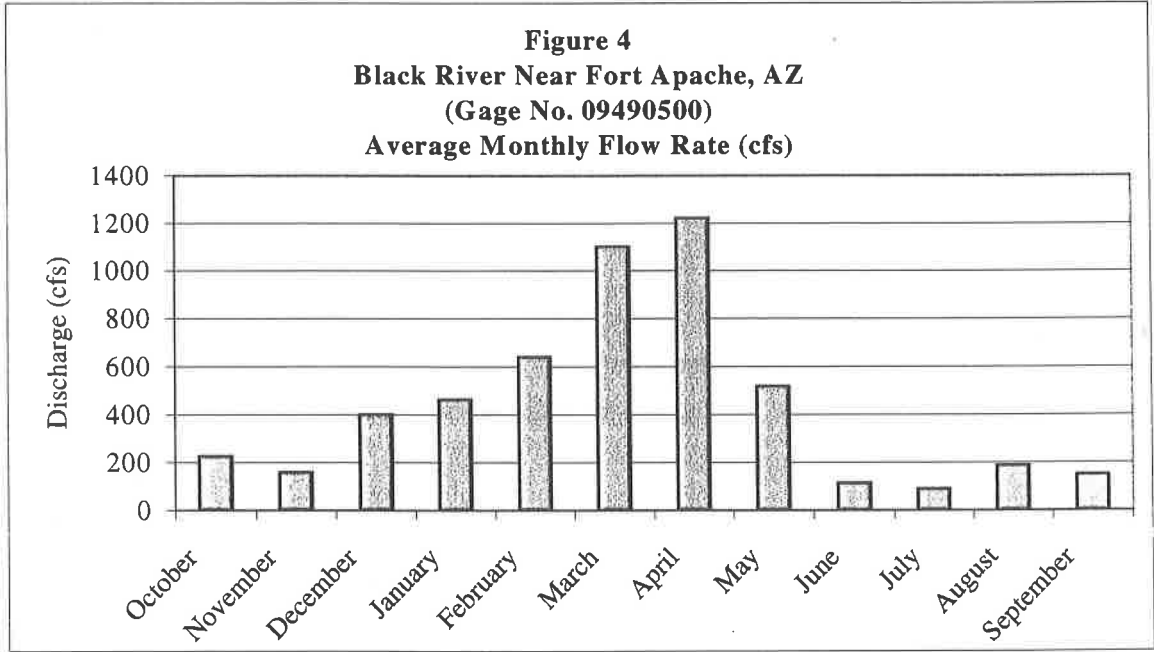
Figure 2
Black River Near Maverick, AZ (Gage No. 09489100)
Average Monthly Flow Rate (cfs)

The flow data summarized above indicates that the Black River is perennial at all the gages. The average monthly flow rates (see Figures 2, 3 and 4) are all above zero. The typical flow rate downstream is around 100 to 200 cfs, with exceptional flows occurring during the winter months and the beginning of spring (January through April).

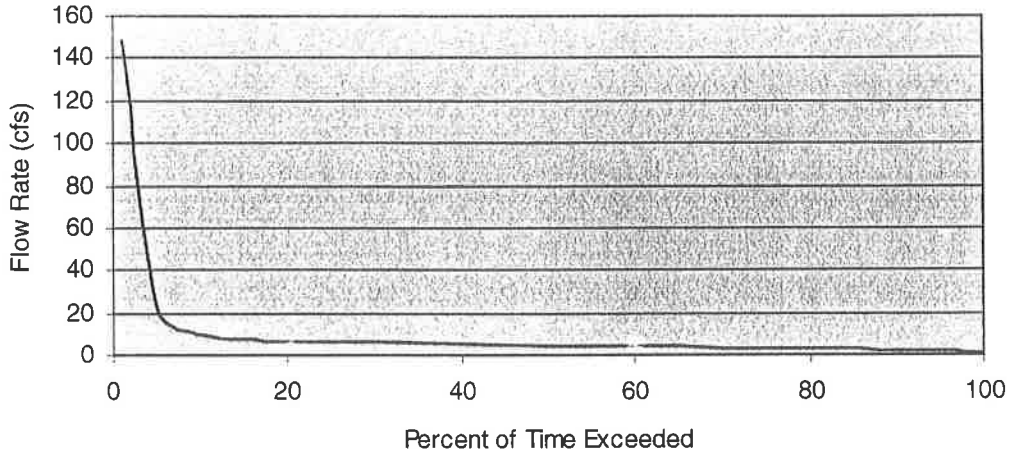
Figure 4. Flow Duration Curve for Bonita Creek (Graham Co.)

The USGS gauge data indicate that the stream is perennial. Both monthly average flows and minimum average flows exceed zero throughout the year, indicating that flow is reliably present in the stream. Field visits conducted on December 13, 2000 and January 5, 2001 indicate that Bonita Creek is perennial downstream of Bonita Spring. The highest average monthly flow rates occur during January through March, due to snowmelt, winter storms, and reduced evapotranspiration.

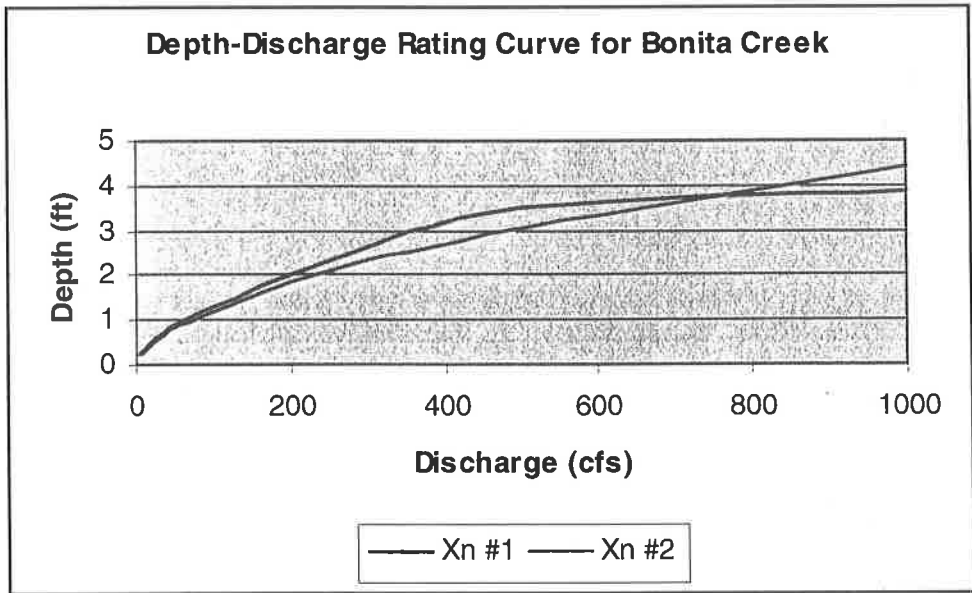
Notes:
1. Section #1 (Xn#1) is located about one mile upstream of Gila River confluence.
2. Section #2 (Xn#2) is located at the crossing of Indian Route 8.

Estimated hydraulic characteristics were developed based on observed stream conditions and historic stream flow records available from the USGS gauges. Table 5 summarizes a range of probable values for stream depth and width at various flow rates. Note that the hydraulic parameters shown below are based on flow data at the USGS gauge sites, and average cross sections for the study reach. The estimates probably represent no better than order-of-magnitude estimates of flow conditions at any specific location within the study reach. A rating curve for an assumed cross section developed from field observations is shown in Figure 7.
