GEOMORPHIC CHARACTER OF THE LOWER GILA RIVER

By: Stanley A. Schumm, Ph.D., P.G.

MUSSETTER ENGINEERING, INC.

June 2004

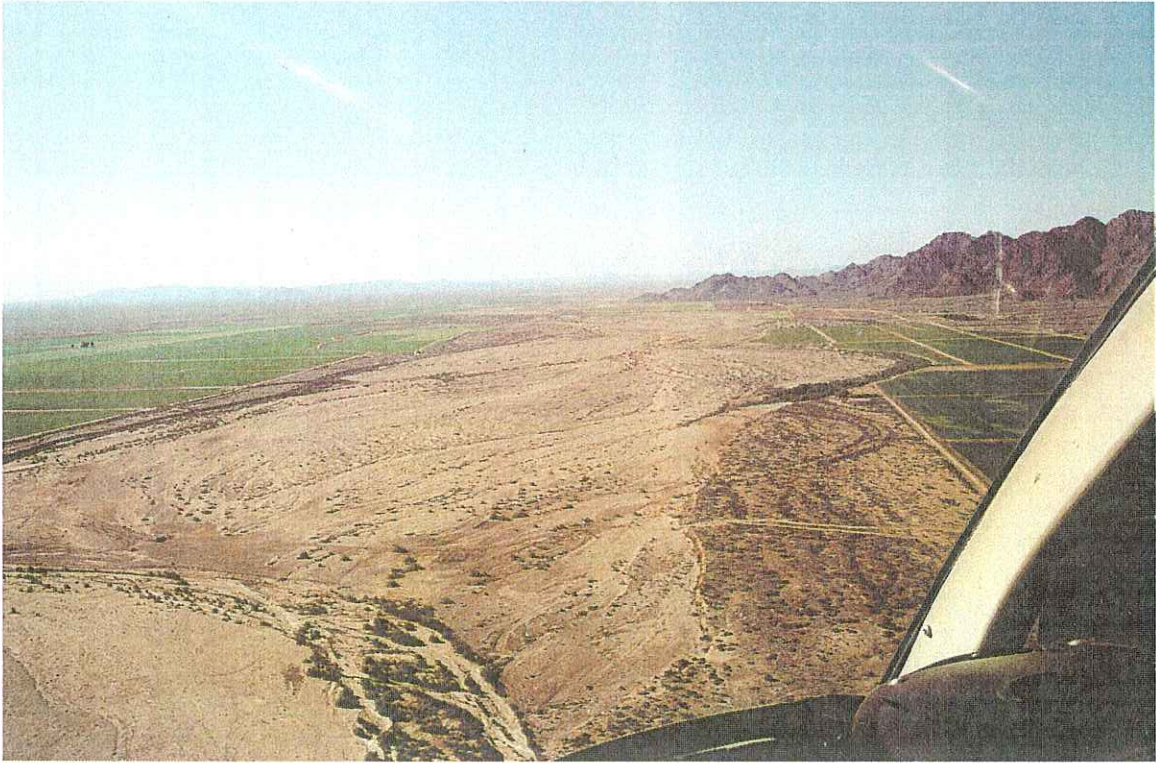
Figure 2. Gila River view downstream toward Gila Bend in March 2004.

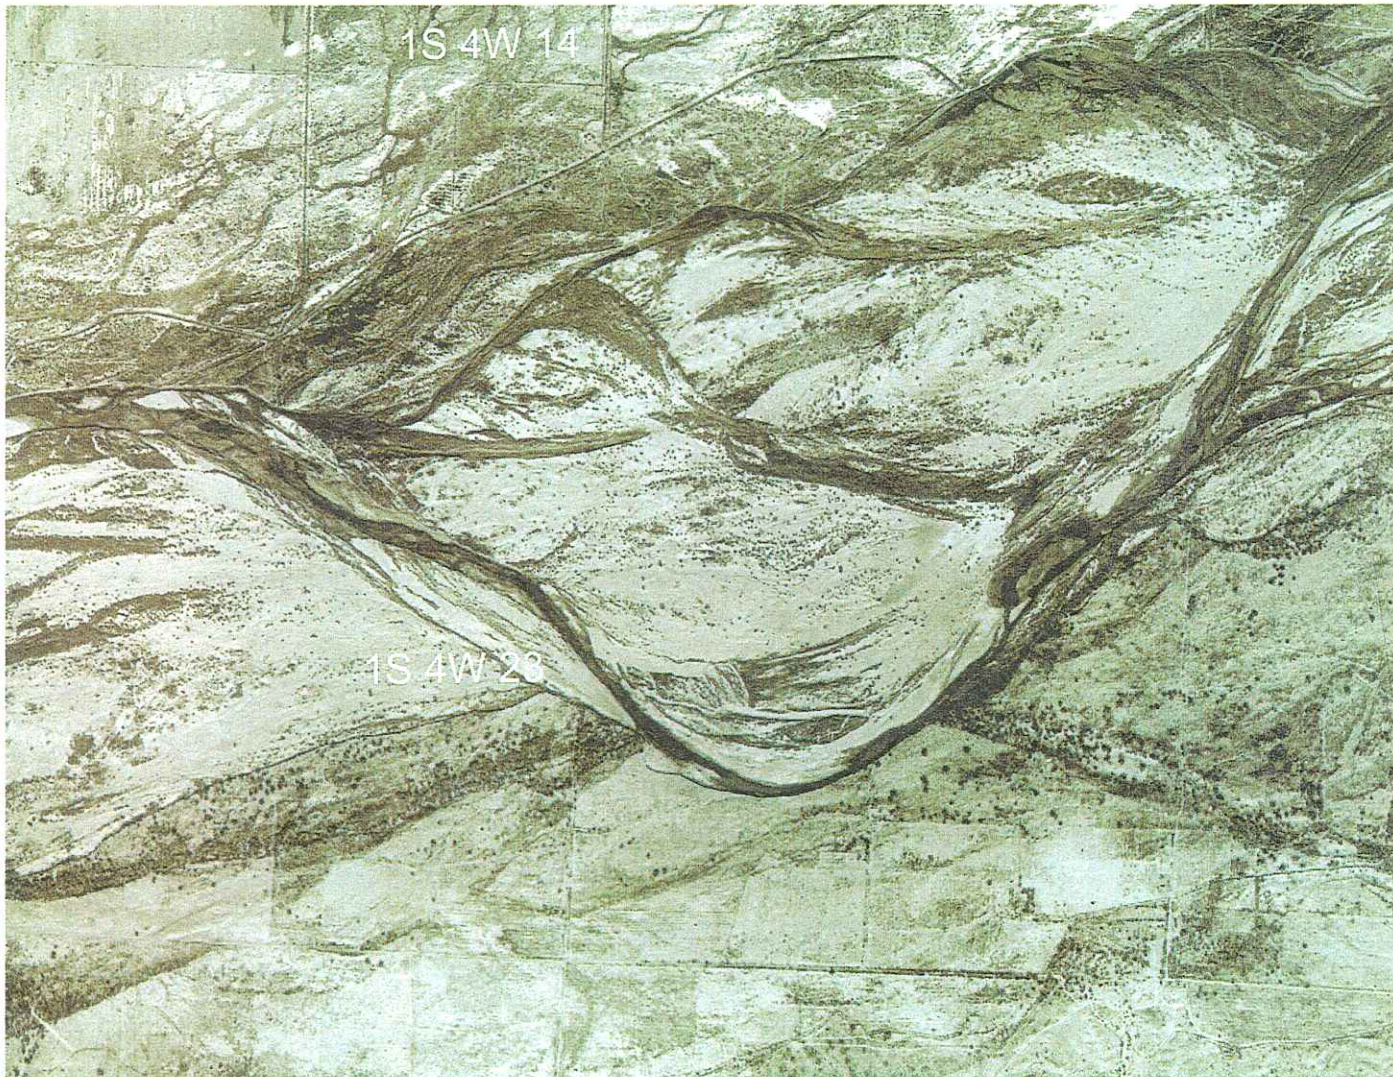
Figure 3. Gila River in T1S, R4W, 1934 aerial photograph. River bed is about one mile wide.

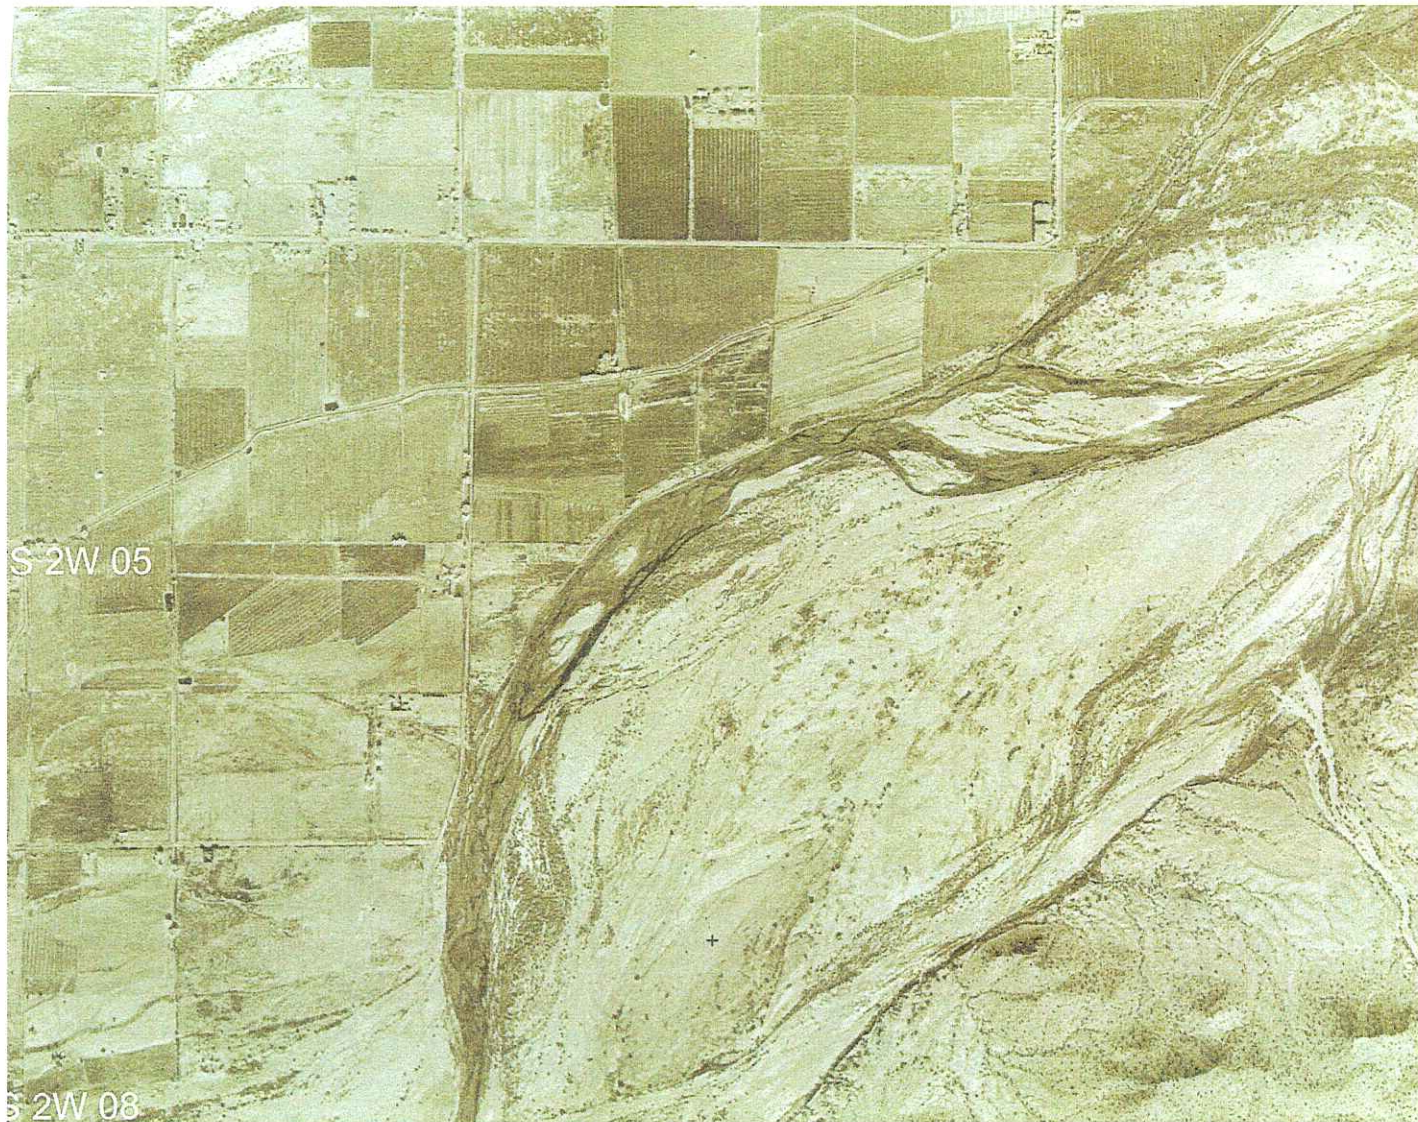
Figure 4. Gila River in T1S, R2W, 1934 aerial photograph. River bed is about one mile wide.

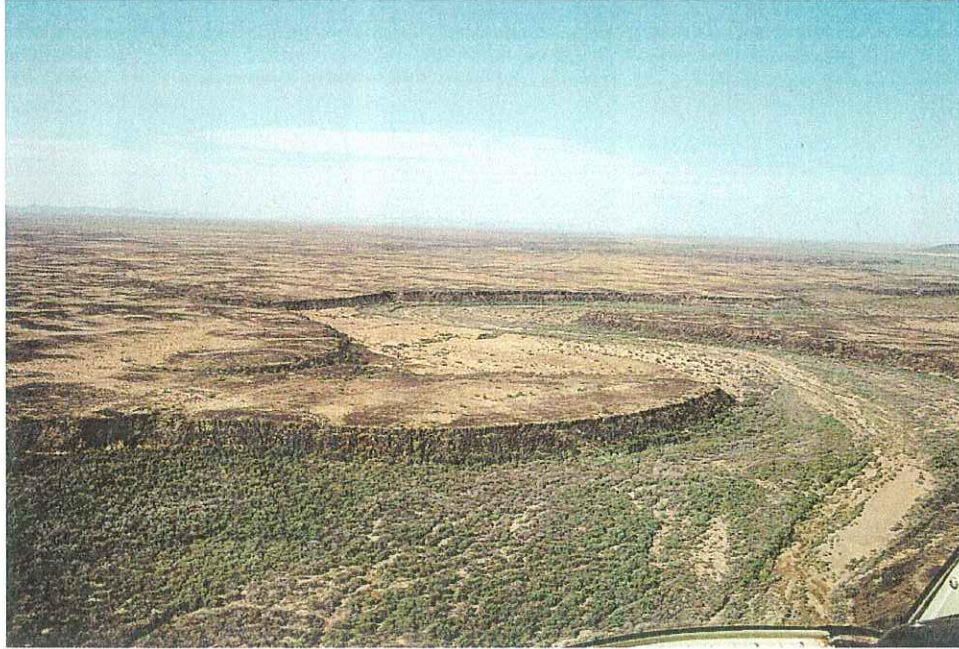
Figure 5. Gila River downstream of Painted Rock Dam. Channel is confined by lava flows east of Aqua Caliente.

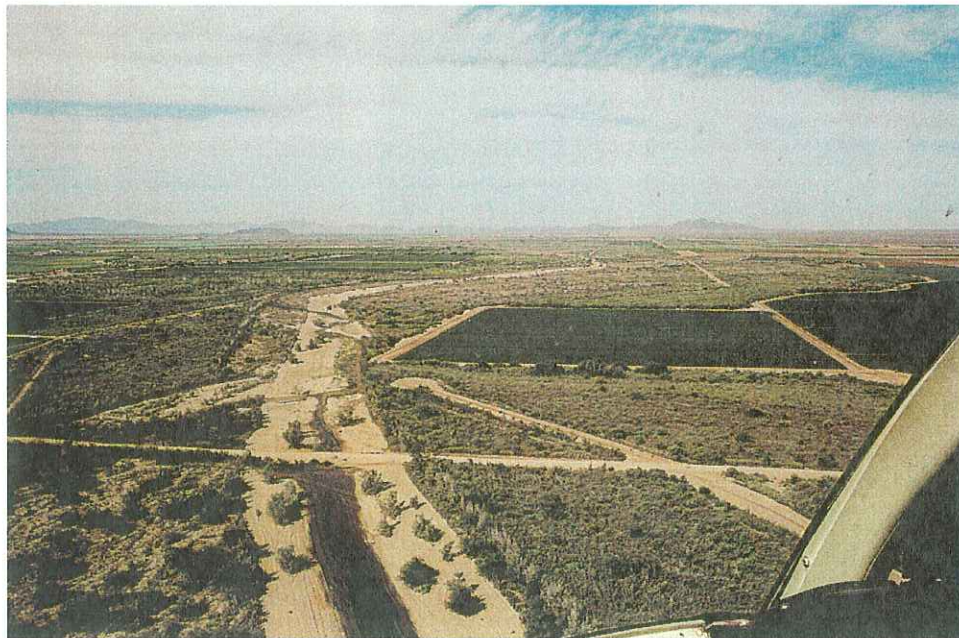
Figure 6. Gila River channelized upstream of Yuma. View downstream northwest of Owl.

The braided Pattern 5 is of most interest because the braided pattern is the Gila River pattern. A braided river is defined by the American Geological Institute (1972) as *a stream that divides into or follows an interlacing or tangled network, of several, small branching and reuniting shallow channels separated from each other by branch islands or channel bars, resembling in plan the strands of a complex braid*. Braided rivers have a high width-depth ratio and relatively steep gradient, as a result of high bed load and large floods, which produce a relatively unstable pattern and a relatively variable channel in time and location. This is a description of the Gila River (**Figures 2 through 5**). However, human activities have significantly altered the Gila River at many locations, encroachment of salt cedar into the channel has narrowed the channel significantly (**Figure 6**), and there are several locations where bedrock may exert a control.
