GEOMORPHIC CHARACTER OF THE VERDE RIVER

By: Stanley A. Schumm, Ph.D., P.G.

MUSSETTER ENGINEERING, INC.

December 2004

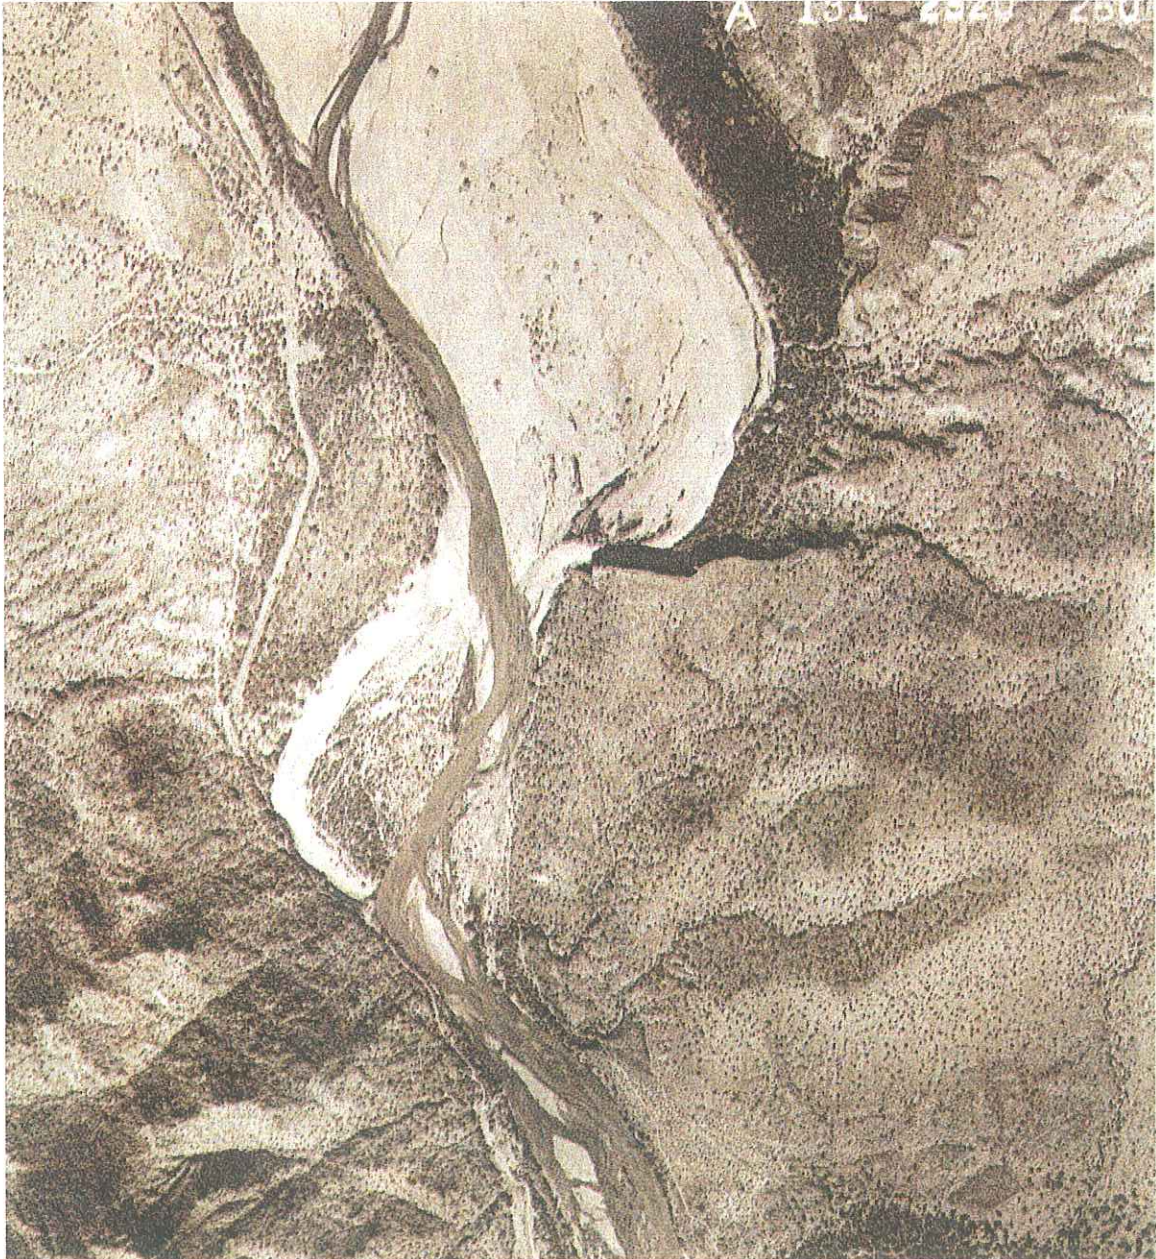
Figure 3. Verde River at “bottom of Fort McDowell Indian Reservation” (T3N, R7E, Sec 31). 1934 aerial photograph showing braided channel pattern and constriction, as a result of geologic control. Note that the channel occupies the entire width of the valley.

Although bedrock and geologic structures strongly control valley and channel morphology, it is obvious that within the Verde River valley, the channel is braided (Figures 2 through 4). However, a cursory glance at aerial photographs of the Verde River could lead to the conclusion that it is a meandering river of Pattern 3, but a more careful study reveals that the valley of the Verde River is sinuous and the river is forced to follow this pattern in a deep valley (Figure 5). Elsewhere, the valley is very straight and so is the river (Figure 6). This is clearly the result of a geologic control. In addition, valley and channel width is highly variable as a result of the effect of bedrock (Figures 2 through 4). These constrictions significantly affect channel width and depth and flow velocity.

The 1934 aerial photographs show a Verde River channel that is wide, occupying the entire valley floor (Figures 2 through 4). This undoubtedly was the condition of the channel in 1912, following the series of major floods (Table 1) that significantly widened the Gila River and its tributaries (**Figure 9**), including the Verde River. The GLO surveys of T3N, R7E in 1901-1902 and 1911 support this conclusion (**Figures 10 and 11**).

Not only did the character of the Verde River vary through time, but the aerial photographs and a longitudinal profile show that the channel is variable as a result of tributary influences (Figures 2 and 3), and lithologic-geologic controls (Figures 2 through 5). The long profile (**Figure 12**) shows great irregularity as a result of bedrock (e.g., Needle Rock, Sta 100,000, **Figure 13**), and tributary effects.

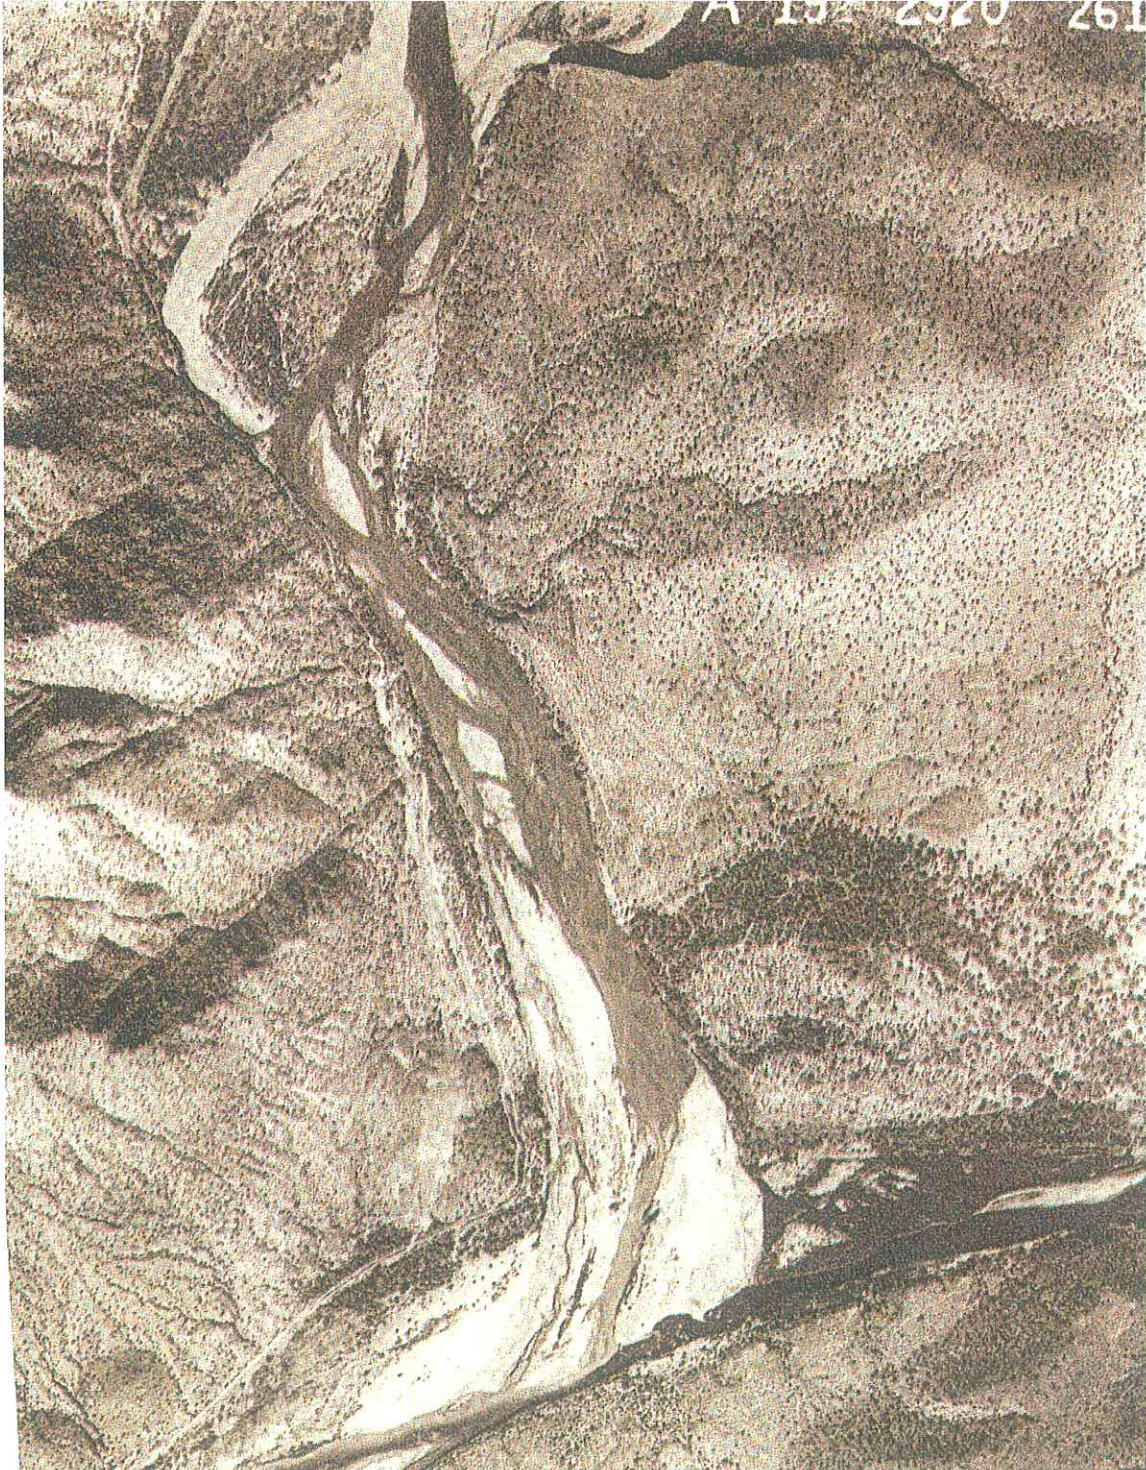
Figure 4. Verde and Salt River confluence (T2N, R7E, Sec 5). 1934 aerial photograph showing braided channel pattern and constriction. Note that large sediment delivery from Verde River forces Salt River channel to south side of valley.

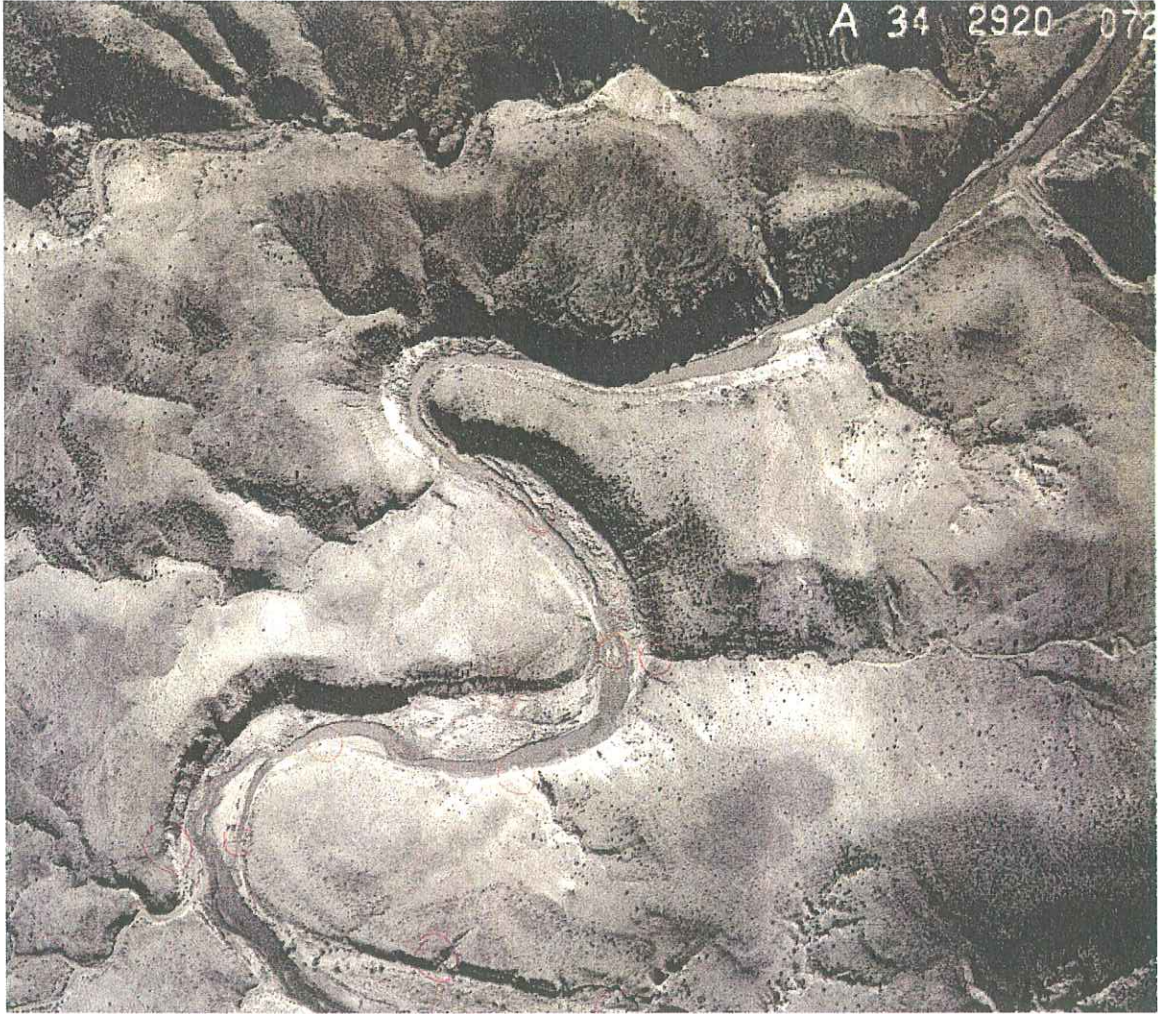
Figure 5. Verde River at Sycamore Canyon (T12N, R5E, Sec 1). 1934 aerial photograph showing sinuous valley, tributary influences constricting channel, and exposed bedrock.

Braided rivers are wide, shallow, and steep, a condition not conducive to navigation. The marked changes of valley width cause dramatic alterations of water depth and velocity (Figures 2 through 5), which would make navigation hazardous. The numerous rapids (Table 3) clearly prevent navigation, and the bedrock that controls the Verde and Salt Rivers at their confluence prevents navigation upstream on both rivers (Figure 15).

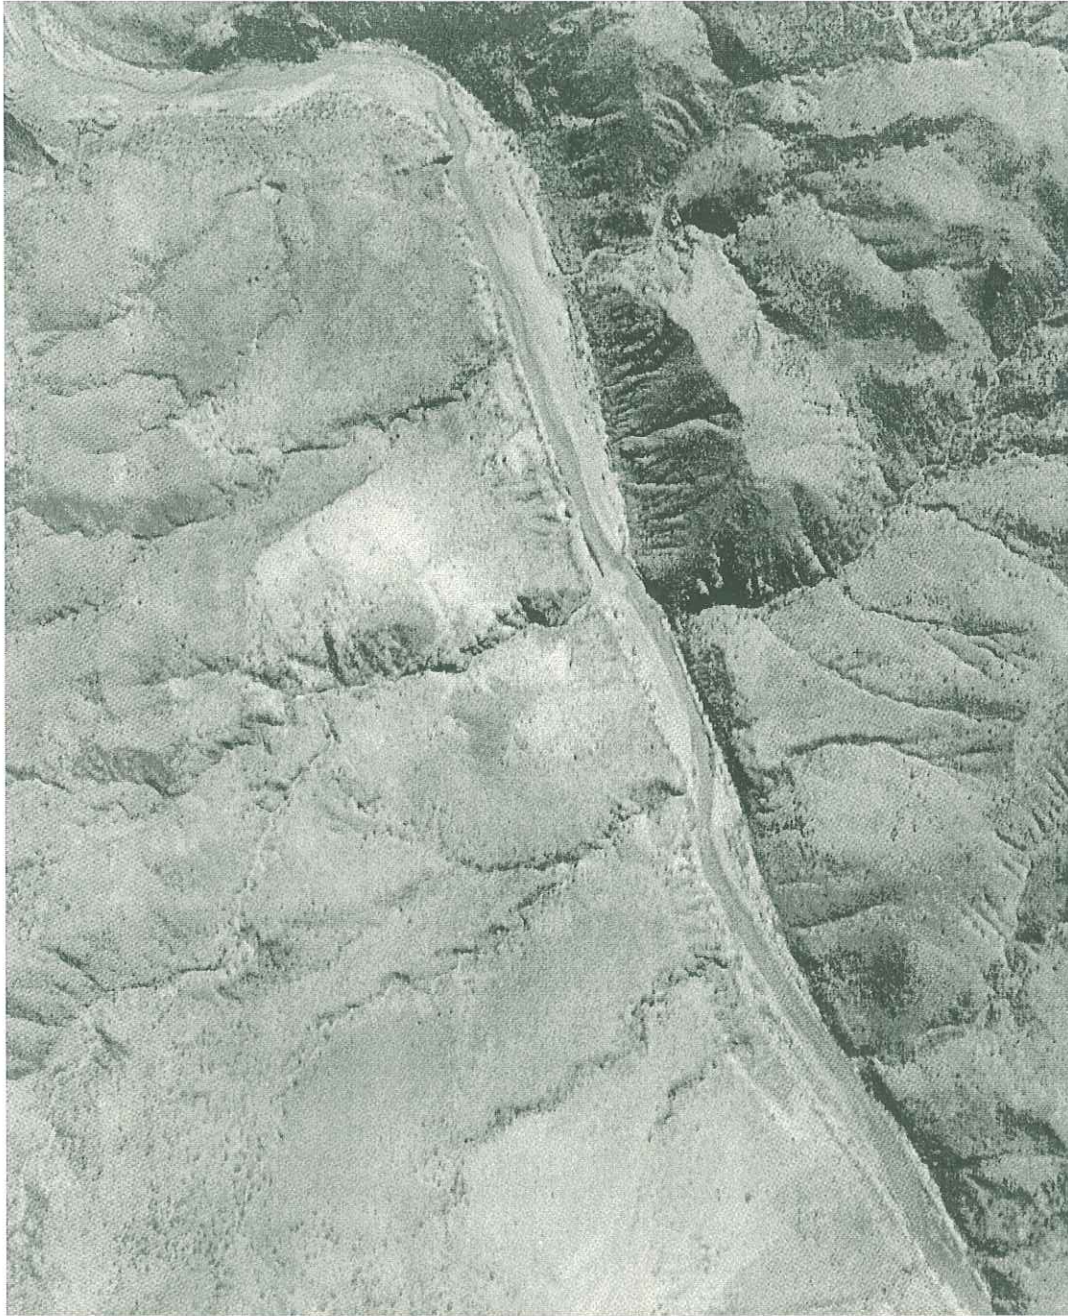
Figure 6. Verde River below Lower Coldwater Creek (T12N, R6E). 1934 aerial photograph of straight reach, a result of a geologic control. Note very narrow valley.

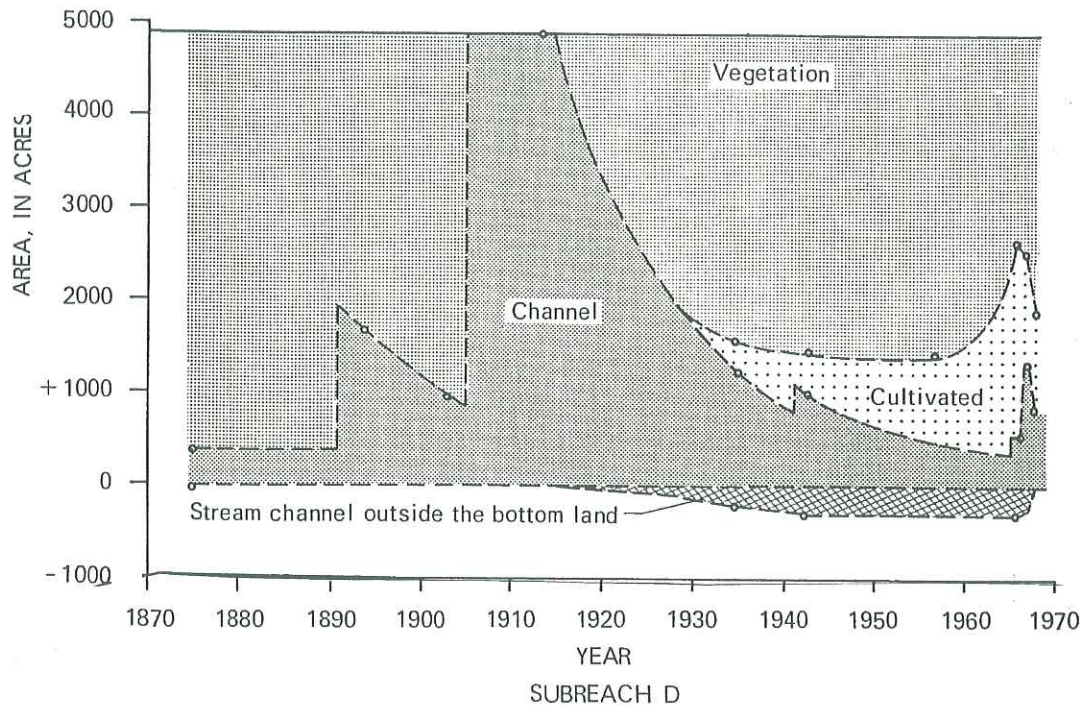
Figure 9a. Historical changes of channel area, upper Gila River, San Simon to Pima (Burkham, 1972).

According to Burkham (1972), the major floods were the cause of the dramatic channel changes along the upper Gila River prior to statehood. He summarizes the changes by plotting channel area in the reach between San Simon and Pima for the period 1875 to 1970 (Figure 9a).

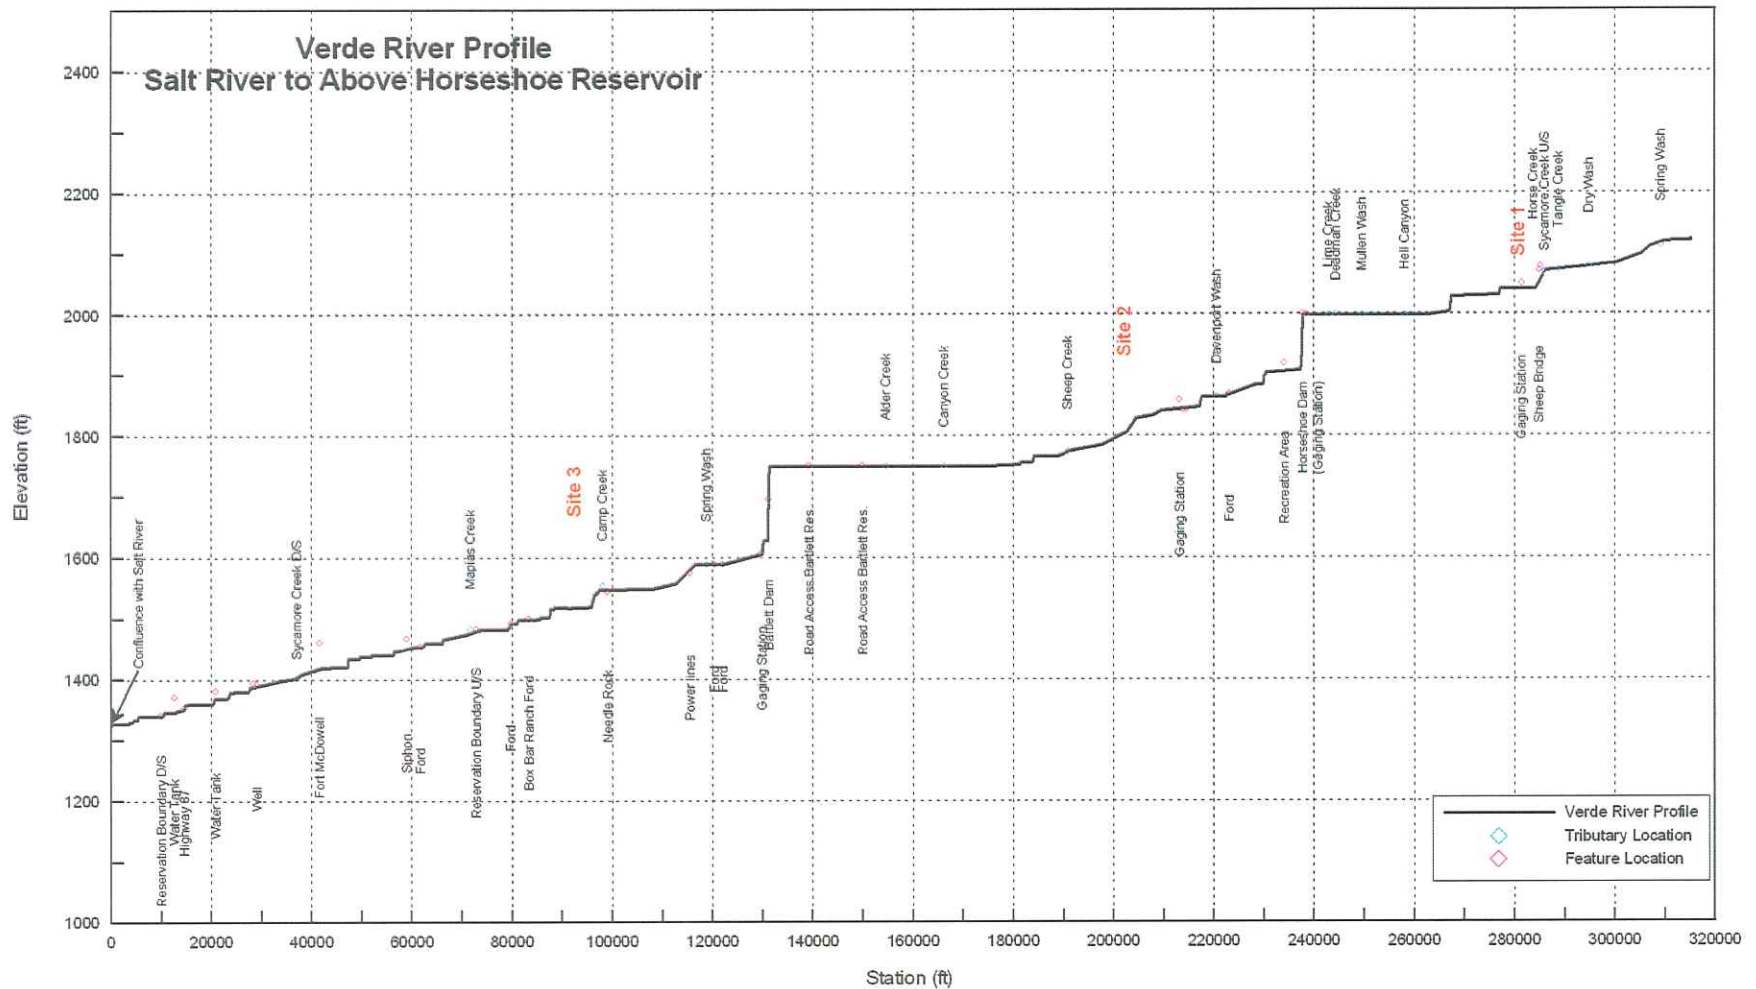
Figure 12. Longitudinal profile of Verde River. The profile shows great irregularity as a result of bedrock and tributary effects. Note location of Mussetter Engineering field sites.

A study by Mussetter Engineering, Inc. (2004) of riparian vegetation provides evidence of Verde River variability. Three sites were selected for detailed study (Figure 12) in wide reaches of the valley, where alluvium is stored and riparian vegetation is present.

Site 1 is located upstream of Horseshoe Dam (Figure 12). At this location, the valley is 600 feet wide and river gradient is 14 feet per mile.

Site 2 is located downstream of Horseshoe Dam (Figure 12). At this location, the valley is 2,000 feet wide and river gradient is 25 feet per mile.

Site 3 is located downstream of Bartlett Dam (Figure 12) where the valley is 4,000 feet wide and channel gradient is 12 feet per mile.

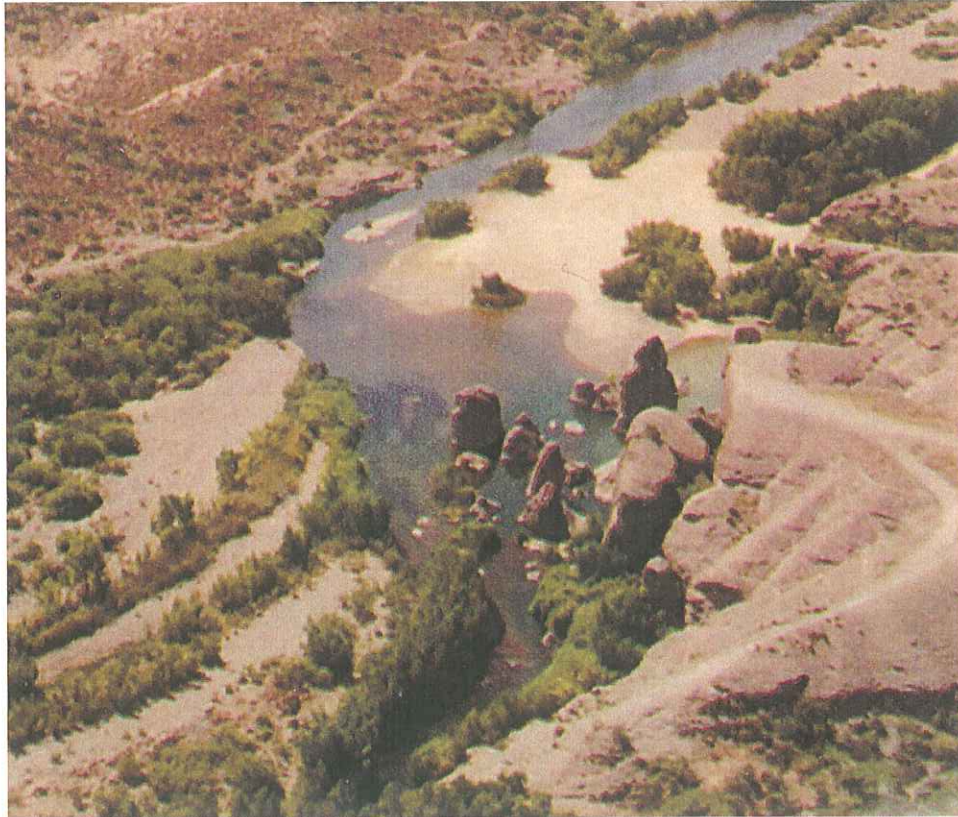
Figure 13. Bedrock in Verde River channel at Needle Rock.
