**BEFORE THE
ARIZONA NAVIGABLE STREAM ADJUDICATION COMMISSION**

**ARIZONA STATE LAND
DEPARTMENT'S MOTION TO
SUPPLEMENT THE RECORD WITH
DR. GARY HUCKLEBERRY'S
AFFIDAVIT CONCERNING THE
GILA RIVER AND MUSSETTER
ENGINEERING, INC.'S
GEOMORPHOLOGY OF THE UPPER
GILA RIVER WITHIN THE STATE
OF NEW MEXICO**

Geomorphology of the Upper Gila River Within the State of New Mexico

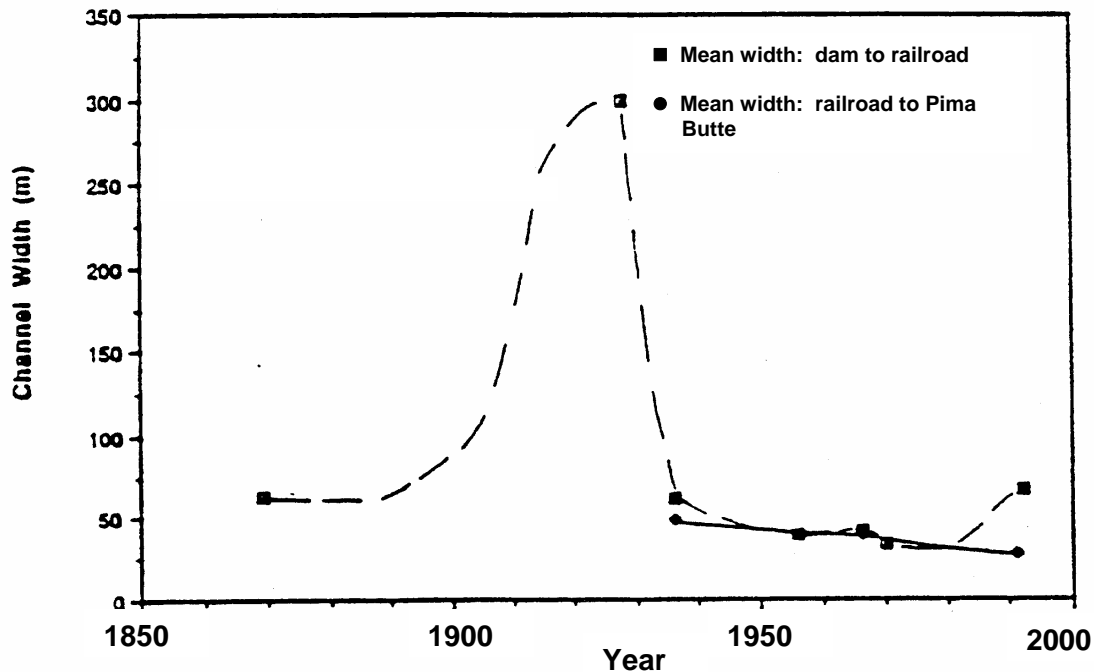
Figure 2.10. Changes in channel width for the middle Gila River (from Huckleberry, 1993).

Huckleberry (1996) reached the same conclusion regarding the middle Gila River (**Figure 2.10**). The early surveys showed the middle Gila as a narrow single channel until 1891. In 1891, the middle Gila River experienced a large flood that caused channel widening and large floods in 1905 and 1906 radically transformed the relatively narrow channel to a wide braided channel. Huckleberry (1996) concluded that major channel changes are related more to the duration of a flood than to its magnitude. Beginning in 1905, the channel experienced great widening as a result of bank cutting during periods of sustained flow. During two years, there were five months of high flow in 1905 and six months of high flow in 1906. Prolonged flow of this magnitude undoubtedly contributed to channel widening.

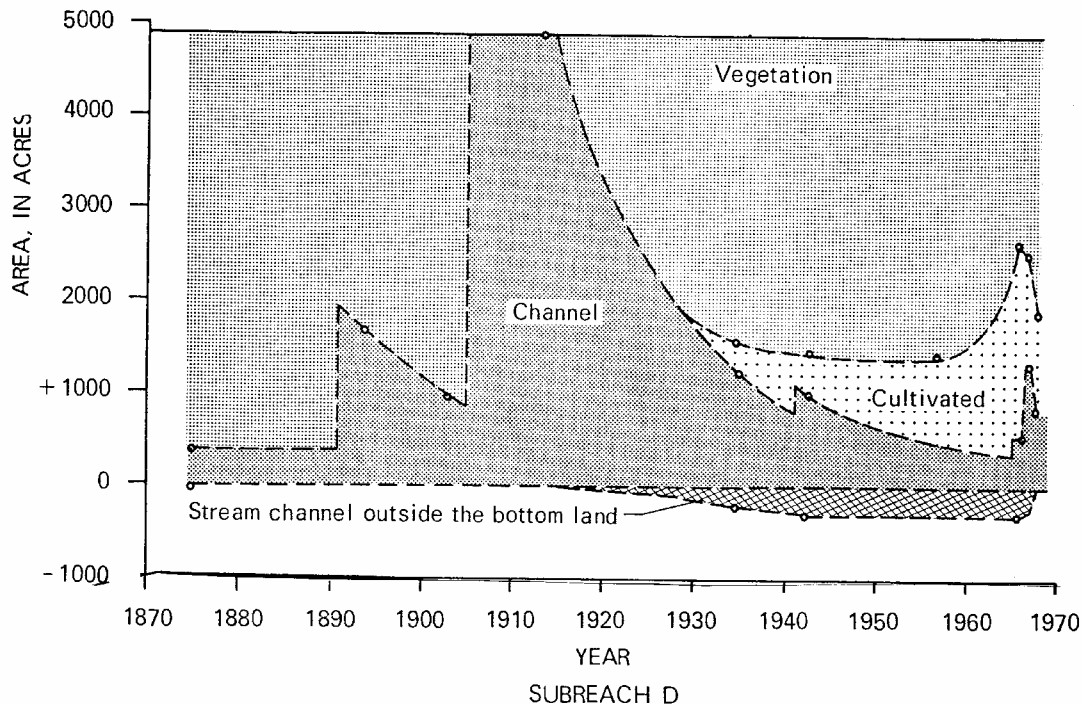
Figure 2.11. Historical changes in channel area of upper Gila River (San Simon to Pima) (from Burkham, 1972).

According to descriptions of Gila River by early explorers and travelers, the river, before 1875, was less than 150 feet wide and 10 feet deep at bankfull. The river was sinuous and flanked by a floodplain that supported willow, cottonwood, and mesquite. According to Burkham (1972), the channel changes of the Gila River in the Safford Valley can be grouped into three periods as follows: (1) 1846-1904, (2) 1905-1917, and (3) 1980-1990. In 1875, width varied from 70 to 220 feet, and it is assumed that width was generally the same from 1846 to 1875, although the response to floods caused some variation. For example, width was about 140 feet in 1875, 500 feet in 1894, and 260 feet in 1903. Major widening of the Gila River began during the flood of 1904. The river widened to 2,000 feet by 1915 (**Figure 2.11**).

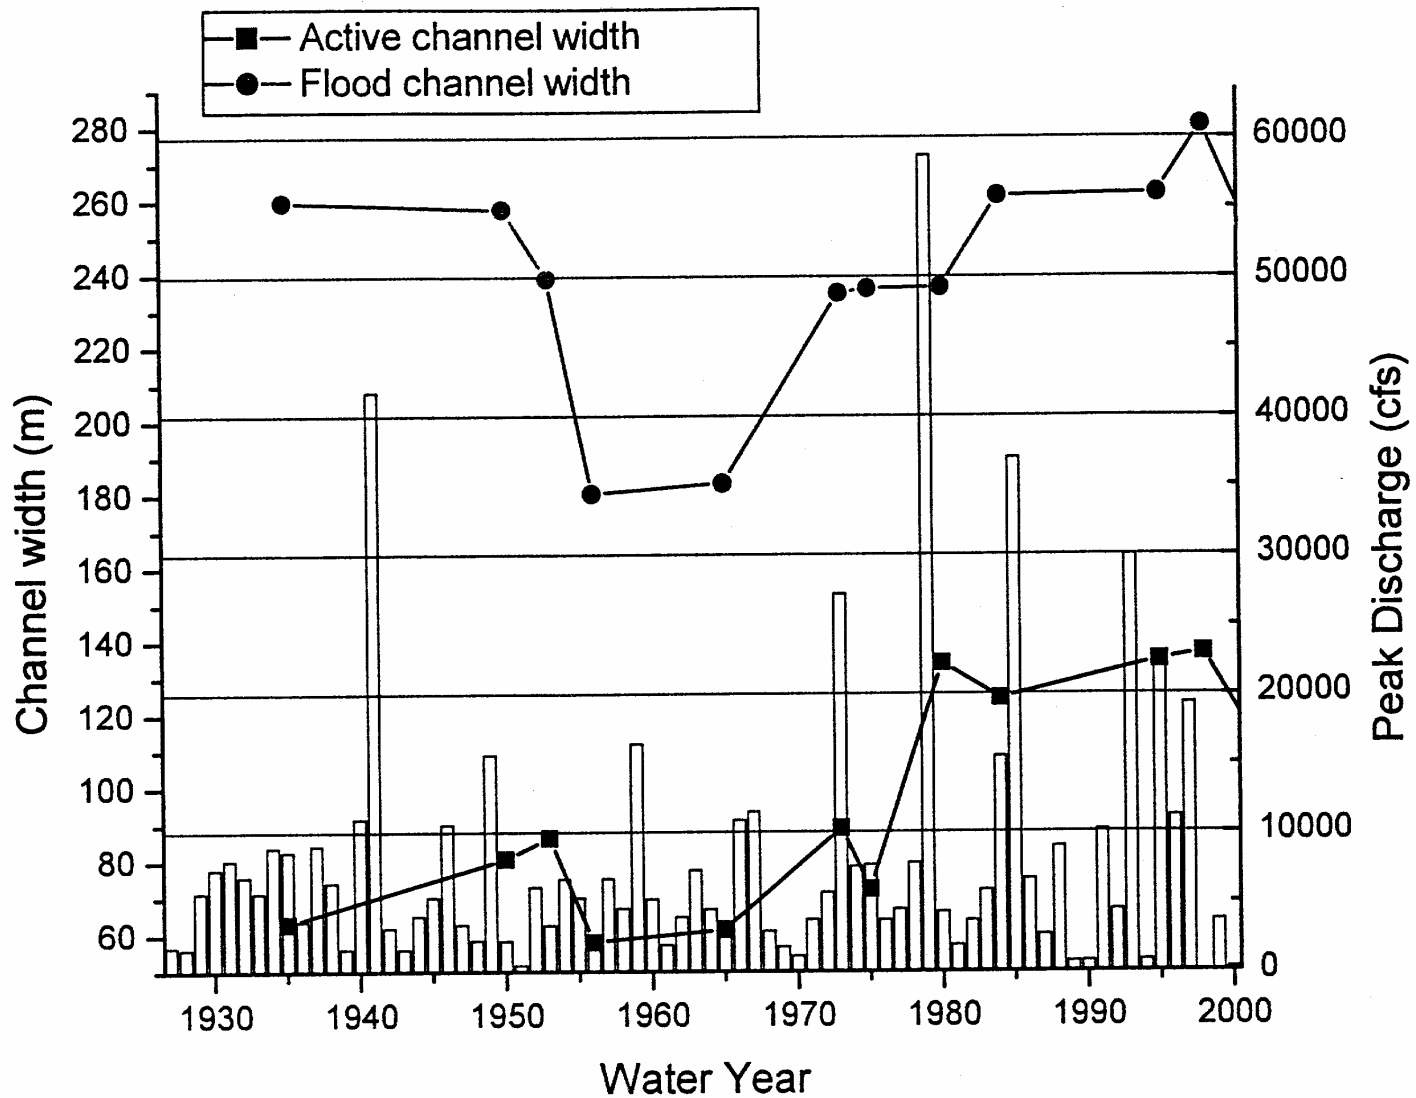
Figure 2.12. Average width data by photograph year. Active channel widths and flood channel widths are superimposed on the stream gage record at the Gila River below Blue Creek near Virden, New Mexico (from Bureau of Reclamation, 2004b).

The river is obviously more susceptible to change during floods, in the valley reaches in contrast to the canyon reaches (boxes). This is shown by data collected near Viriden, New Mexico (Figure 2.12). During a period of low peak discharge (1950-1970), the channel narrowed. During a period of high peak discharges, the channel widened. This corresponds well with channel changes in the Middle Gila River as described earlier (Burkham, 1970; Huckleberry,

1994). As documented by the Bureau of Reclamation (2002b), elsewhere along the Gila River, the period 1980-2000 was one of channel widening in response to large floods (Figure 2.12).

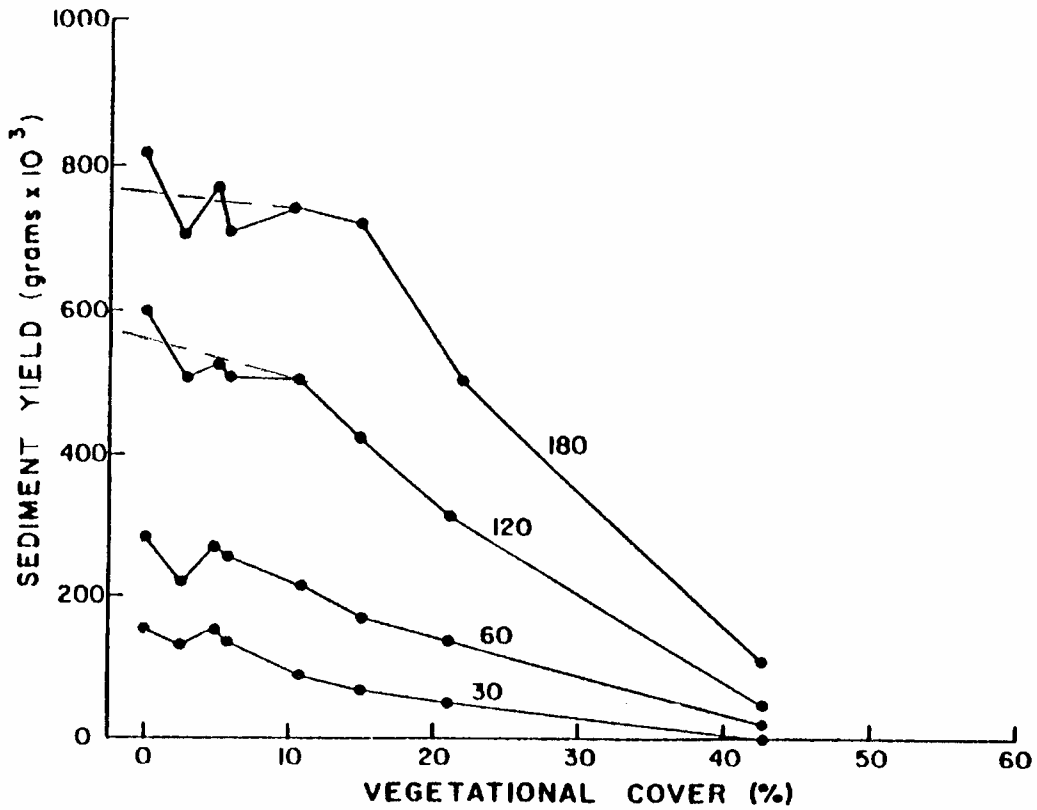
Figure 2.14. Effect of vegetational cover on sediment yield. Experiments performed on a 10-percent slope at 10, 60, 120, and 180 minutes of precipitation (from Rogers and Schumm, 1991).

Furthermore, experimental studies reveal that below about 15 percent vegetation cover, erosion is roughly constant (**Figure 2.14**), and therefore, a further reduction of vegetational cover below 15 percent will have a minor effect on sediment yield (Rogers and Schumm, 1991).

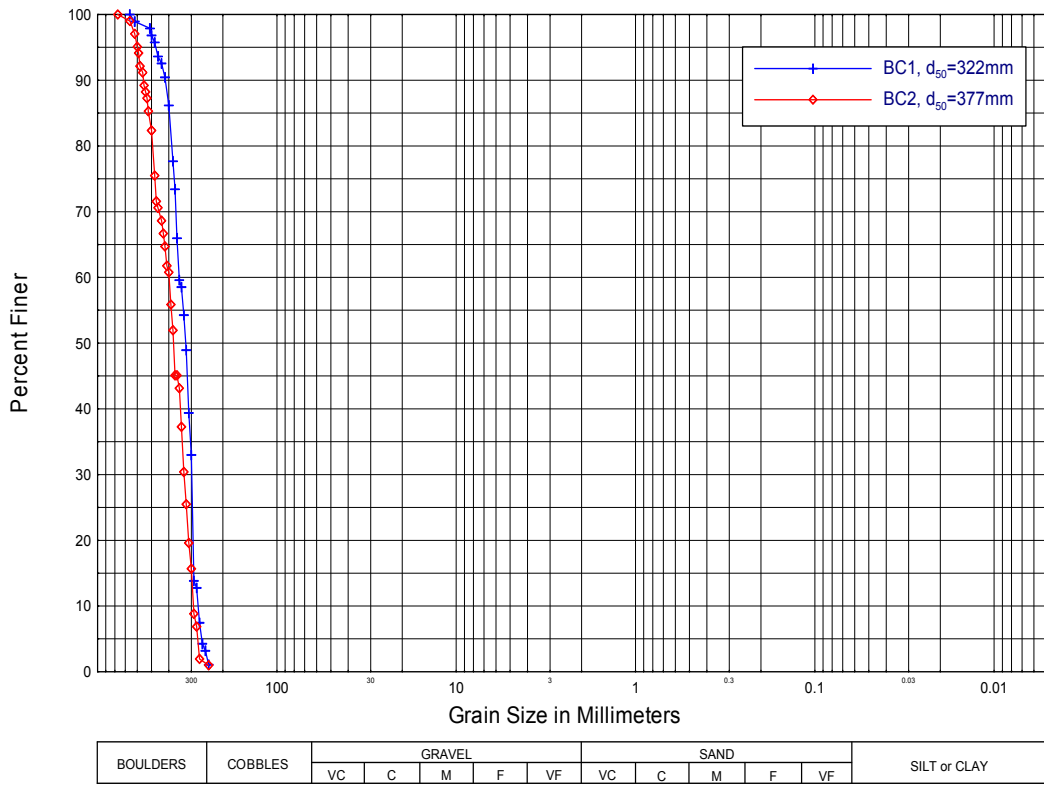
Figure 3.2. Gradation curves developed from non-randomized size measurements of boulders in riffles at Cross Sections 1 and 2.5 at the Turkey Creek site.

The boulder count data (**Figure 3.2**) show that the boulder-controlled riffles (Figure A.5) have median sizes (D_{50}) greater than 300 mm (~12 in.) and D_{90} (size of which 90 percent is smaller) sizes between 400 and 600 mm (16 to 24 in.). These coarse grained deposits are rarely if ever mobilized and form the local hydraulic controls in the channel. The surface gradations developed from the pebble counts (**Figure 3.3**) identify three classes of sedimentary deposits at the site. WC1 represents the surface gradation of the sediments introduced to the channel by the 2005 debris flow in Brock Canyon. The D_{50} is 44 mm (1.7 in.), and the D_{84} (size of which 84 percent is smaller) is 90 mm (3.5 in.) (**Figure A.7**). WC2 represents a gravel/cobble riffle in the channel at XS4, and is reasonably representative of the non-boulder riffles in this reach of the Gila River (**Figure A.8**). The D_{50} is 80 mm (3 in.), and the D_{84} is 160 mm (6.3 in.). WC3 represents the surface gradation of the sediments that were transported and deposited during the 2005 flood (**Figure A.9**). The D_{50} is 36 mm (1.4 in.), and the D_{84} is 70 mm (2.8 in.). The three bulk samples that were laboratory sieved (ASTM D422) by Vinyard & Associates, Inc., Albuquerque, NM, provide an indication of the caliber of material supplies by the Brock Canyon

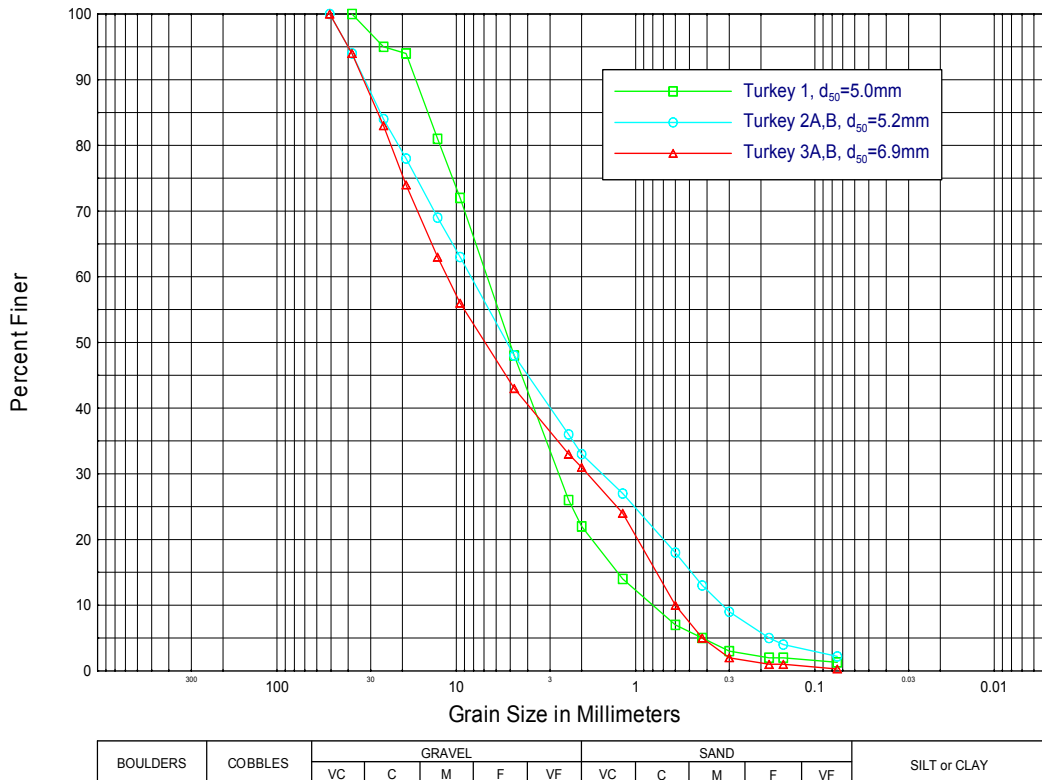
Figure 3.4. Gradation curves developed from bulk samples at the Turkey Creek site.

tributary and its subsequent sorting by the Gila River, and the sediment load transported in the Gila River in the 2005 flood. Sample Turkey 1 represents the finer fraction of the sediments delivered by the debris flow, and has a D_{50} of 5 mm (0.2 in.), and the D_{84} of 17 mm (0.7 in., **Figure 3.4**). Reworking of the finer fraction of the debris flow deposit (Turkey 2) does not significantly affect the D_{50} (5.2 mm), but it does increase the D_{84} size (28 mm) (**Figure A.10**). Between 30 and 35 percent of the samples are composed of sand-sized sediments. Sample Turkey 3 has a D_{50} of 7 mm (0.3 in.) and a D_{84} of 28 mm (1 in.), and is an indication of the sediment load transported and deposited during the 2005 flood. About 30 percent of the transported load was sand-sized and finer.

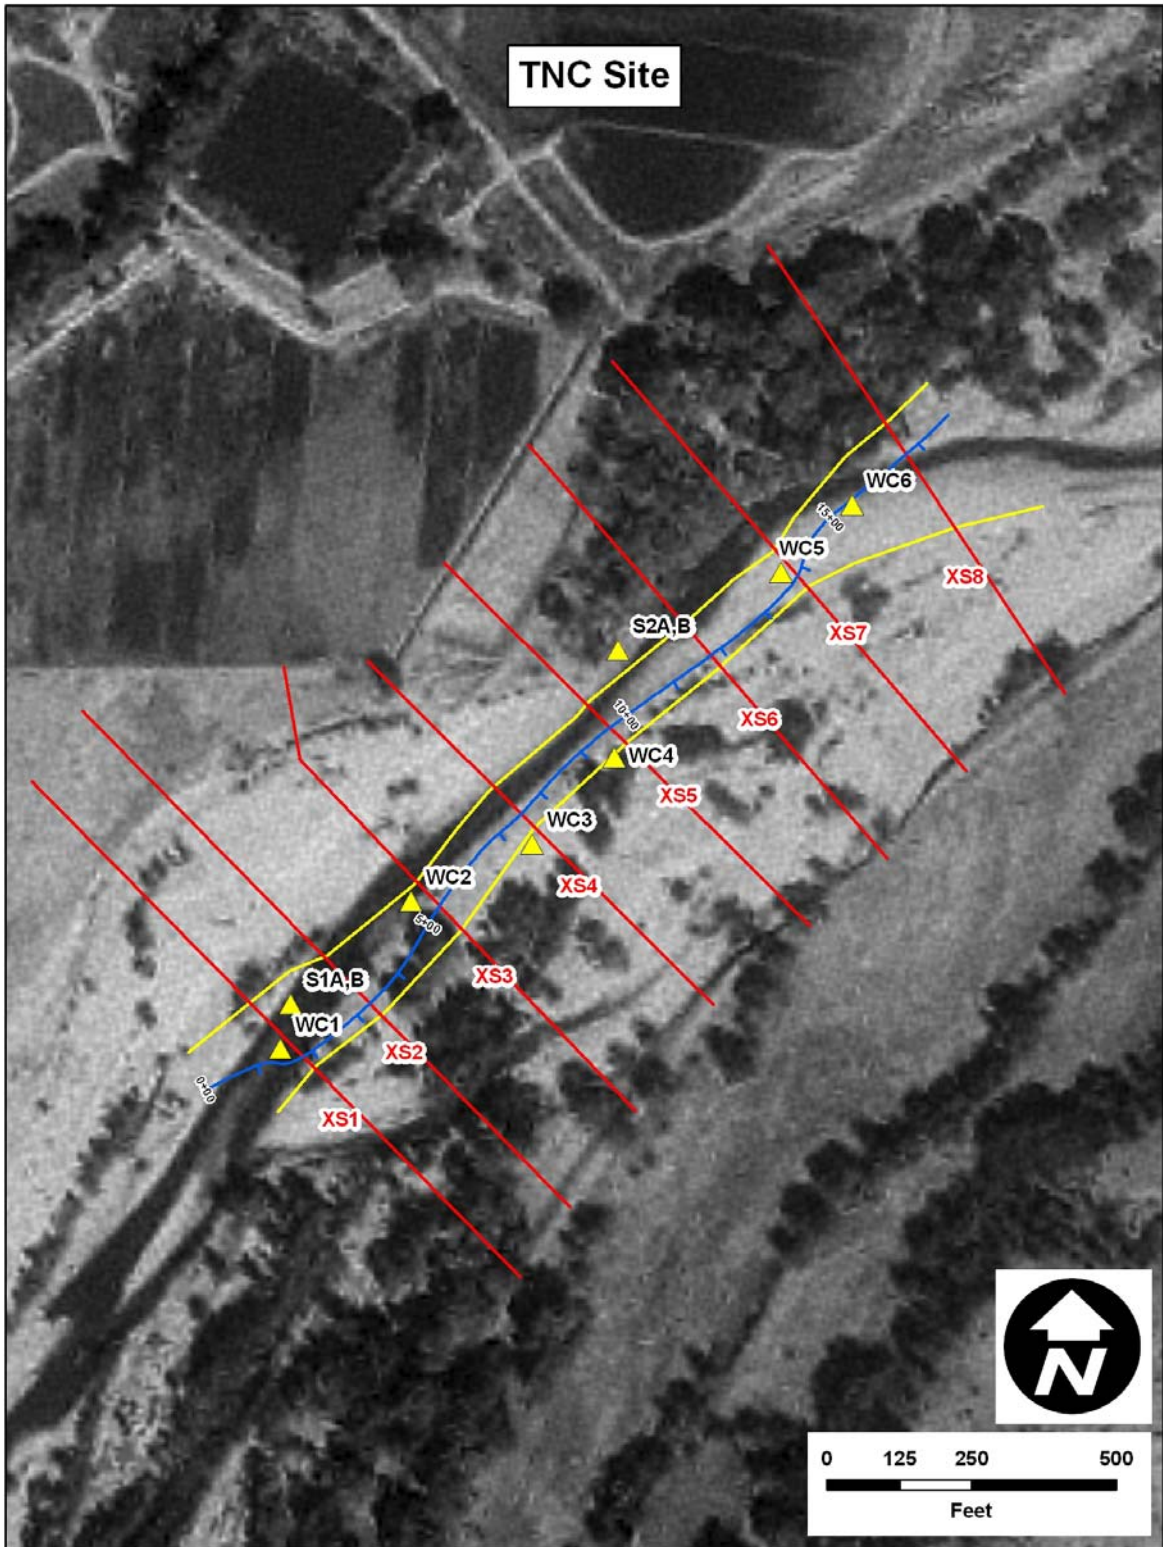
Figure 3.5. Aerial photograph showing the morphology of the TNC site, the locations of the surveyed cross sections and the locations of the sediment samples.

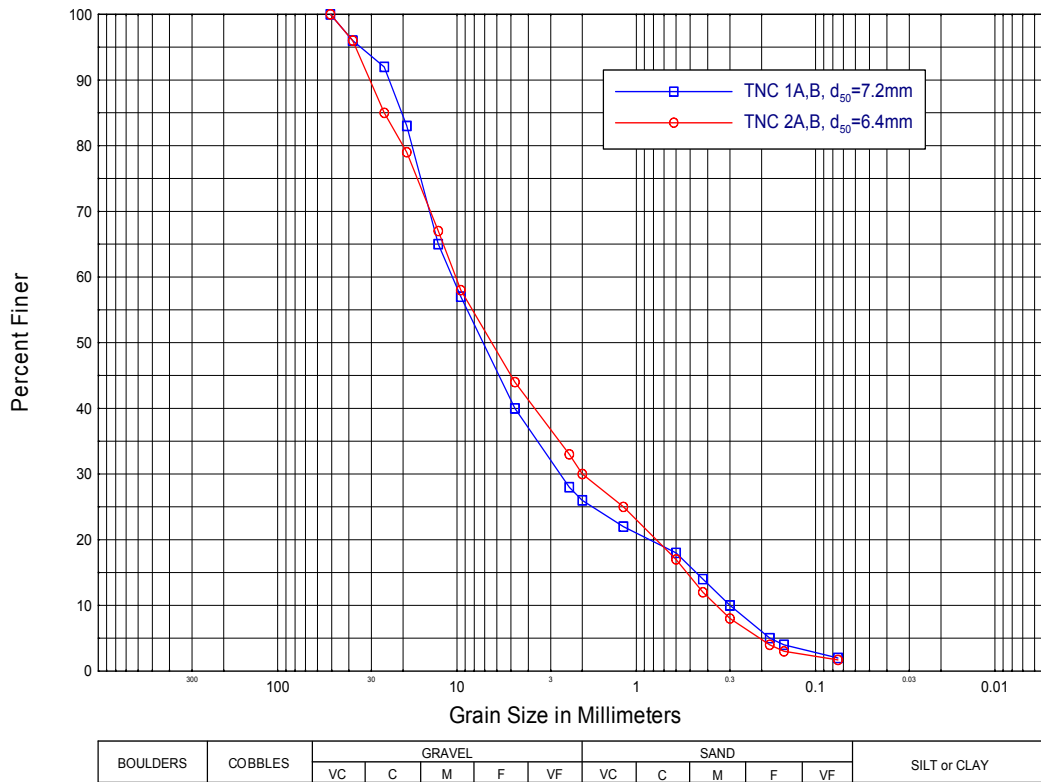
Figure 3.7. Gradation curves developed from bulk samples at the TNC site.

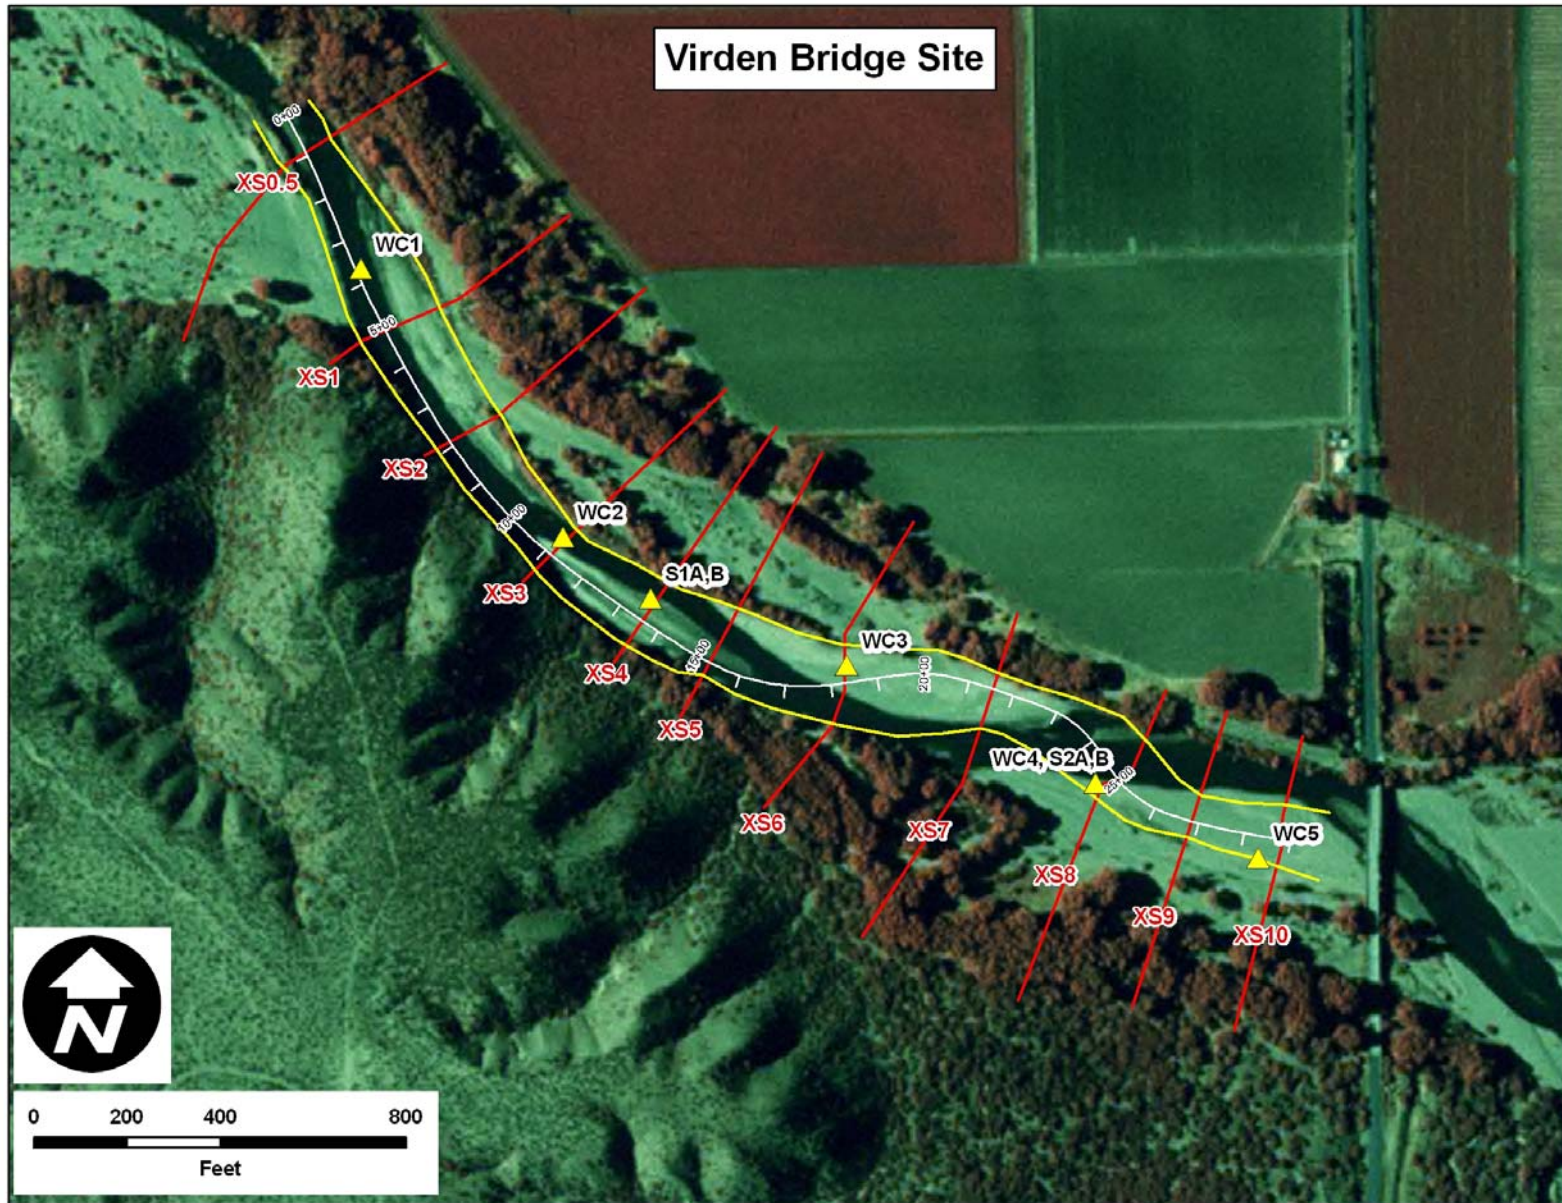
Figure 3.14. Aerial photograph showing the morphology of the Virden Bridge site, the locations of the surveyed cross sections and the locations of the sediment samples.

Figure 3.14 shows the general morphology of the site, and the locations of the 11 cross sections that were surveyed in February 2006 with RTK-GPS and Total Station methods. The cross sections and thalweg profiles were used to develop a 1-D step-backwater HEC-RAS (USACE, 2005) hydraulic model of the site (Chapter 5). Also shown on Figure 3.14 are the locations of the five pebble counts (WC1-WC5) that were conducted on the coarse-grained riffles, and the locations of the two bulk samples that were collected from low-elevation bank-attached bars (S1, S2).

The Virден Bridge Site HEC-RAS model was developed from the 11 cross sections surveyed in February 2006 (Figure 3.14). The model was calibrated to the measured discharge (40 cfs) at the time of the survey. Thalweg, and bank profiles and the water-surface profiles of a range of flows between 5 and 22,900 cfs (15-year peak flow recurrence interval) are shown on **Figure 5.5**. **Table 5.5** summarizes the reach-averaged hydraulic parameters for the range of flows modeled (5 to 87,100 cfs). At the 2-year flow (5,190 cfs), the average channel velocity is about 6 fps, hydraulic depth is about 5 feet, and the channel top width is about 158 feet. At the estimated 2005 peak flow (22,900 cfs), which is the most geomorphically-effective flow at the site since 1997, the average velocity was about 9 fps, the hydraulic depth was about 12 feet and the channel width was about 103 feet. Effective width-, channel velocity- and hydraulic depth-

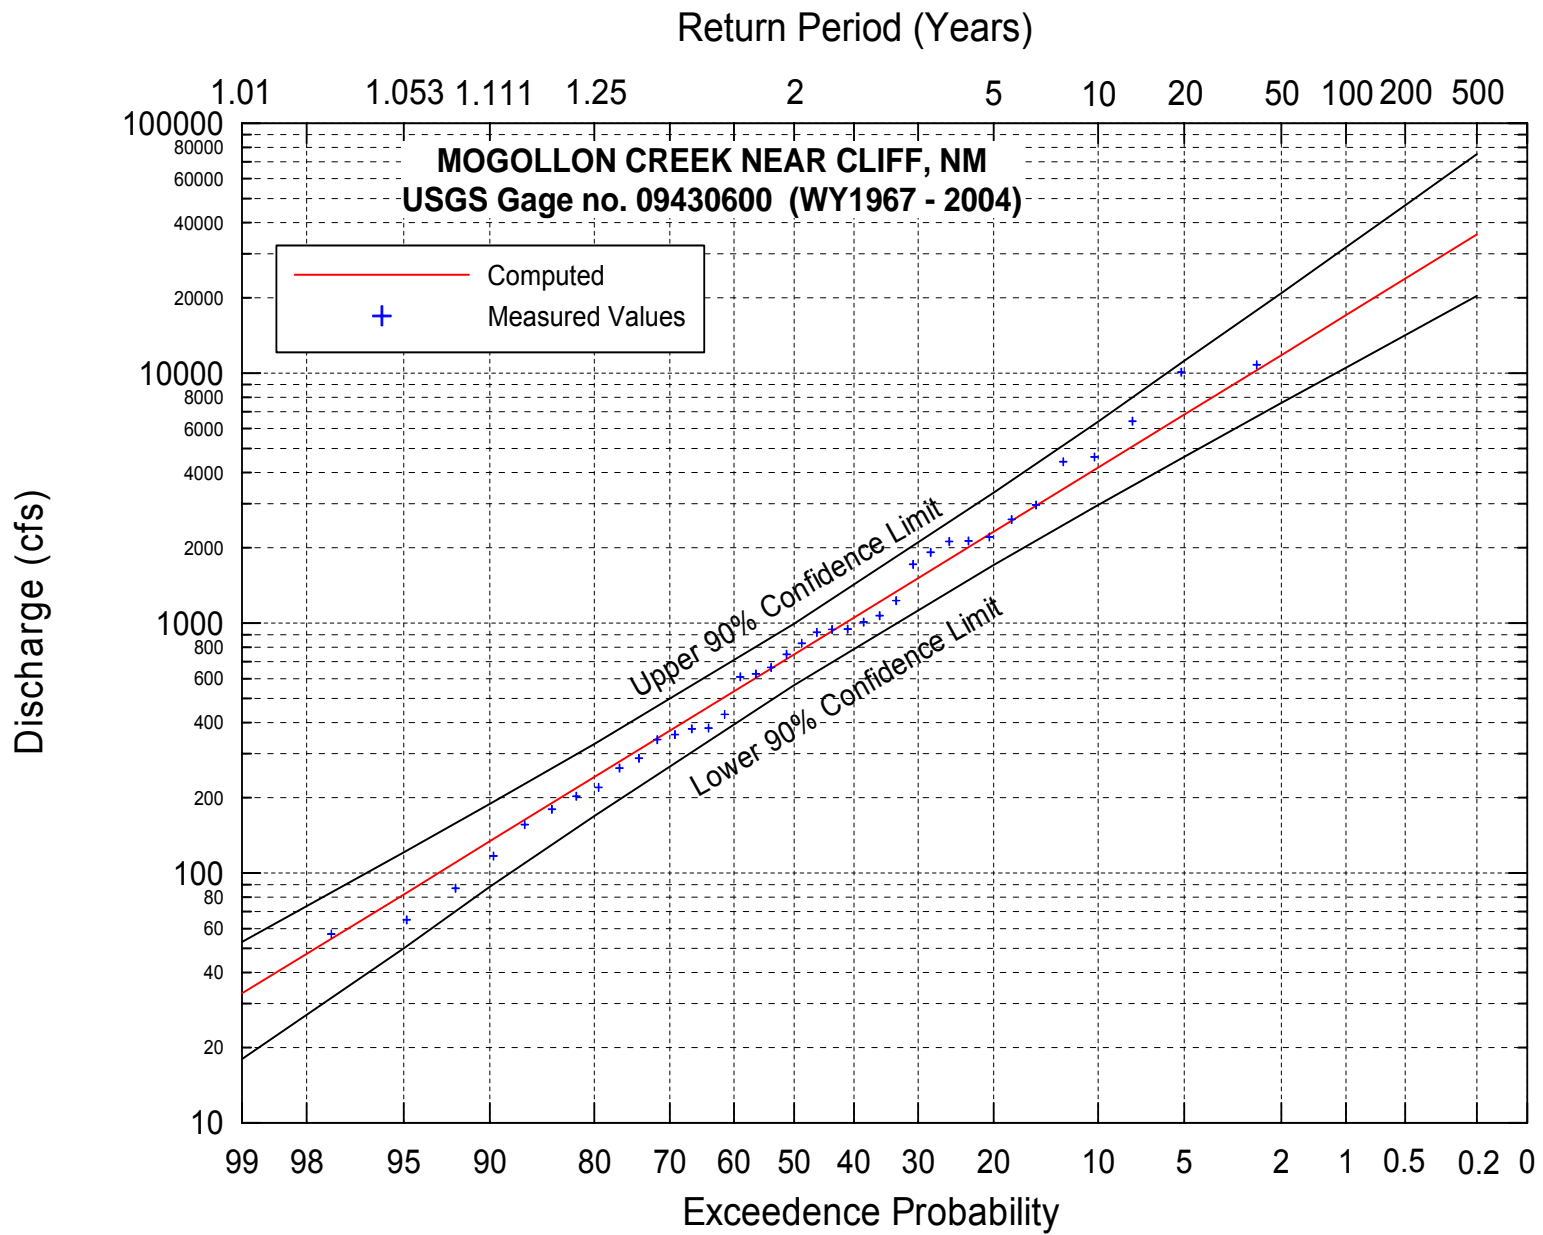
Figure 4.5. Flood-frequency curve for USGS Mogollon Creek near Cliff, NM (9430600) gage, WY1967-WY2004.

Figures 4.5 through 4.7 shows the peak flood frequency curves for the Mogollon Creek near Cliff, Duck Creek at Cliff and Mangas Creek near Cliff gages, respectively. The exceedence probabilities and return periods for these gages for the 1- to 500-year floods are summarized in Table 4.3. The 2-year recurrence interval peak flows for the three gages are 749, 3,710, and 652 cfs, respectively. The 100-year recurrence interval peak flows for the three gages are 17,100, 14,400, and 8,090 cfs, respectively. The only provisional peak flow value for the 2005 flood is that for Mogollon Creek (5,800 cfs), which has a recurrence interval of about 15 years.

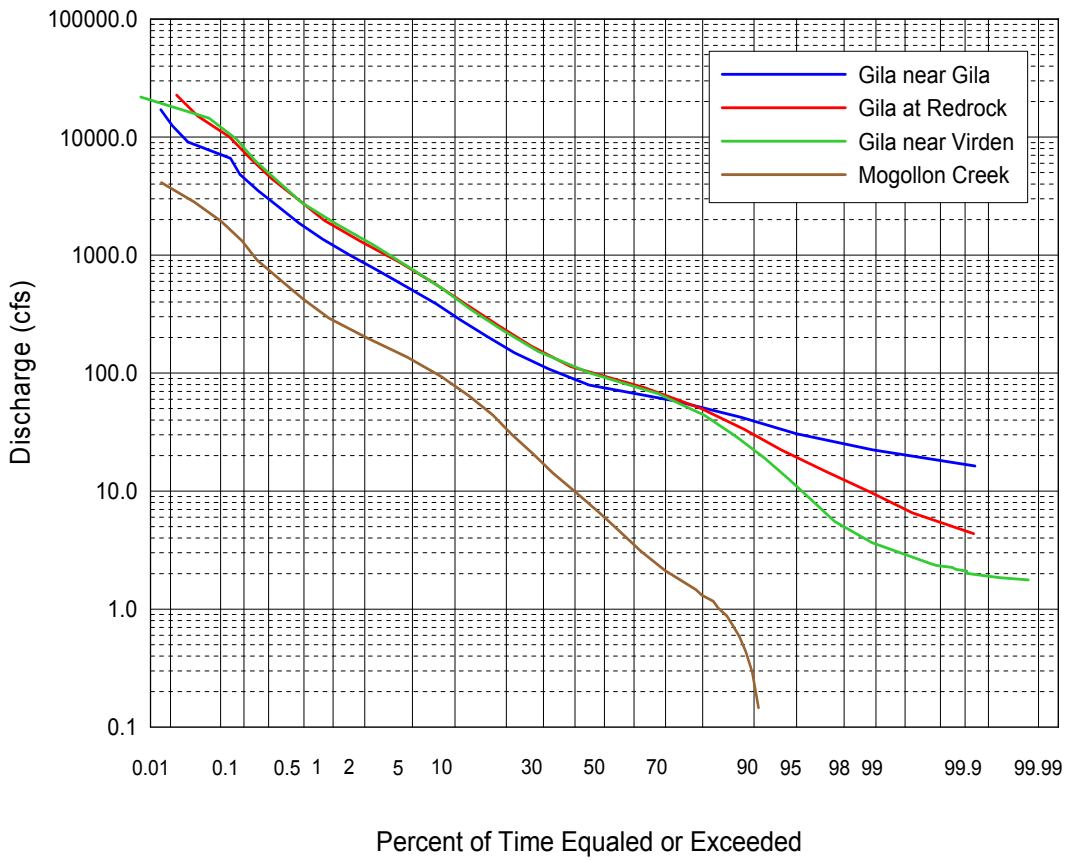
Figure 4.8. Flow-duration curves for Gila River near Gila, Gila River near Redrock, Gila River near Virden and Mogollon Creek gages.

Flow-duration curves were developed for all of the gages with a mean daily flow record (Table 4.1). The flow-duration curves for the Gila River near Gila, Gila River near Redrock and Gila River near Virден gages, and for Mogollon Creek are shown on **Figure 4.8**. Summary statistics for the 4 gages are provided in **Table 4.4**. On the Gila River, 90 percent of the time, flows are equal to or exceed 38 cfs at the upstream gage and equal or exceed 22 cfs at the downstream gage as a result of existing flow diversions. Fifty percent of the time flows are equal to or exceed 74 cfs at the upstream gage and 90 cfs at the downstream gage due to flow accretion in the downstream direction. Similarly, the 10-percent exceedence flows increase from 302 cfs at the upstream gage to 431 cfs at the downstream gage.

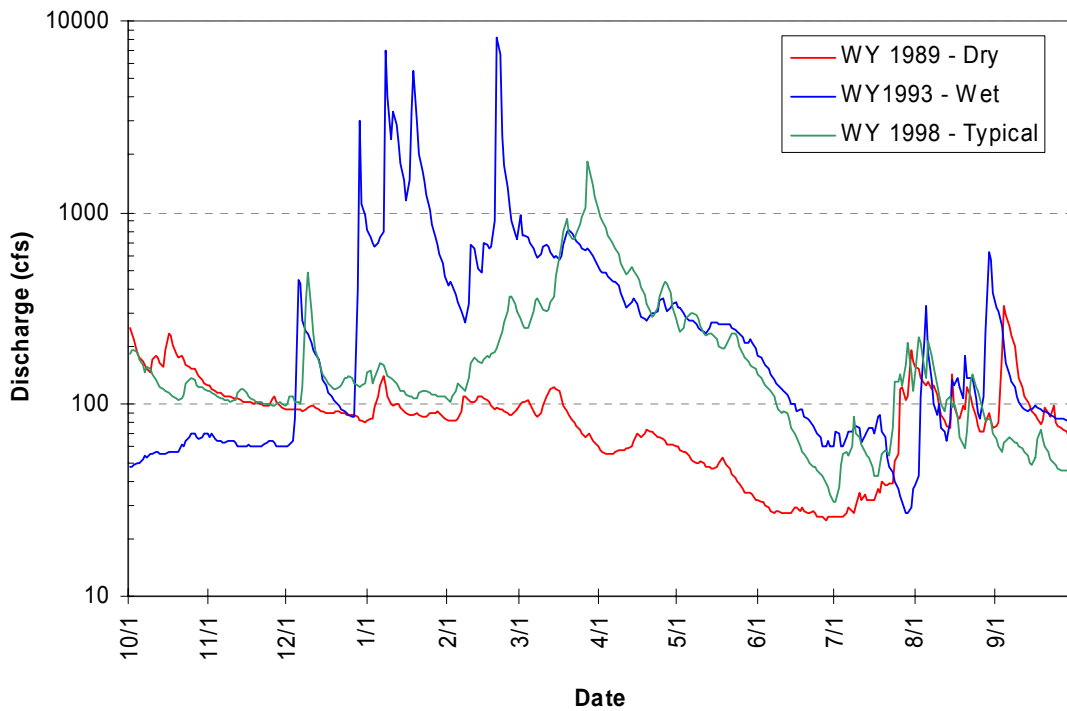
Figure 4.9. Annual hydrographs for dry, typical and wet years for the Gila River near Gila gage.

For the Gila River near Gila gage the annual hydrographs for 1989, 1998 and 1993 clearly show the differences in water year types (**Figure 4.9**). The annual hydrographs show the winter runoff events as well as the spring snowmelt and the monsoonal flows in the fall. Annual hydrographs for the representative water year types for the Gila River near Redrock (**Figure 4.10**) and Gila River near Virден (**Figure 4.11**) show the same patterns.

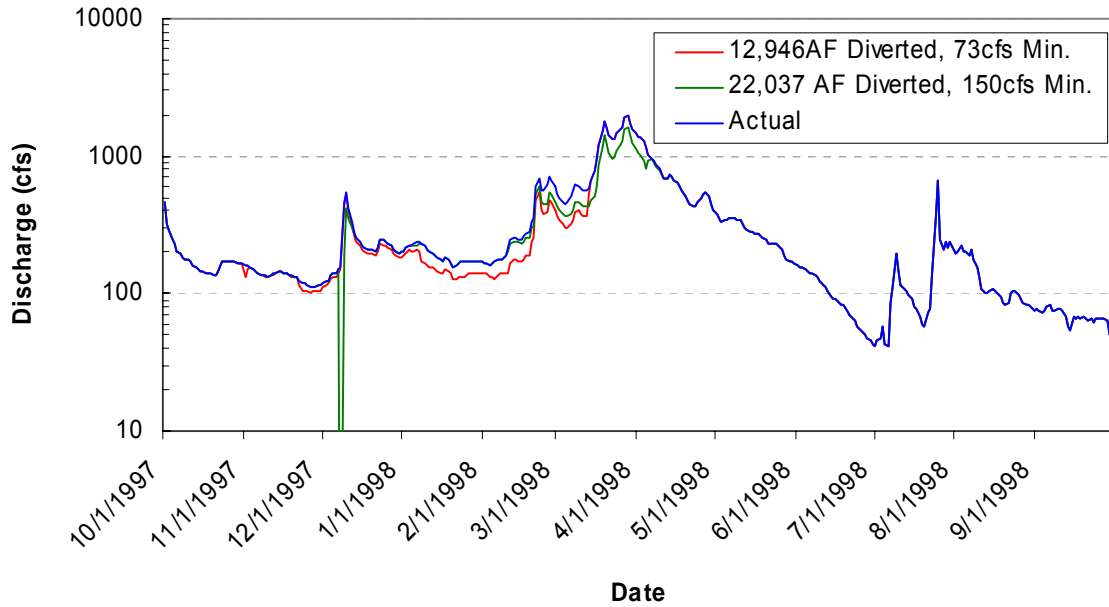
Figure 4.19. 1998 hydrographs (representative typical year) for existing conditions and with 73- and 150-cfs minimum bypass requirements for the Gila River near Virden gage.

Annual hydrographs for the three representative year types with the same diversions applied were developed for the Gila River near Redrock gage (**Figures 4.15 through 4.17**) and the Gila River near Virden gage (**Figures 4.18 through 4.20**) so that the effects of the diversions on sediment transport and hence geomorphic processes could be evaluated (Chapter 6). Diversion of the same flows at the downstream gages occasionally results in the bypass flows at these gages being less than the minima, but since no algorithm for diversion was provided, it was not possible to adjust the flows. However, the differences resulting from this issue are very unlikely to be geomorphically significant.

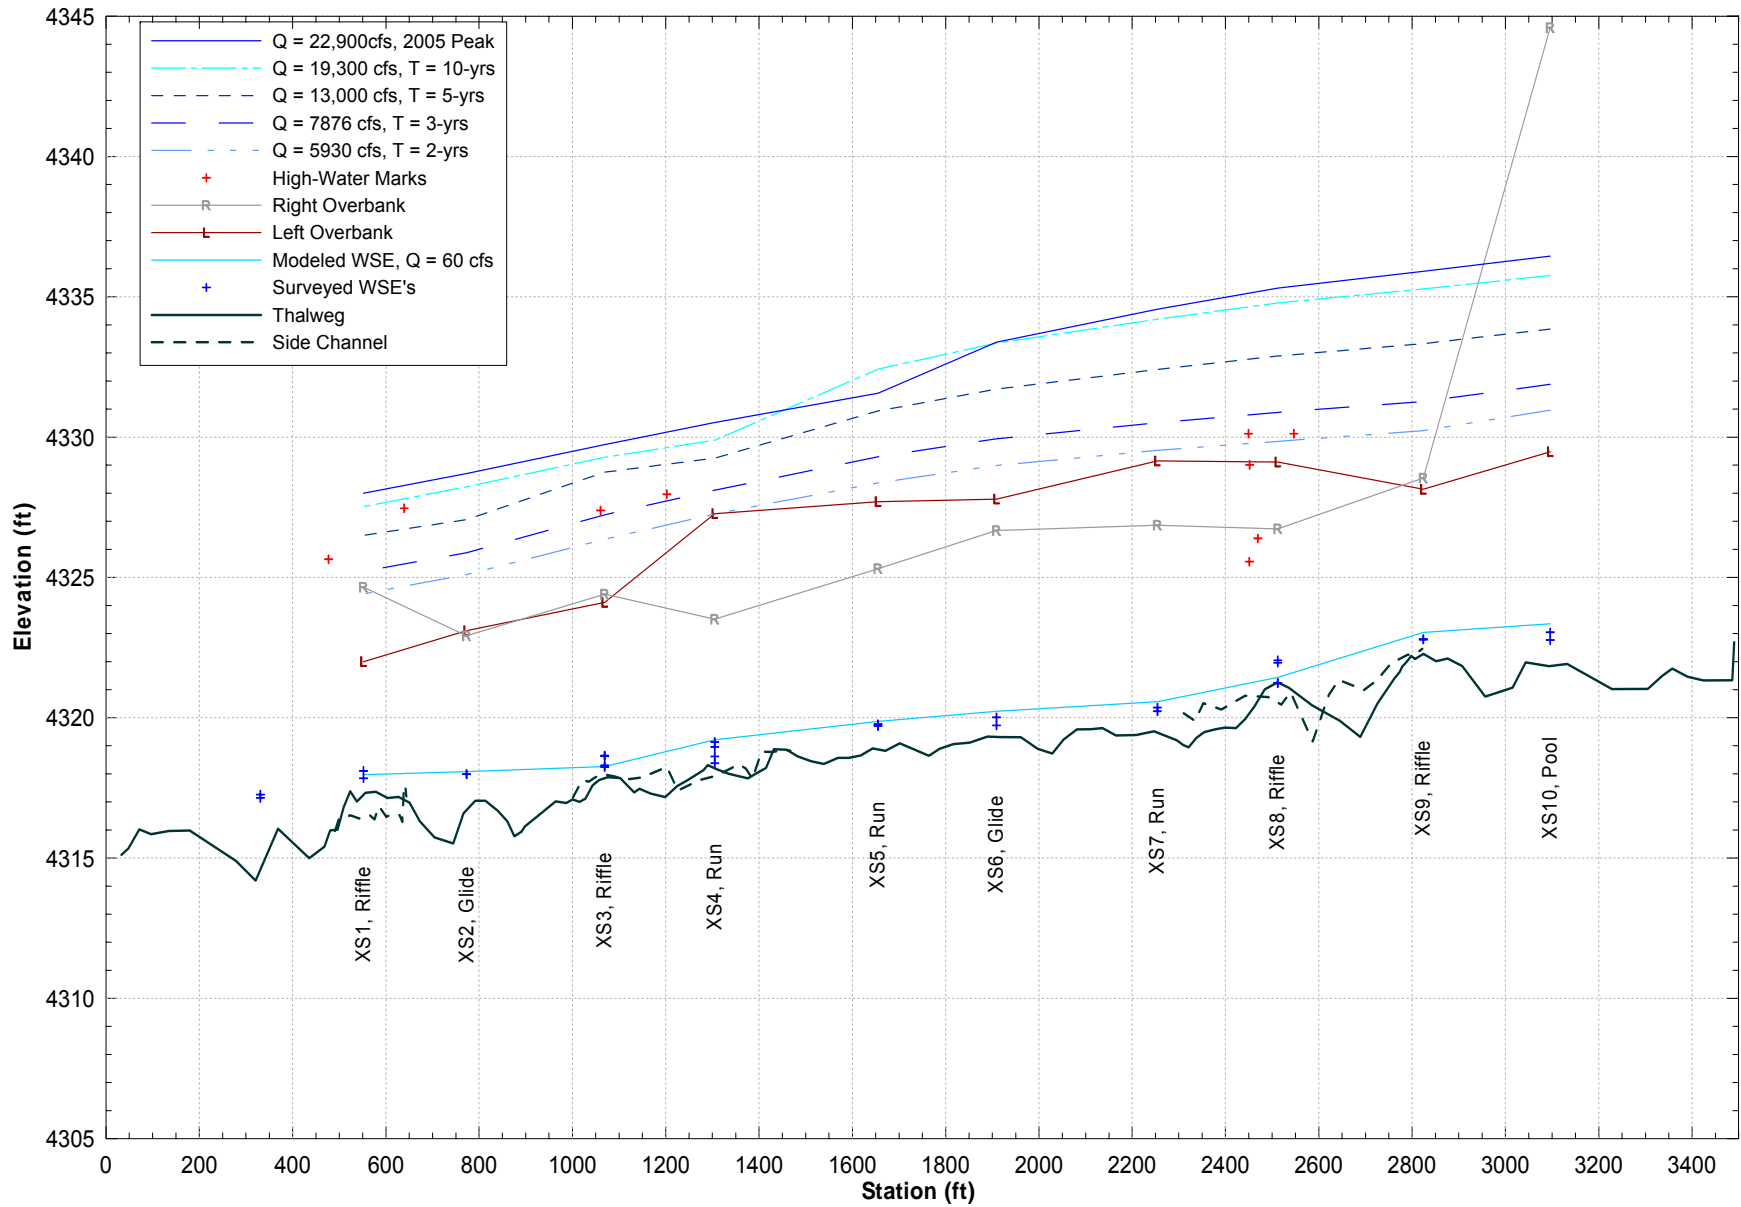
Figure 5.3. Thalweg, top-of-bank and water-surface profiles for the Birds site.

flows between 5 and 28,200 cfs (25-year peak flow recurrence interval) are shown on **Figure 5.3**. **Table 5.3** summarizes the reach-averaged hydraulic parameters for the range of flows modeled (5 to 72,900 cfs). At the 2-year flow (5,930 cfs), the average channel velocity is about 5 fps, hydraulic depth is about 7 feet, and the channel top width is about 151 feet. At the 2005 peak flow (22,900 cfs), which is the most geomorphically effective flow at the site since 1997, the average velocity was about 8 fps, the hydraulic depth was about 10 feet and the channel width was about 151 feet. Effective width-, channel velocity- and hydraulic depth-discharge rating curves for each of the cross sections at the site that can be used to evaluate the in-channel hydraulic characteristics at the various habitat units (riffles, runs, pools, glides) are provided in **Appendix B**.

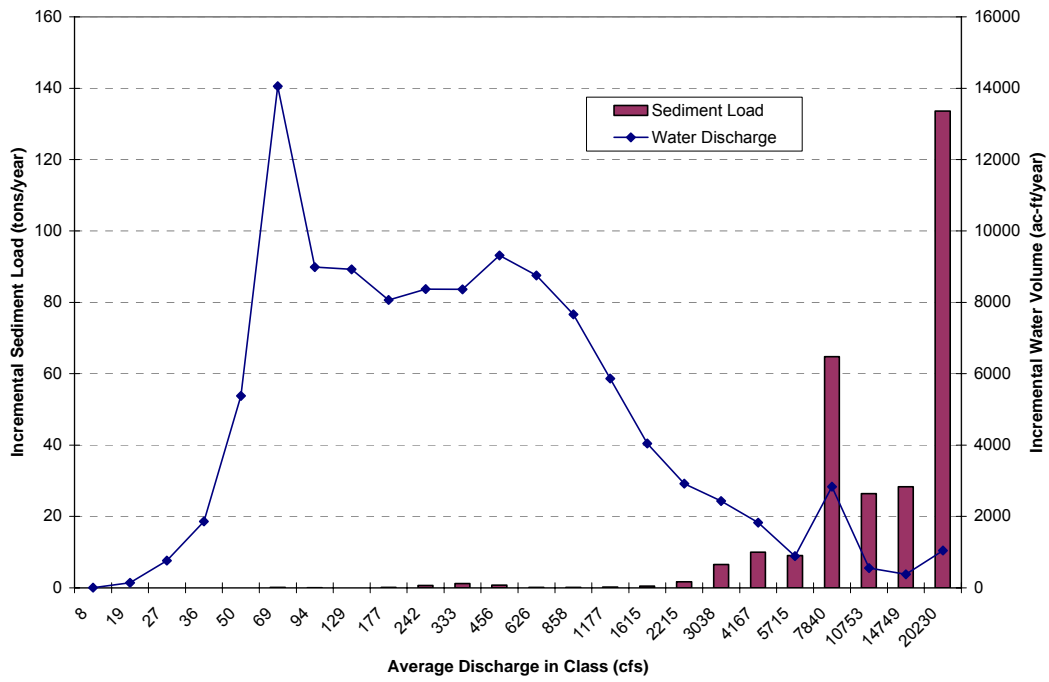
Figure 6.7. Effective discharge plot for the TNC site.

flows (Figures 6.6, 6.7, 6.8, 6.10). Based on the diversion estimates provided by NMISC, the maximum diversion is estimated to be 350 cfs, and therefore, unless the diversions occur in the range of the incipient-motion and significant sediment-transport thresholds, there should be no significant geomorphic impacts.

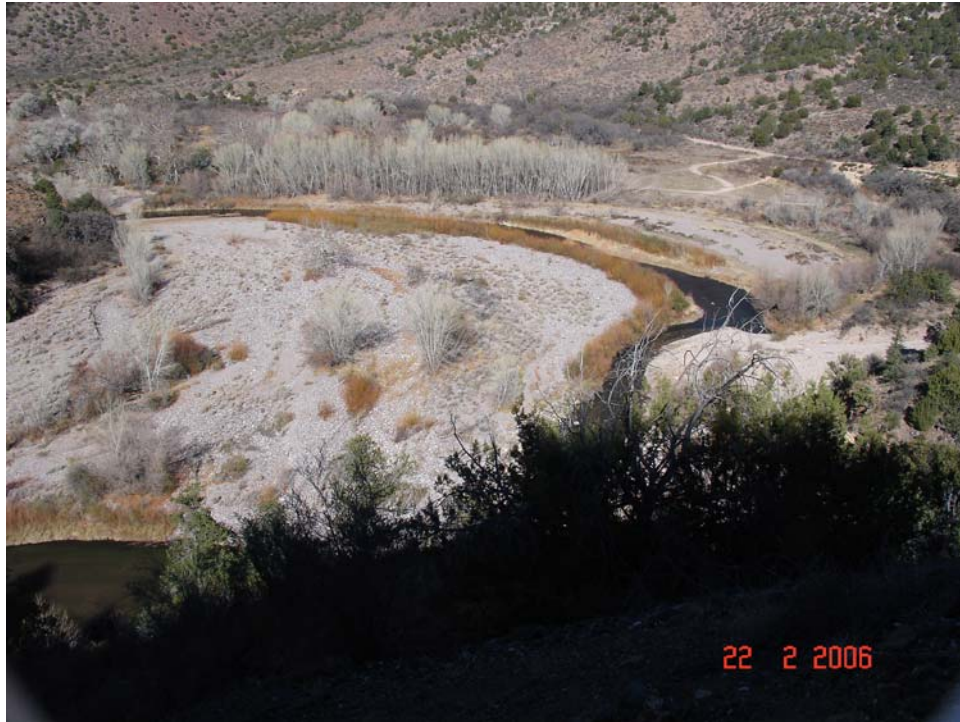
Figure A.1. View upstream of Gila River at Turkey Creek site showing bedrock control of the site, overbank chute channels and terraces supporting the larger cottonwoods.

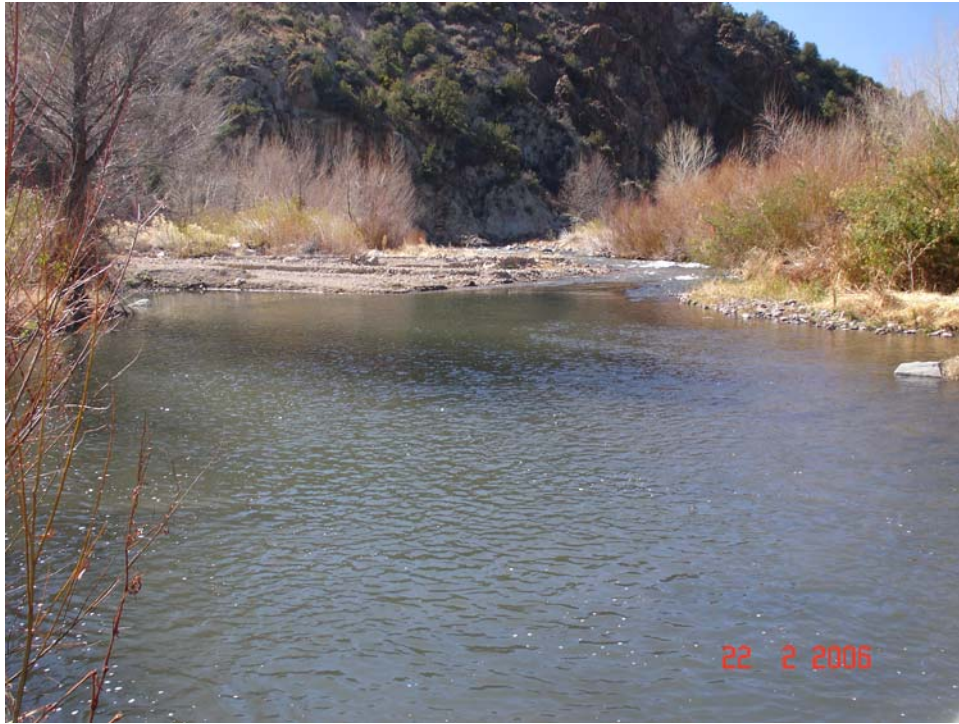
Figure A.3. View downstream of contraction of Gila River caused by recent debris flows in Brock Canyon. Note ponding upstream of the contraction.

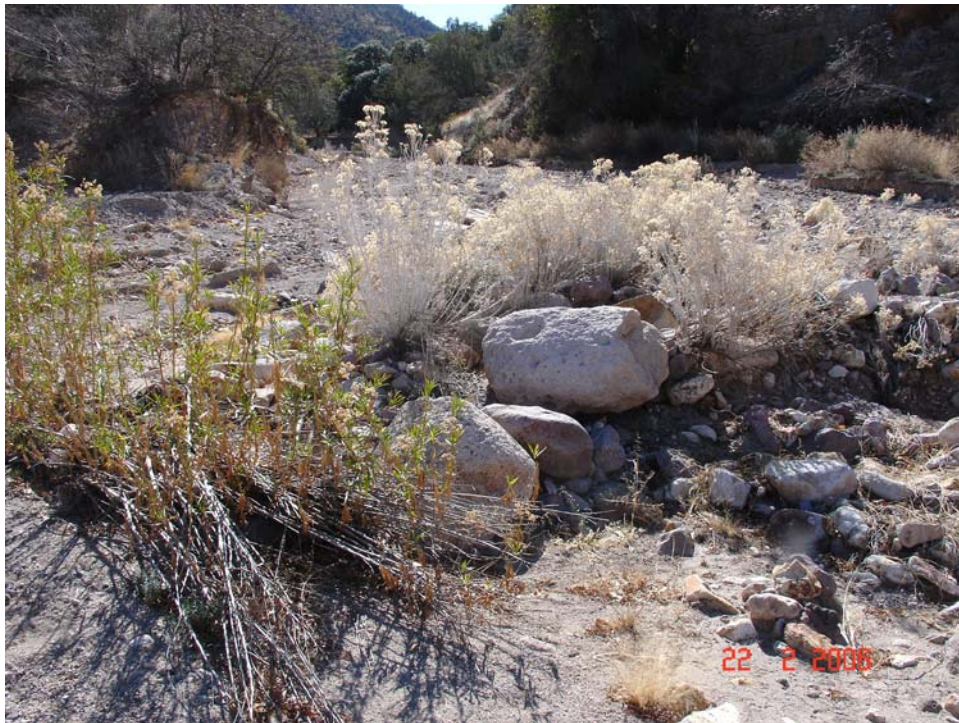
Figure A.4. Large boulders delivered to the Gila River by debris flows in Brock Canyon. Boulder lag deposits form coarse grained riffles in the channel of the Gila River.
