**BEFORE THE
ARIZONA NAVIGABLE STREAM ADJUDICATION COMMISSION**

**ARIZONA STATE LAND
DEPARTMENT'S MOTION TO
SUPPLEMENT THE RECORD WITH
DR. GARY HUCKLEBERRY'S
AFFIDAVIT CONCERNING THE
GILA RIVER AND MUSSETTER
ENGINEERING, INC.'S
GEOMORPHOLOGY OF THE UPPER
GILA RIVER WITHIN THE STATE
OF NEW MEXICO**

Geomorphology of the Upper Gila River Within the State of New Mexico

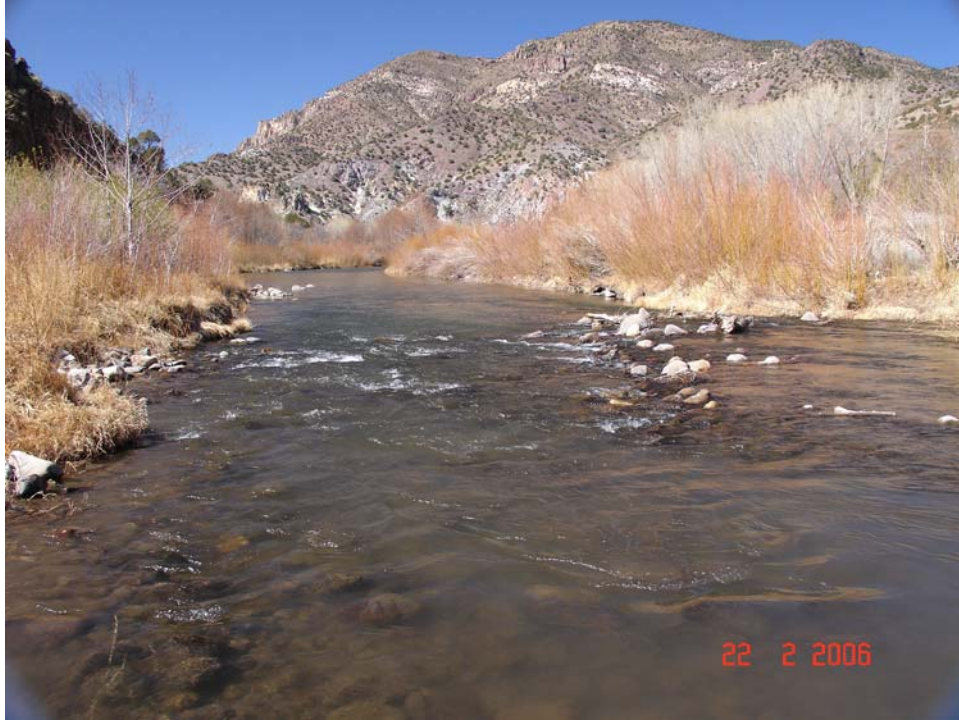
Figure A.5. View downstream of Gila River at Turkey Creek site showing typical pool-riffle morphology. The boulders in the riffle are derived from the local tributaries.

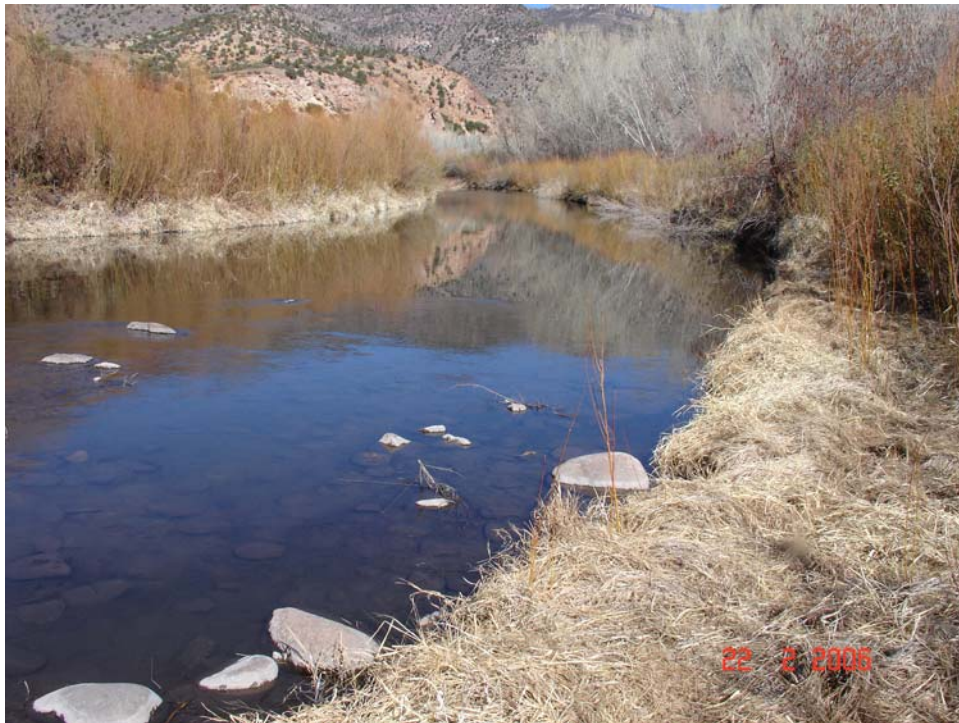
Figure A.6. View upstream of Gila River at Turkey Creek site showing a deep pool located upstream of a cobble-gravel riffle.

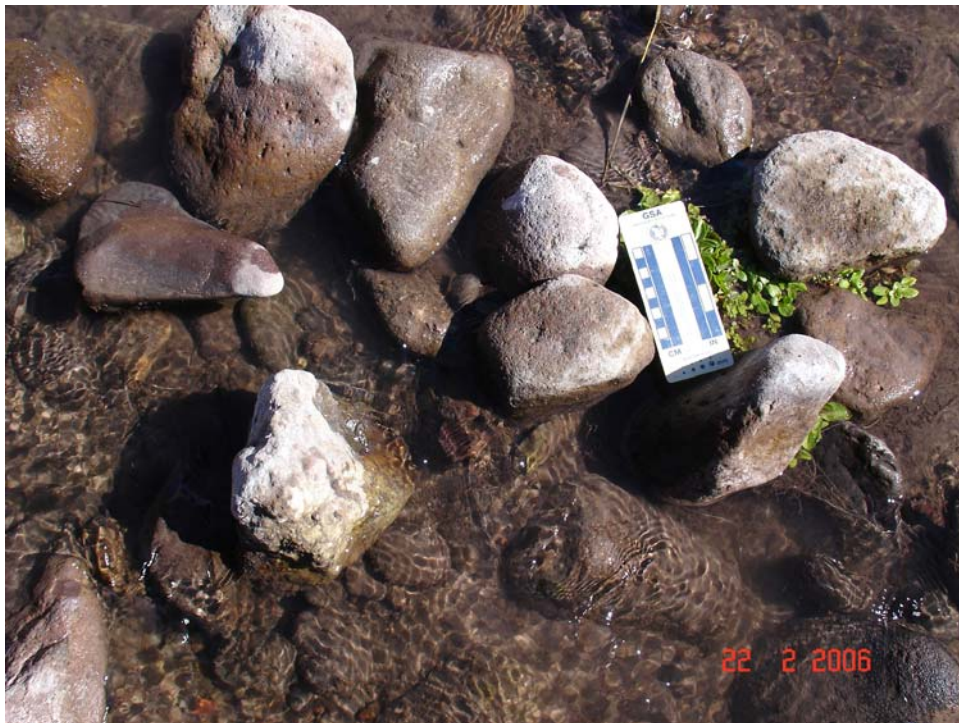
Figure A.8. Close up view of gravels and cobbles that comprise the riffle at Cross Section 4 at the Turkey Creek site at WC 2 ($D_{50} = 80$ mm).

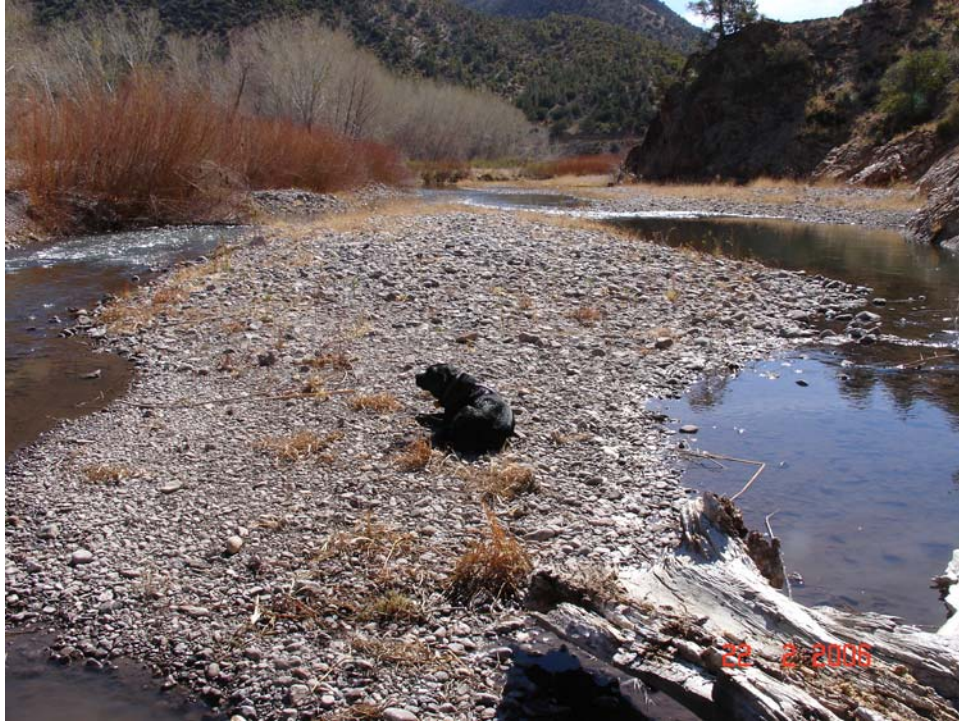
Figure A.9. View downstream of gravel bar deposited in the 2005 flood in the vicinity of Cross Section 7 at the Turkey Creek site. The surface gradation was determined by WC 3 ($D_{50} = 36$ mm).

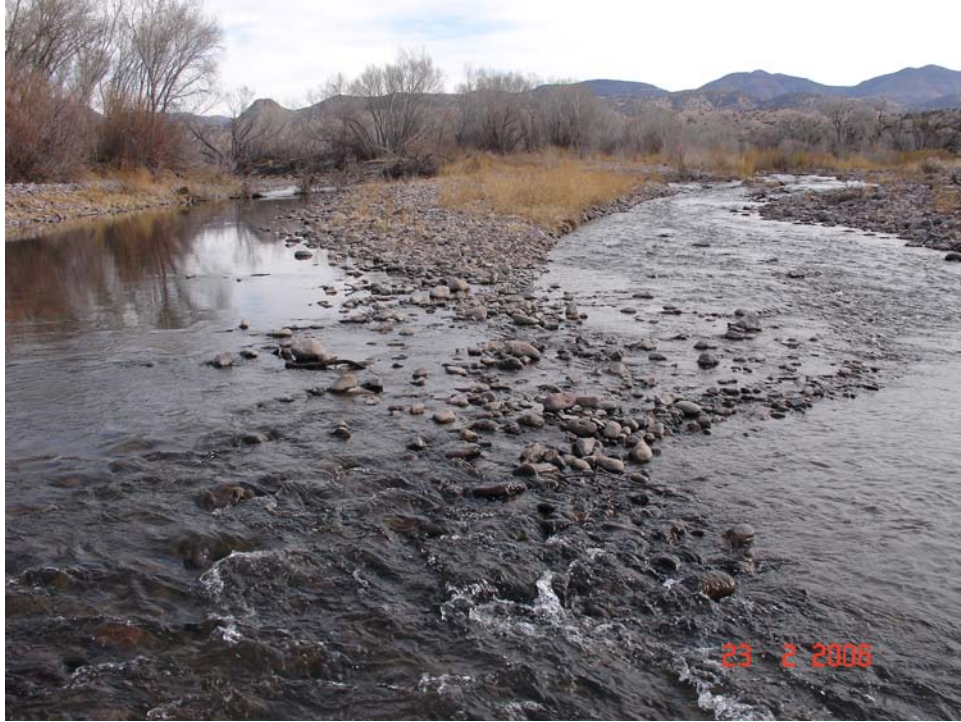
Figure A.11. View upstream of the Gila River at the TNC site showing the split flow at the head of the reach caused by the 2005 flood.

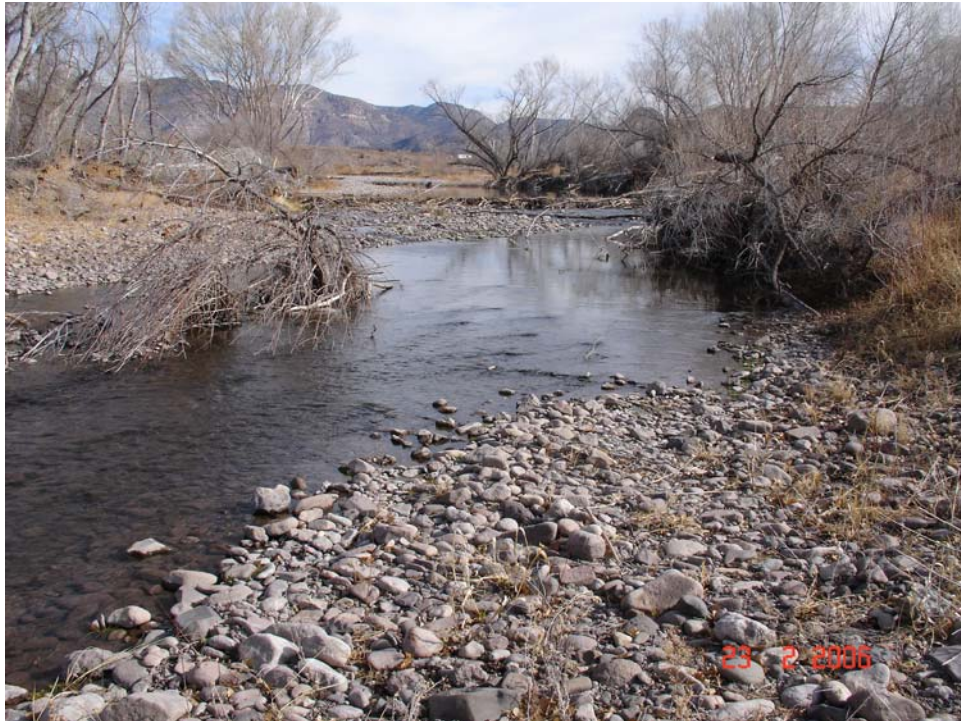
Figure A.12. View upstream of the channel formed as a result of a channel avulsion during the 2005 flood at the TNC site. Note the large number of cottonwood trees in the channel due to channel erosion.

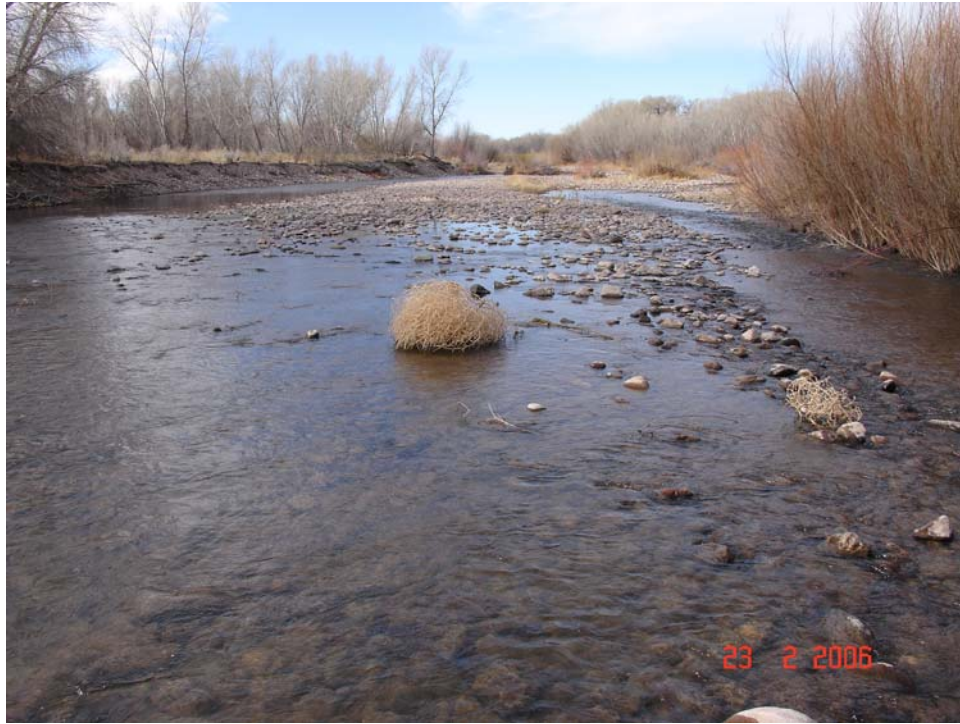
Figure A.13. View downstream of the TNC site showing erosion of the left bank and deposition of the right bank that occurred in the 2005 flood.

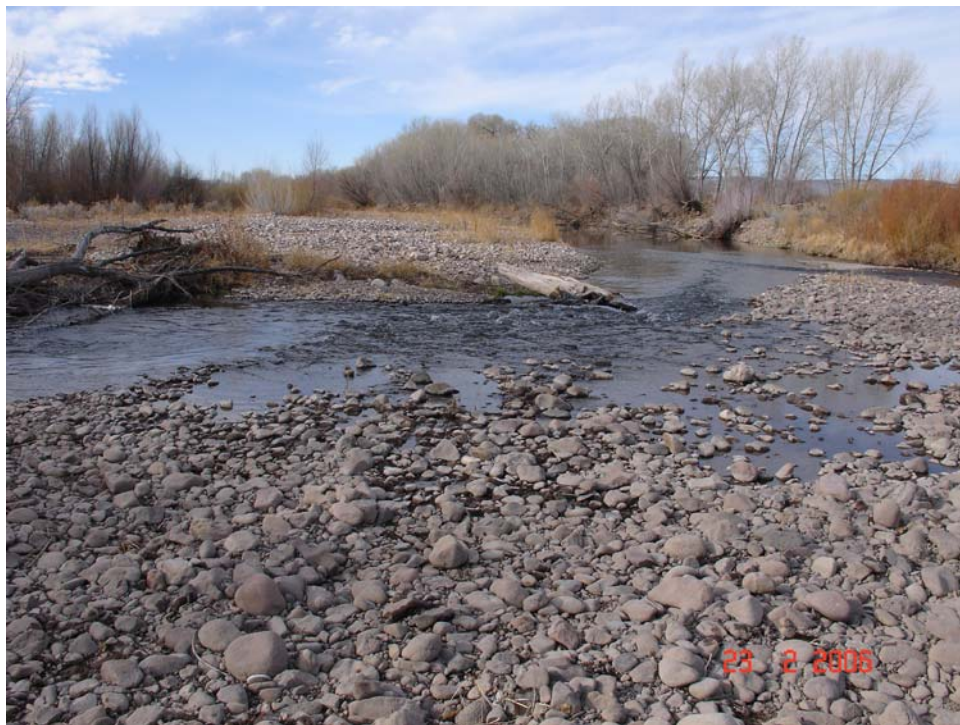
Figure A.14. View downstream of the Gila River at the TNC site showing the pool-riffle channel morphology.

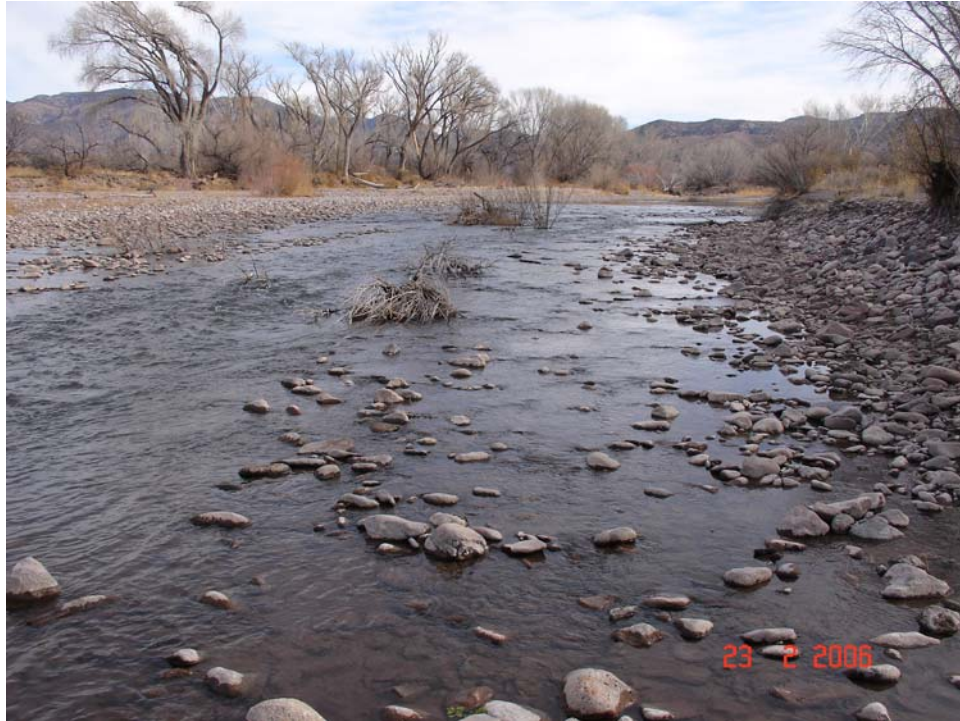
Figure A.15. View upstream of the Gila River showing the wide channel section in the middle of the TNC site where widening occurred during the 2005 flood and the consequent plane-bed morphology.

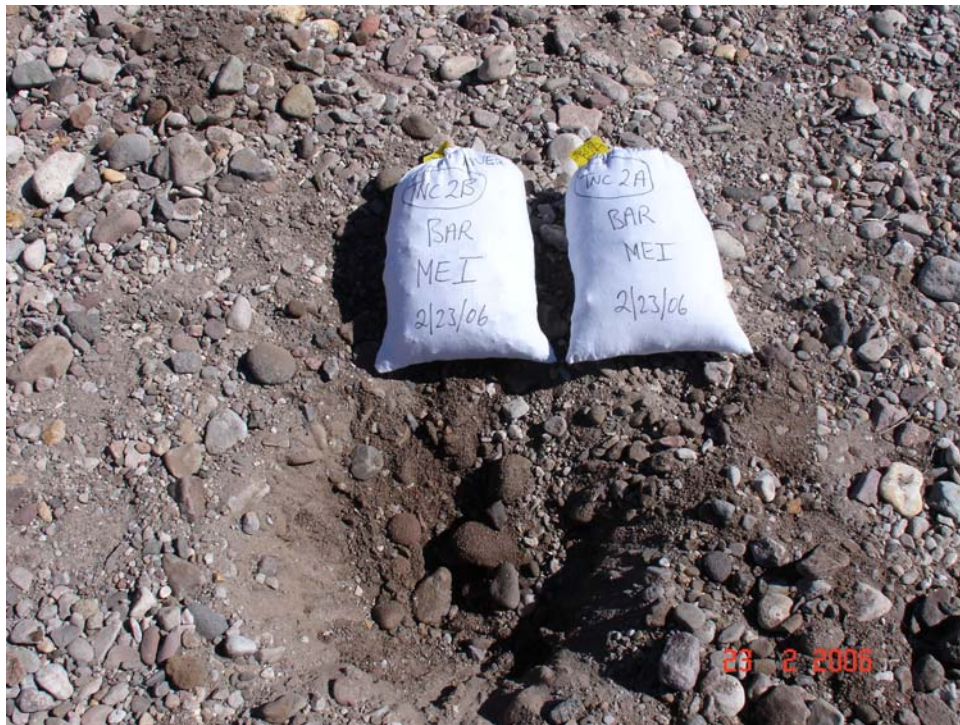
Figure A.17. Close up view of sediments (TNC 2) that form the bank-attached bar between Cross Sections 5 and 6 at the TNC site ($D_{50} = 6.4$ mm).

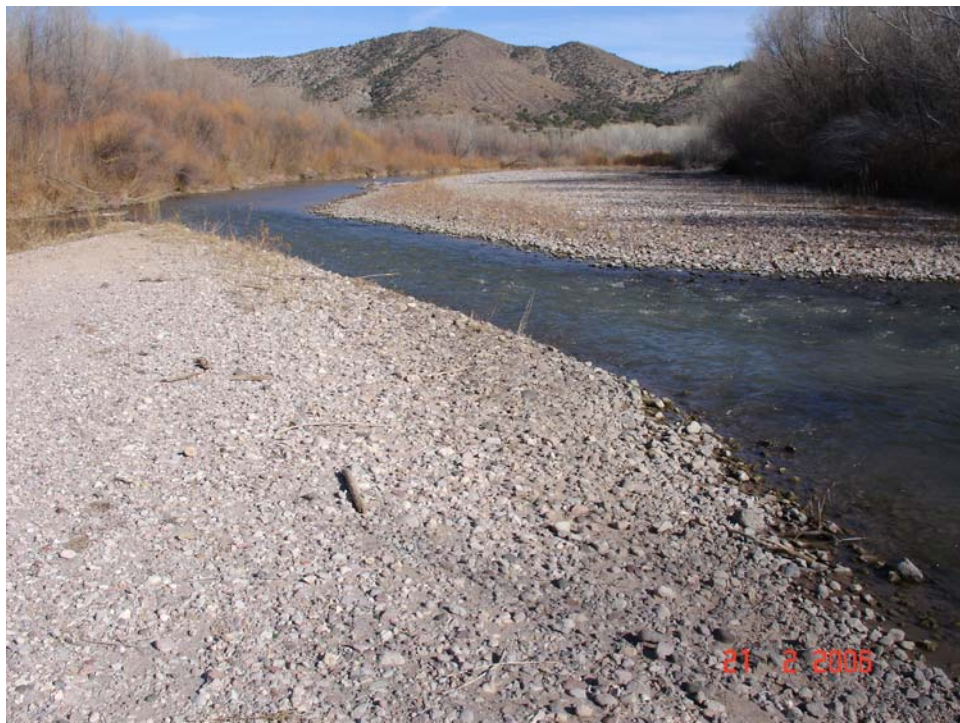
Figure A.18. View downstream of the Gila River at the Birds site showing the pool-rifle morphology of the site.

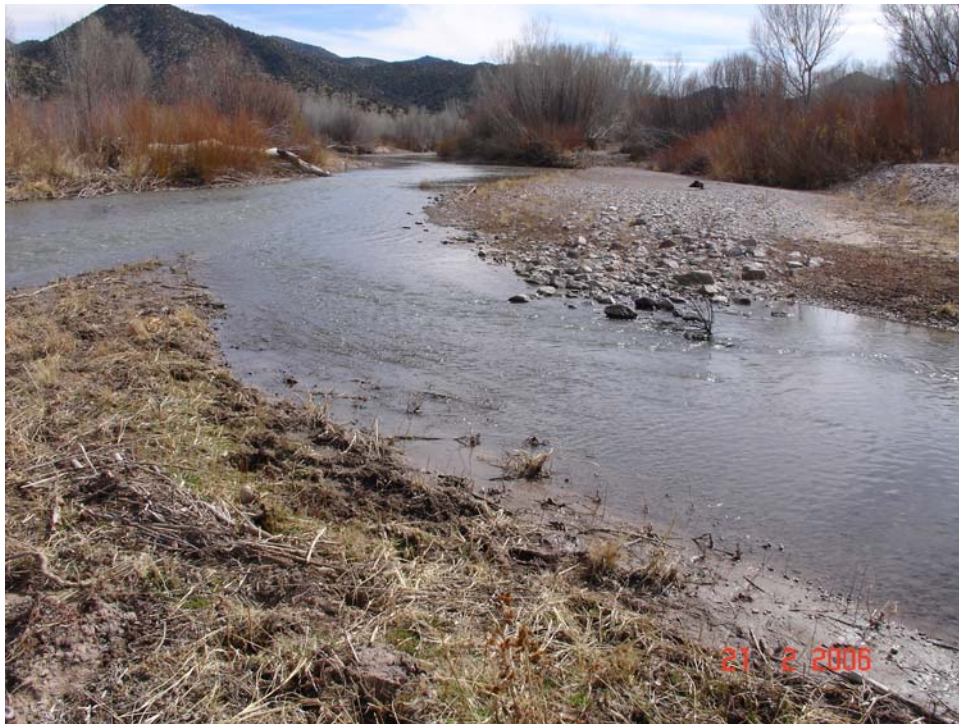
Figure A.19. View upstream of mid-channel bars and braided channel morphology in the lower portion of the Birds site. Bars were deposited during the 2005 flood.

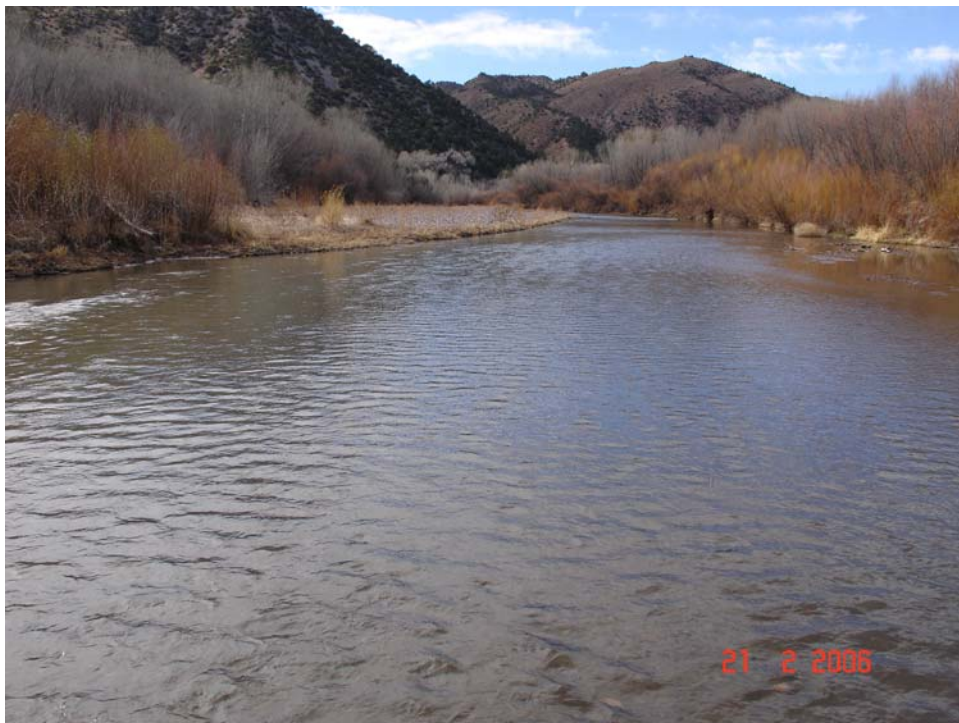
Figure A.20. View upstream of long pool formed upstream of the mid-channel bars in the lower reach of the Birds site.

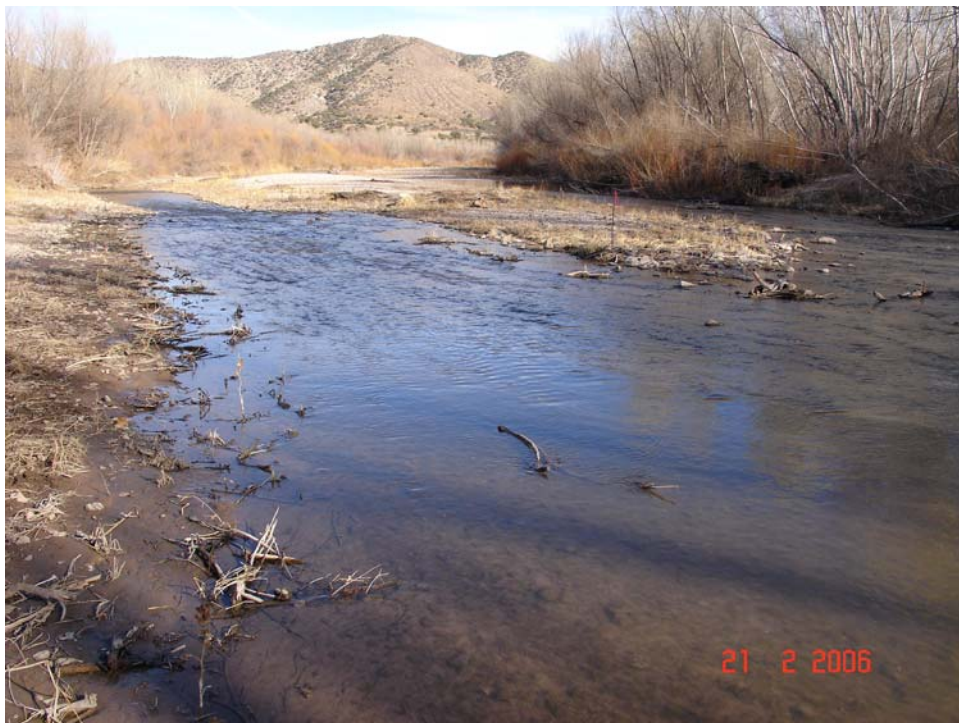
Figure A.22. View downstream of dense willow growth along both banks of the Gila River at the Birds site.

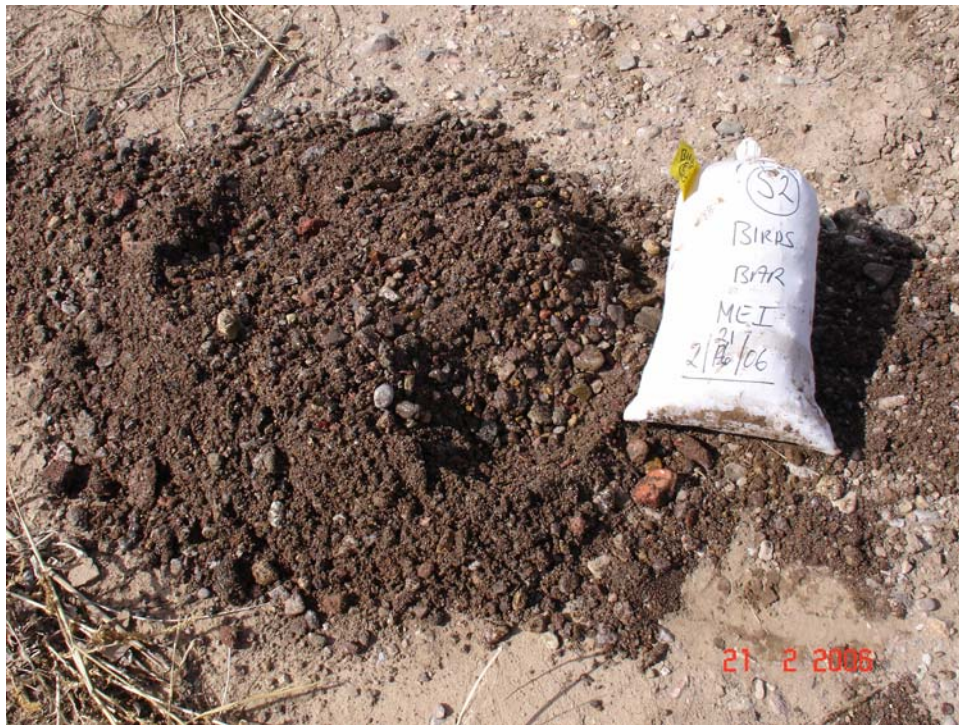
Figure A.23. Close up view of mid-channel bar sample S2 at Cross Section 3 at the Birds site. The D_{50} is 4 mm and the sand content is about 45 percent.

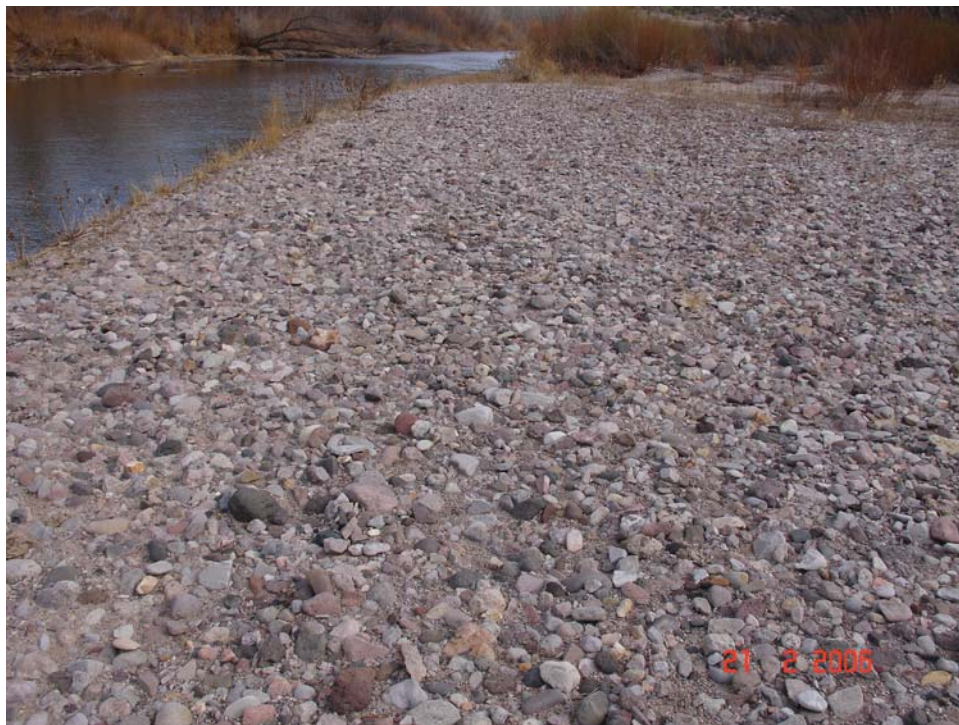
Figure A.24. View downstream of bank-attached bar at Cross Section 5 at the Birds site. The D_{50} of the surface sediments is 47 mm (WC3).

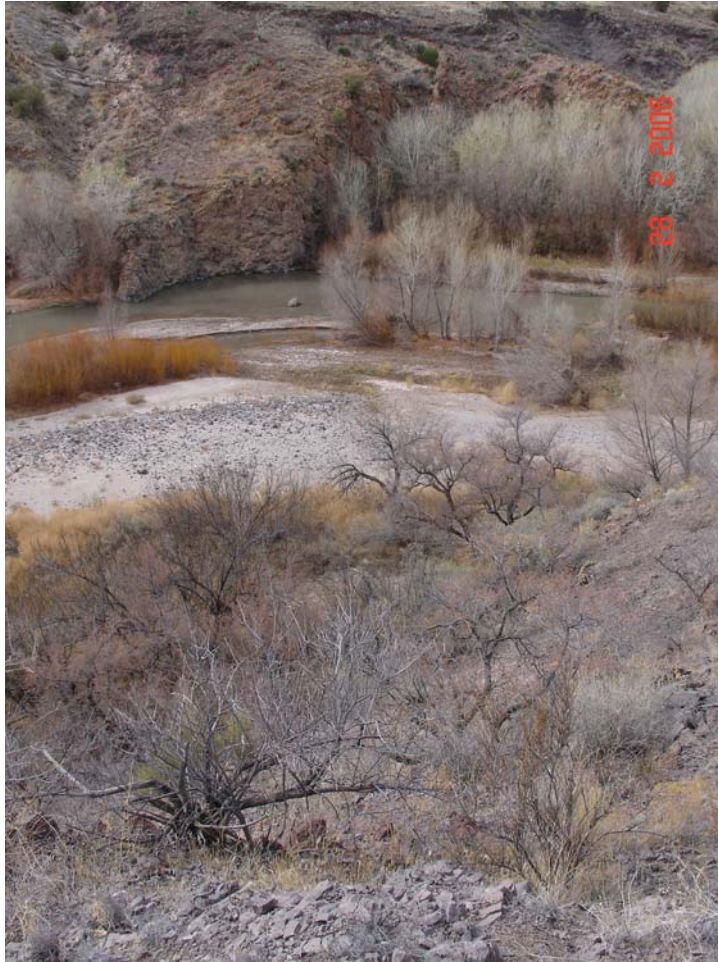
Figure A.25. View west of bedrock contraction at the downstream end of the Box site, which is the upstream end of the Lower Box canyon reach.

and terraces that have been deposited over time in response to the backwater created during floods by the bedrock contraction at the head of the Lower Box canyon. The basic channel morphology at the site is pool-riffle with the riffles being composed of cobble-boulder-sized materials. However, the pool-riffle spacing greatly exceeds the expected 5 to 7 times channel width norm (Leopold et al., 1964; Richards, 1982), primarily because the 2005 flood caused in excess of 3 feet of sand and fine gravel deposition within the channel and the deposition masks the normal-pool riffle spacing. At the time of the survey, the bed of the channel between the riffles was composed of migrating sand-wave mesoforms spaced at approximately one channel width intervals.

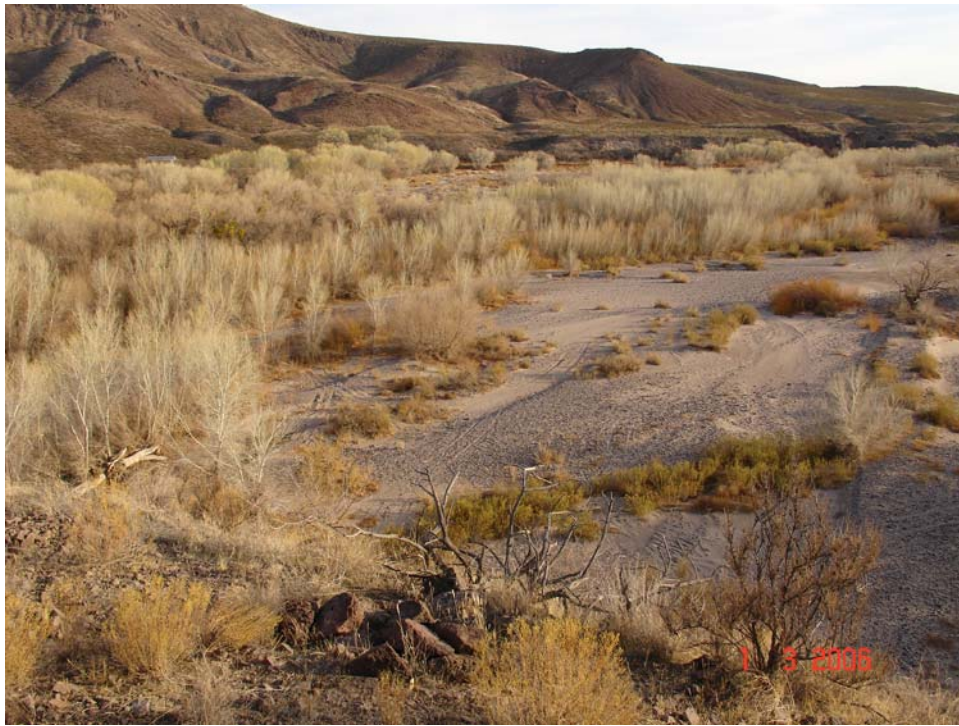
Figure A.26. View upstream of the Box site showing the 2005 flood overbank flow paths as well as the location of the perennial channel in the center of the photograph that is bounded by the dense willow growth.

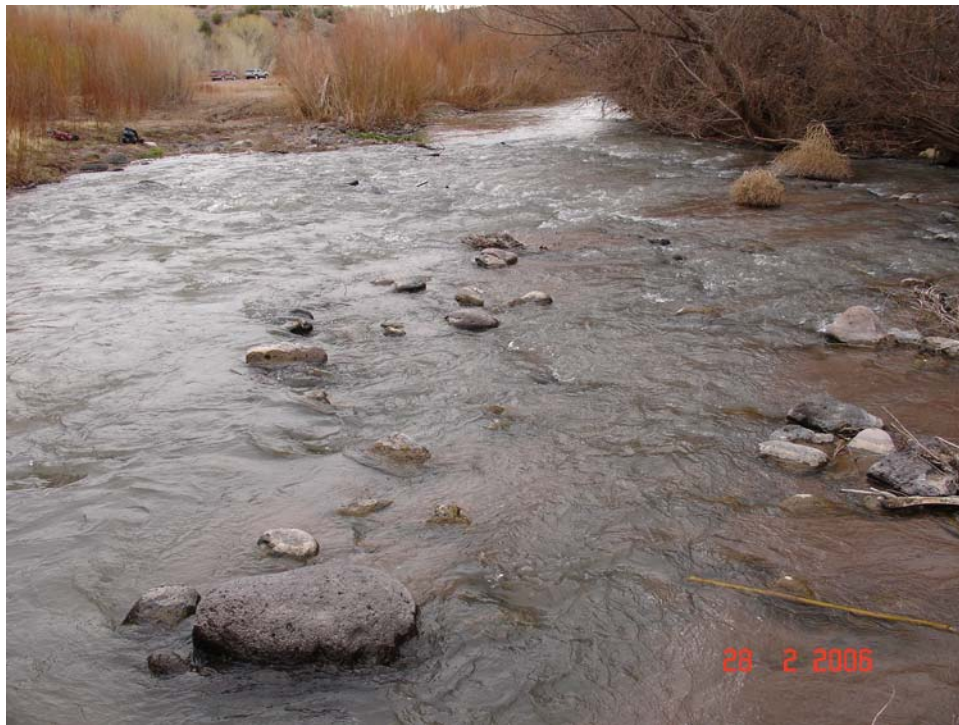
Figure A.28. View downstream of the boulder riffle at Cross Section 6 at the Box Site. The D_{50} of the riffle sediments is 157 mm. Note the sand deposits in the riffle amongst the boulders.

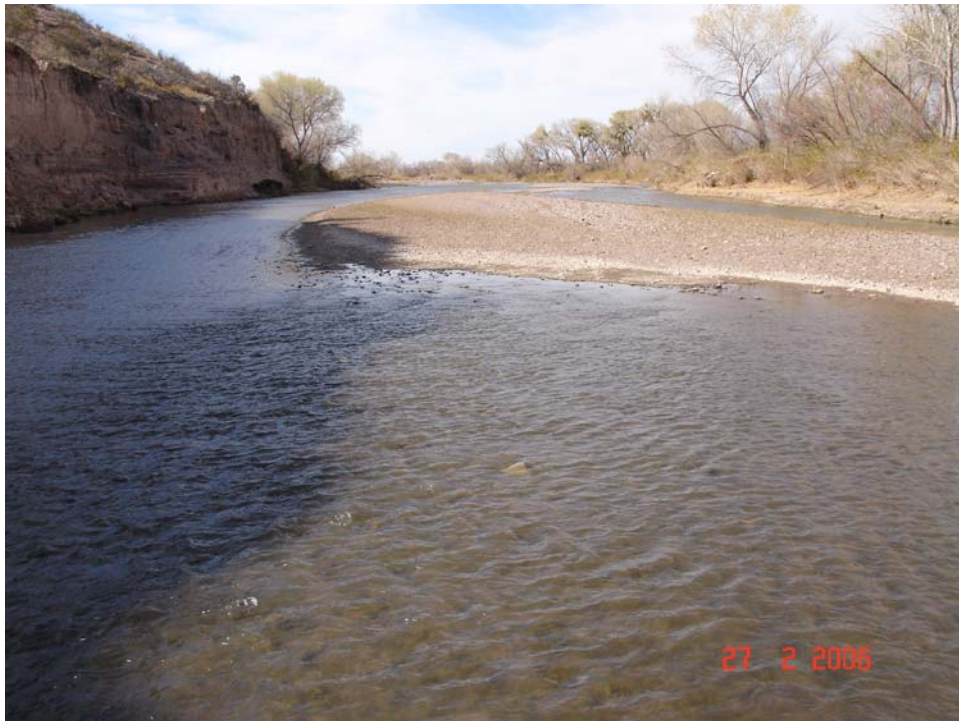
Figure A.31. View downstream of the Gila River at the Virden site showing the hillslope that forms the left bank in the lower part of the reach and a mid-channel bar formed in the 2005 flood.

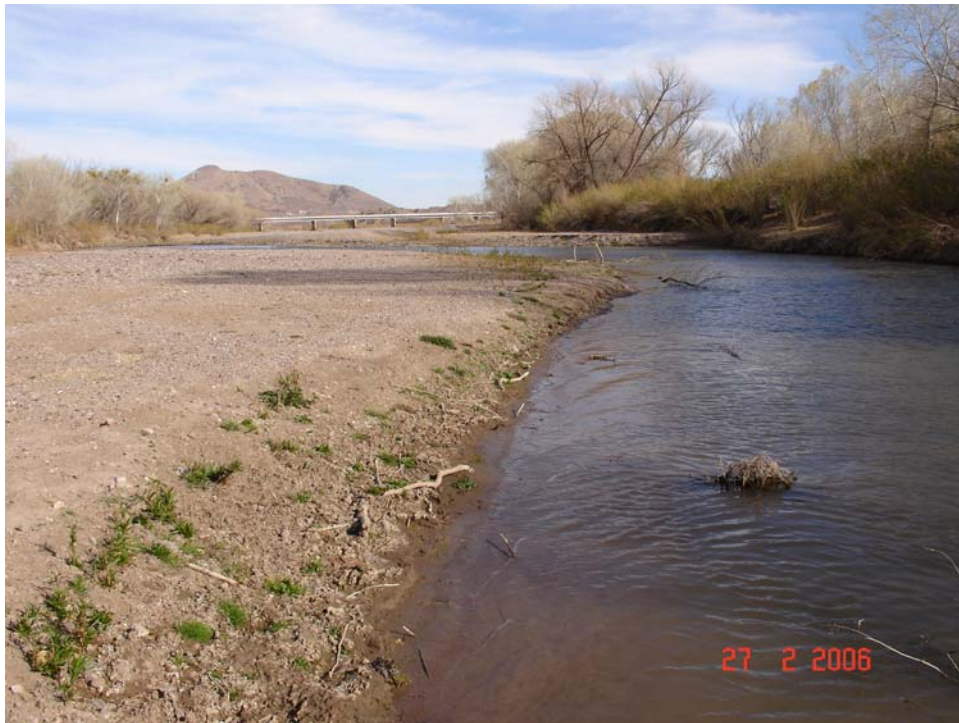
Figure A.33. View upstream of the Gila River at the Virden site showing the pool-riffle morphology of the channel.

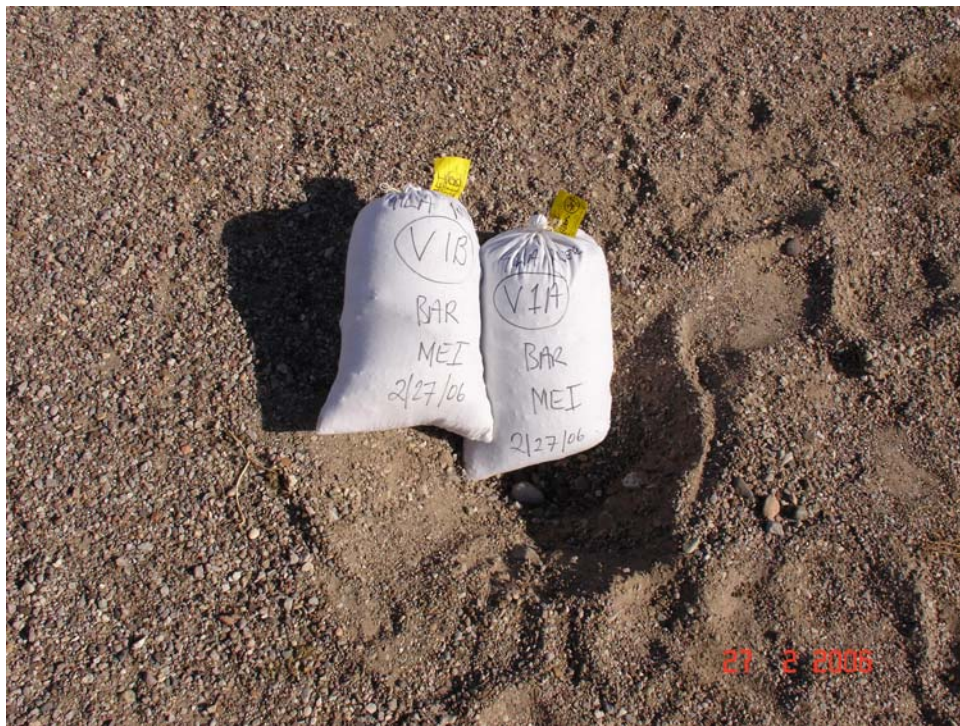
Figure A.34. Close up view of sediments deposited in the mid-channel bar at Cross Section 4 (V1) at the Virden site. The D_{50} is 1 mm and the sand content is about 55 percent.

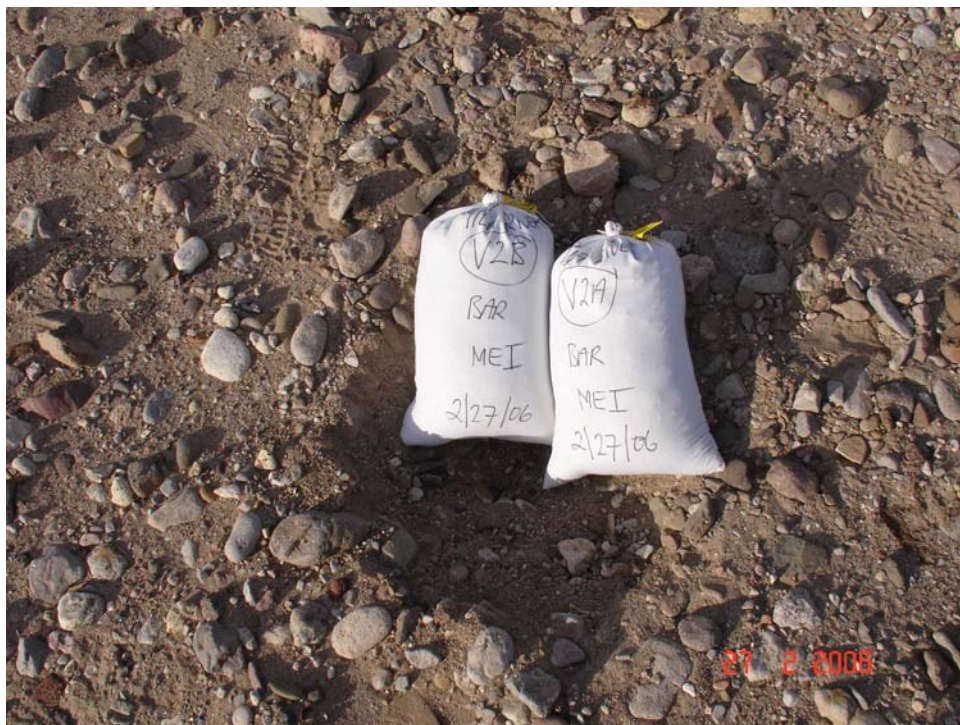
Figure A.35. Close up view of the bank-attached bar sediments (V2) at Cross Section 8 at the Virden site. The D_{50} is 4 mm and the sand content is about 33 percent.
