Geomorphology of the Upper Gila River Within the State of New Mexico

Submitted to:

Mussetter Engineering, Inc.
1730 S. College Avenue, Suite 100
Fort Collins, Colorado 80525

MEI Project No. 05-23

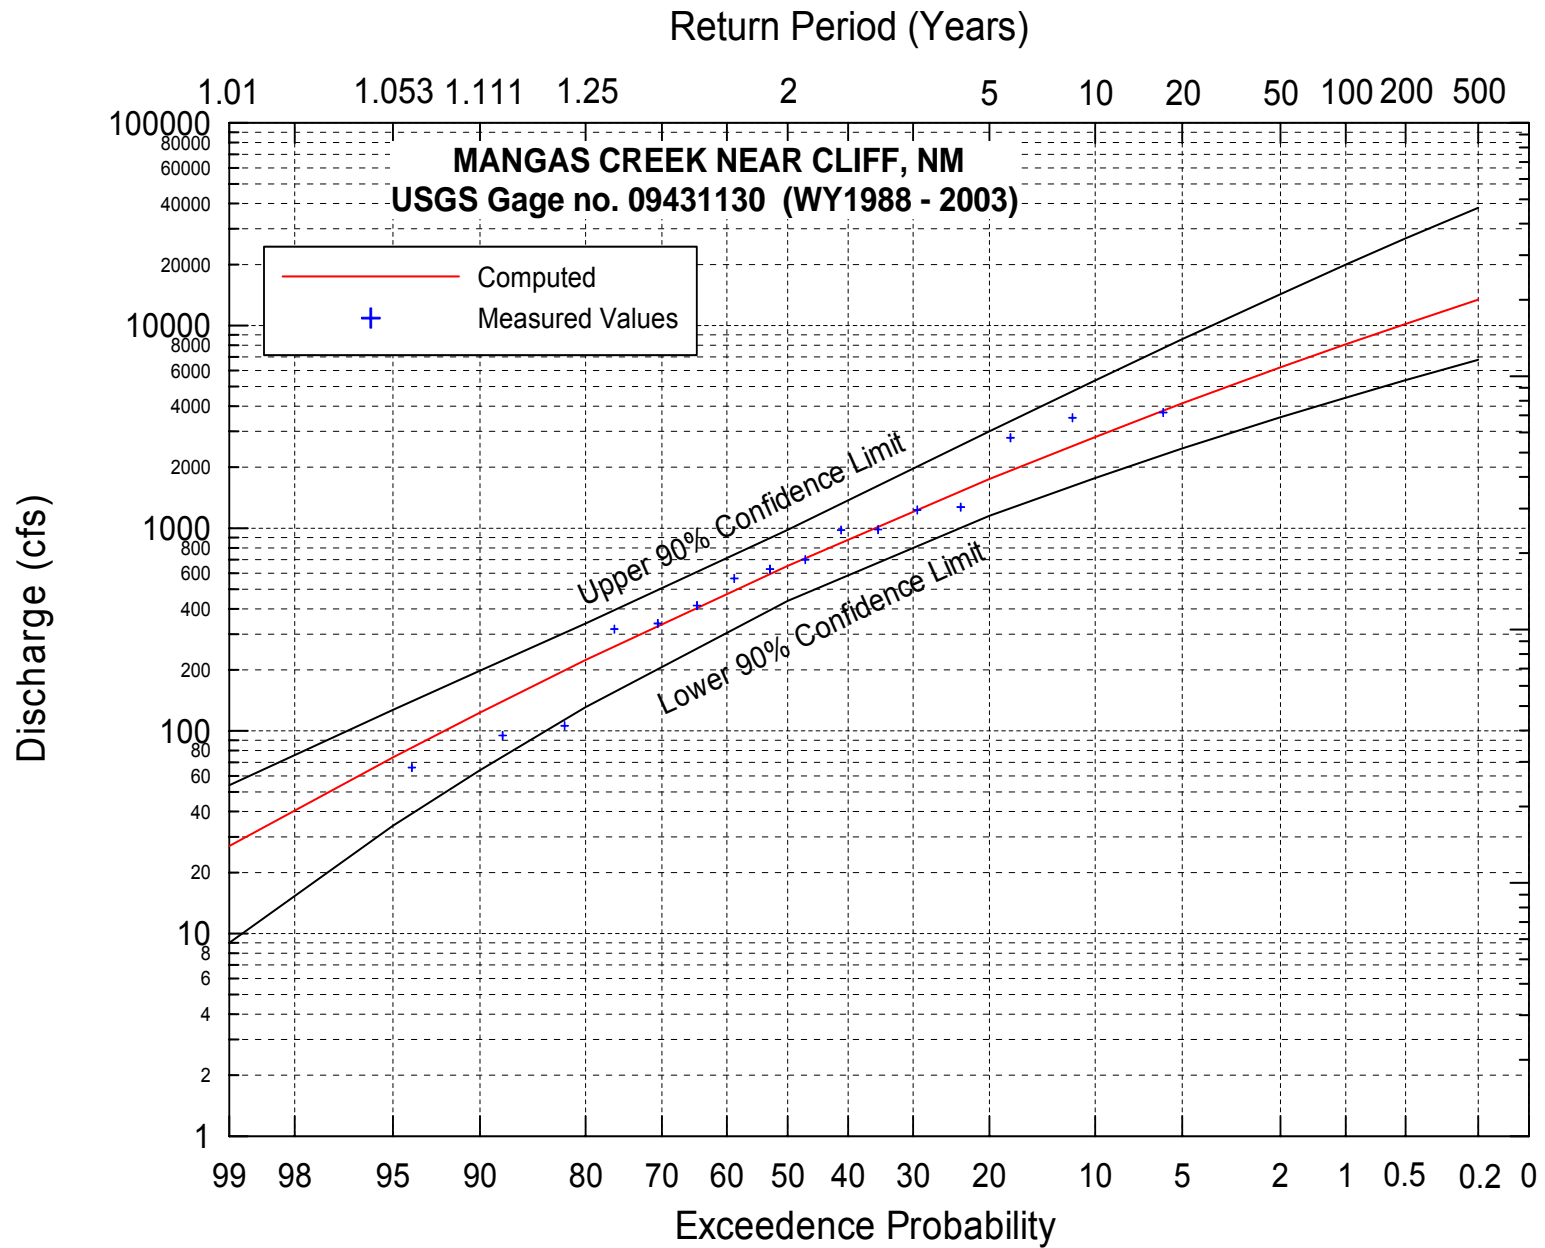
Figure 4.5. Flood-frequency curve for USGS Mogollon Creek near Cliff, NM (9430600) gage, WY1967-WY2004.

Figure 4.6. Flood-frequency curve for USGS Duck Creek at Gila, NM (943090) gage, WY1957-WY2003.

Figure 4.7. Flood-frequency curve for USGS Mangas Creek near Cliff, NM (9431130) gage, WY1988-WY2003.

Figures 4.5 through 4.7 shows the peak flood frequency curves for the Mogollon Creek near Cliff, Duck Creek at Cliff and Mangas Creek near Cliff gages, respectively. The exceedence probabilities and return periods for these gages for the 1- to 500-year floods are summarized in Table 4.3. The 2-year recurrence interval peak flows for the three gages are 749, 3,710, and 652 cfs, respectively. The 100-year recurrence interval peak flows for the three gages are 17,100, 14,400, and 8,090 cfs, respectively. The only provisional peak flow value for the 2005 flood is that for Mogollon Creek (5,800 cfs), which has a recurrence interval of about 15 years.

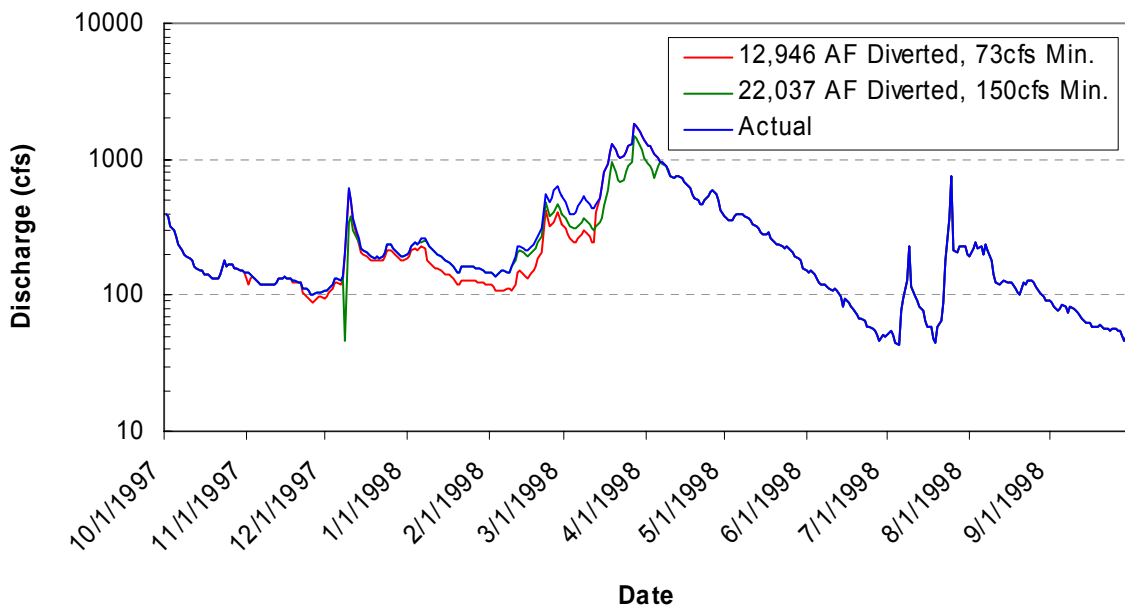
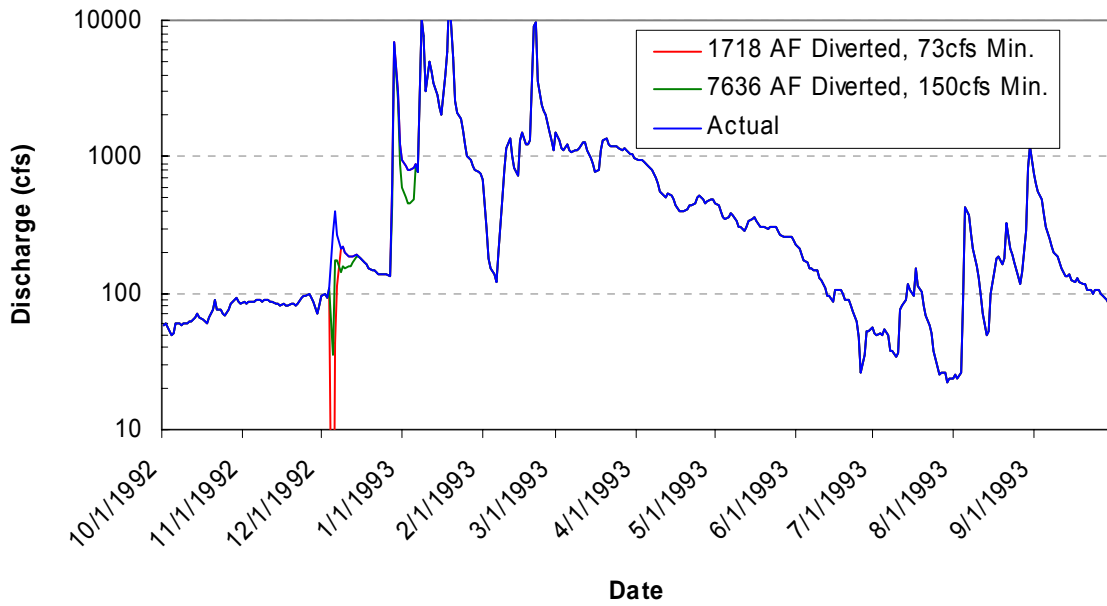
Figure 4.15. 1989 hydrographs (representative dry year) for existing conditions and with 73- and 150-cfs minimum bypass requirements for the Gila River near Redrock gage.

Figure 4.16. 1998 hydrographs (representative typical year) for existing conditions and with 73- and 150-cfs minimum bypass requirements for the Gila River near Redrock gage.

Figure 4.17. 1989 hydrographs (representative wet year) for existing conditions and with 73- and 150-cfs minimum bypass requirements for the Gila River near Redrock gage.

Annual hydrographs for the three representative year types with the same diversions applied were developed for the Gila River near Redrock gage (**Figures 4.15 through 4.17**) and the Gila River near Virden gage (**Figures 4.18 through 4.20**) so that the effects of the diversions on sediment transport and hence geomorphic processes could be evaluated (Chapter 6). Diversion of the same flows at the downstream gages occasionally results in the bypass flows at these gages being less than the minima, but since no algorithm for diversion was provided, it was not possible to adjust the flows. However, the differences resulting from this issue are very unlikely to be geomorphically significant.

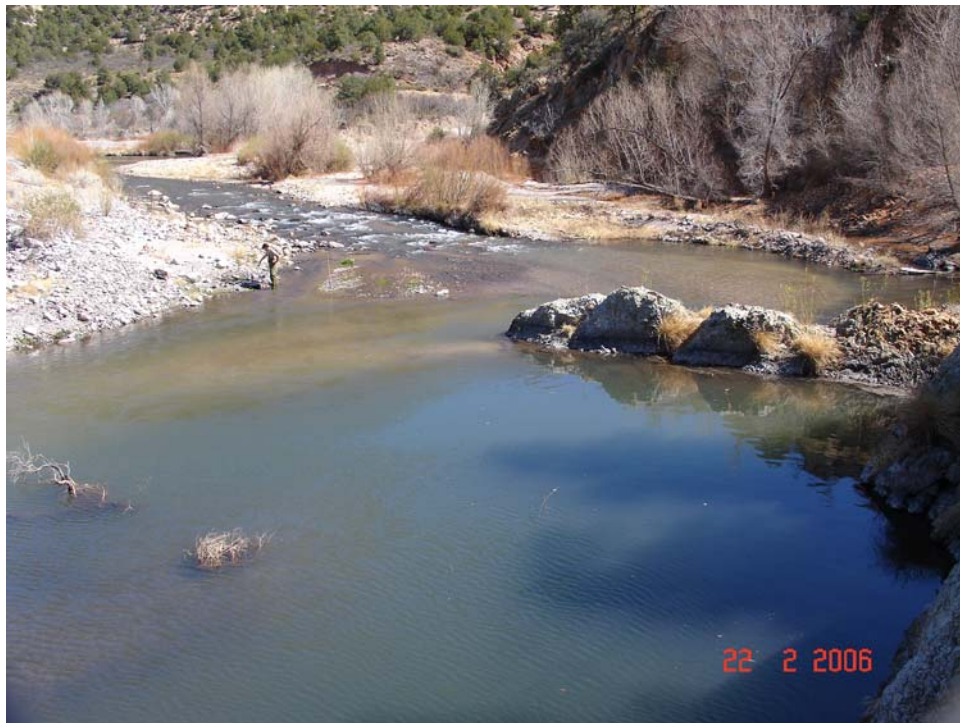
Figure A.2. View upstream of Gila River at Turkey Creek site showing bedrock control, boulder riffle and recent debris fan at mouth of Brock Canyon.

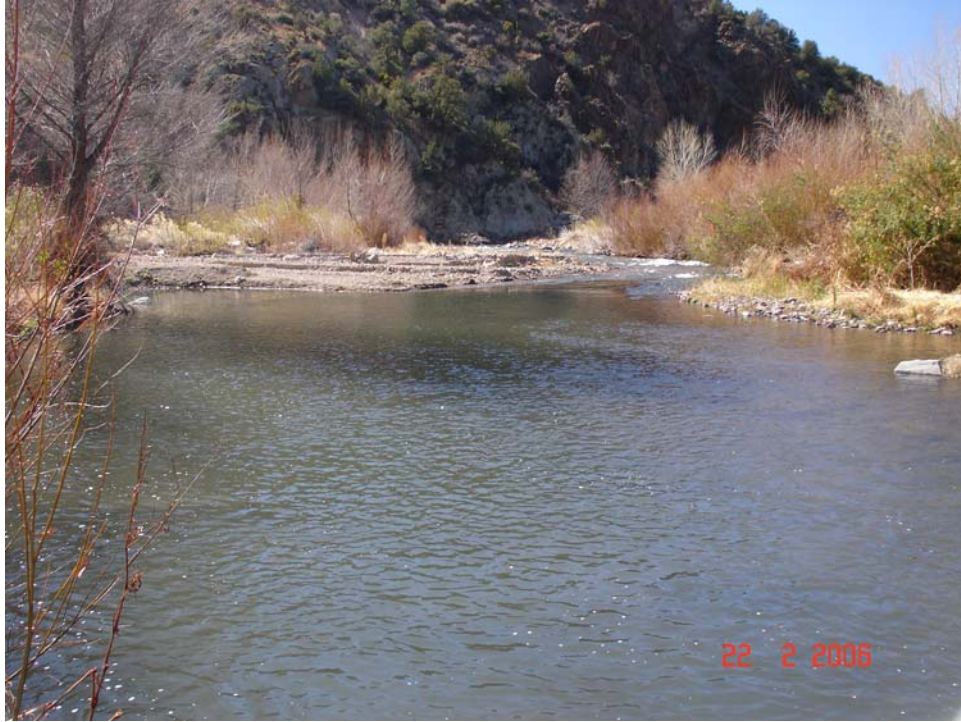
Figure A.3. View downstream of contraction of Gila River caused by recent debris flows in Brock Canyon. Note ponding upstream of the contraction.

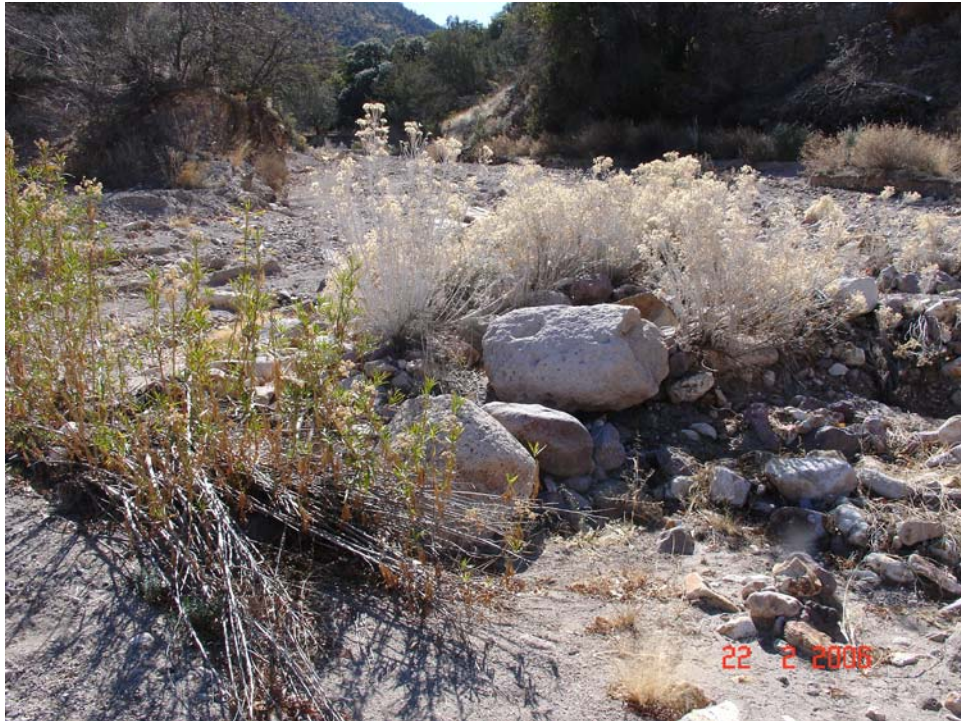
Figure A.4. Large boulders delivered to the Gila River by debris flows in Brock Canyon. Boulder lag deposits form coarse grained riffles in the channel of the Gila River.

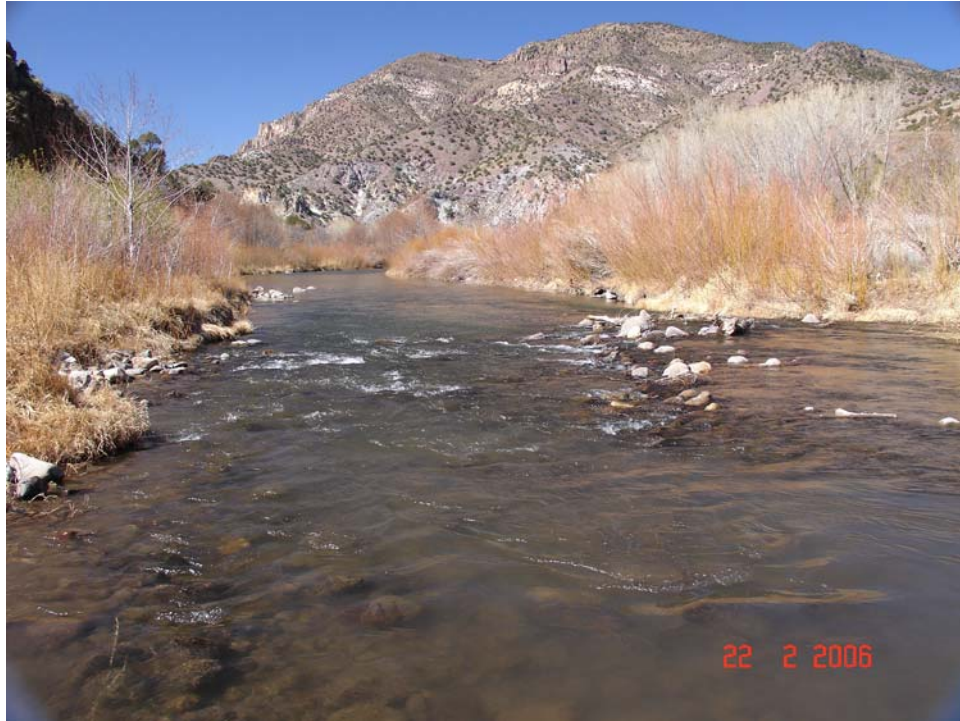
Figure A.5. View downstream of Gila River at Turkey Creek site showing typical pool-riffle morphology. The boulders in the riffle are derived from the local tributaries.

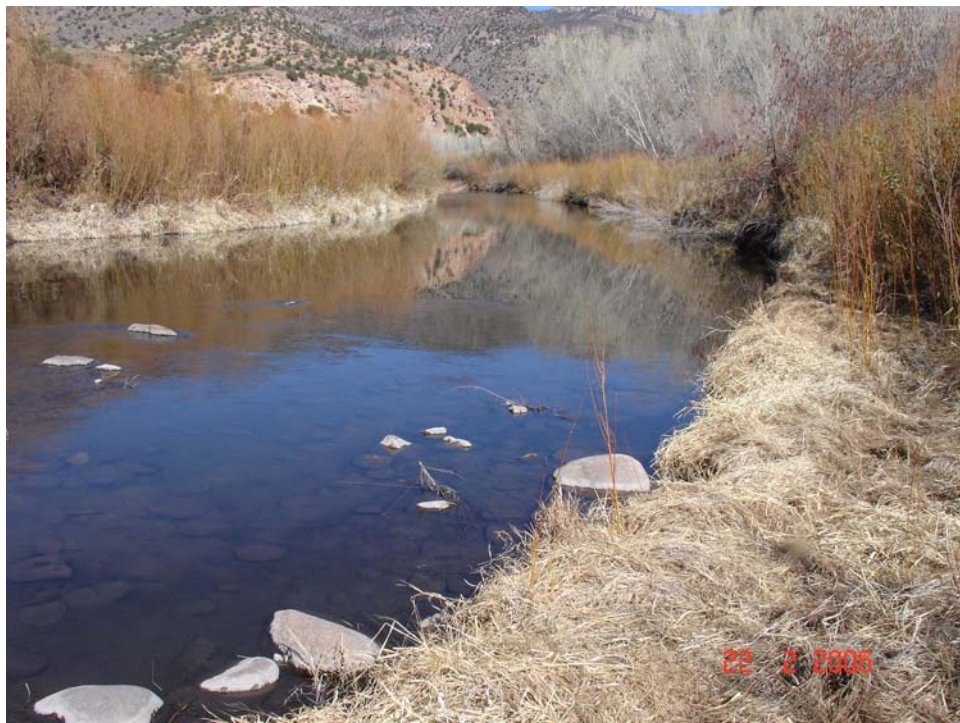
Figure A.6. View upstream of Gila River at Turkey Creek site showing a deep pool located upstream of a cobble-gravel riffle.

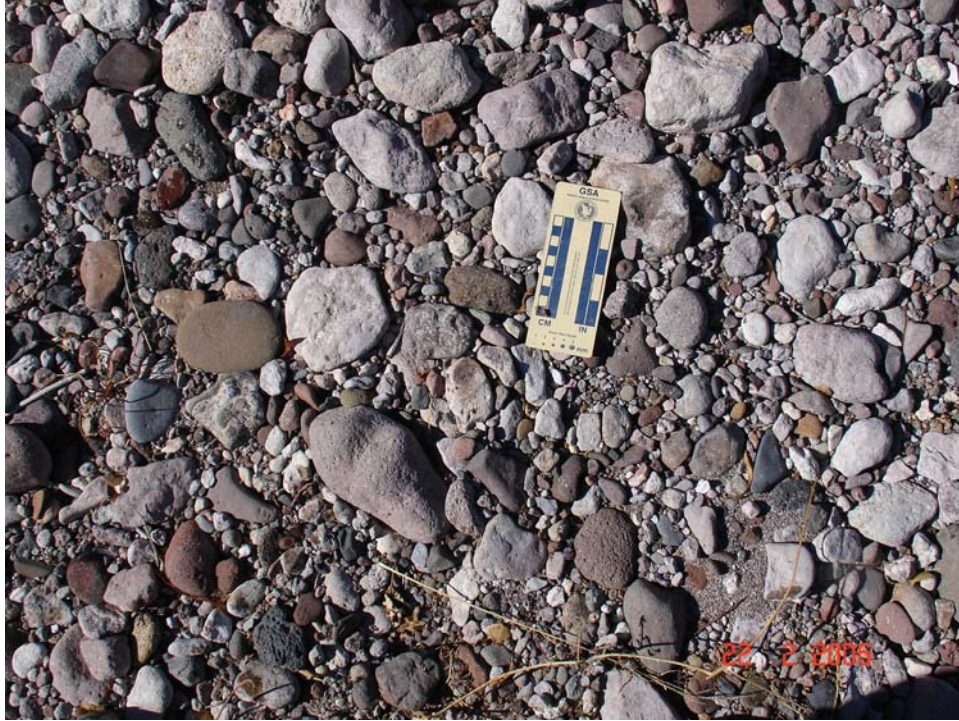
Figure A.7. Surface sediments on the Brock Canyon debris fan ($D_{50}=44$ mm) that were delivered to the Gila River in 2005.

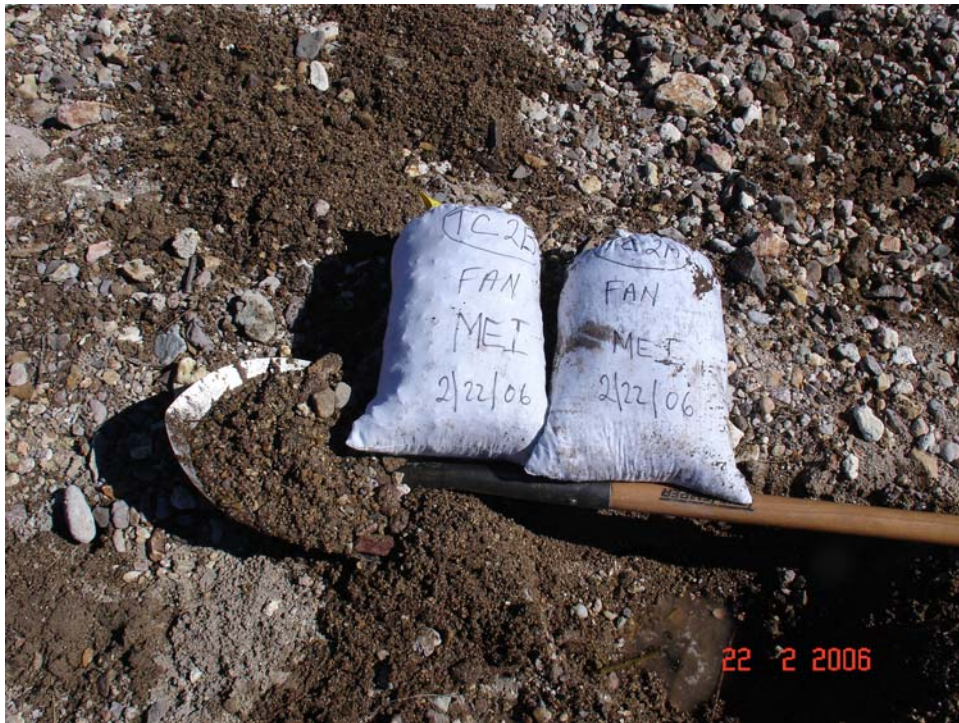
Figure A.10. Subsurface sediments on the Brock Canyon fan at the Turkey Creek site. The D_{50} is 5.2 mm and the sand content is about 35 percent.

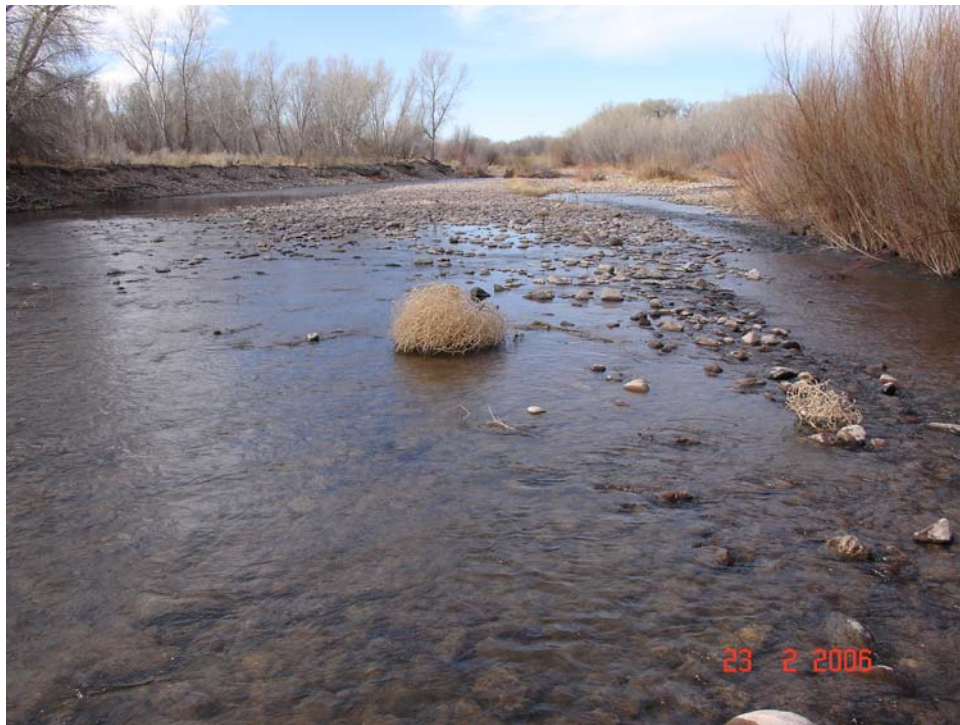
Figure A.13. View downstream of the TNC site showing erosion of the left bank and deposition of the right bank that occurred in the 2005 flood.

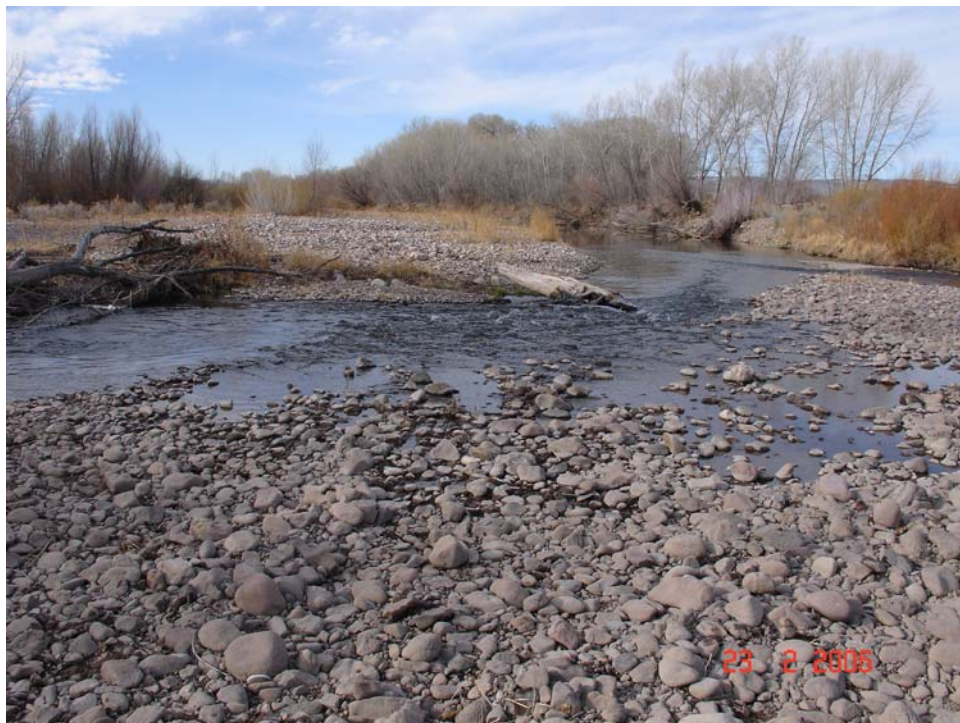
Figure A.14. View downstream of the Gila River at the TNC site showing the pool-riffle channel morphology.

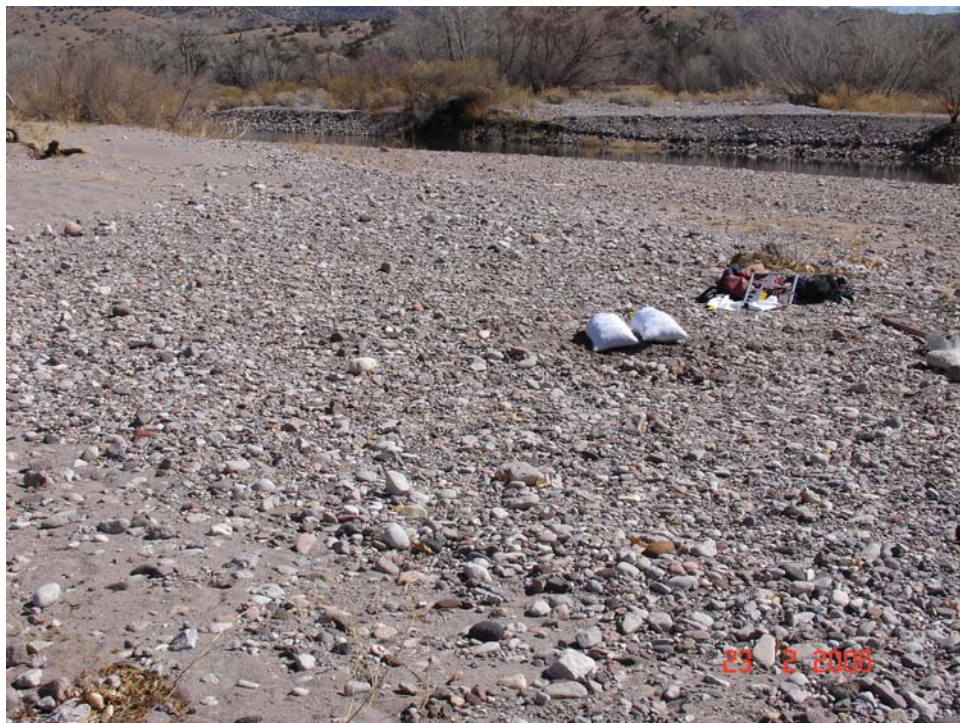
Figure A.16. View upstream of bank-attached bar on the right bank of the Gila River at the TNC site that was formed in the 2005 flood. The location of sample TNC 2 is at the two sample bags.

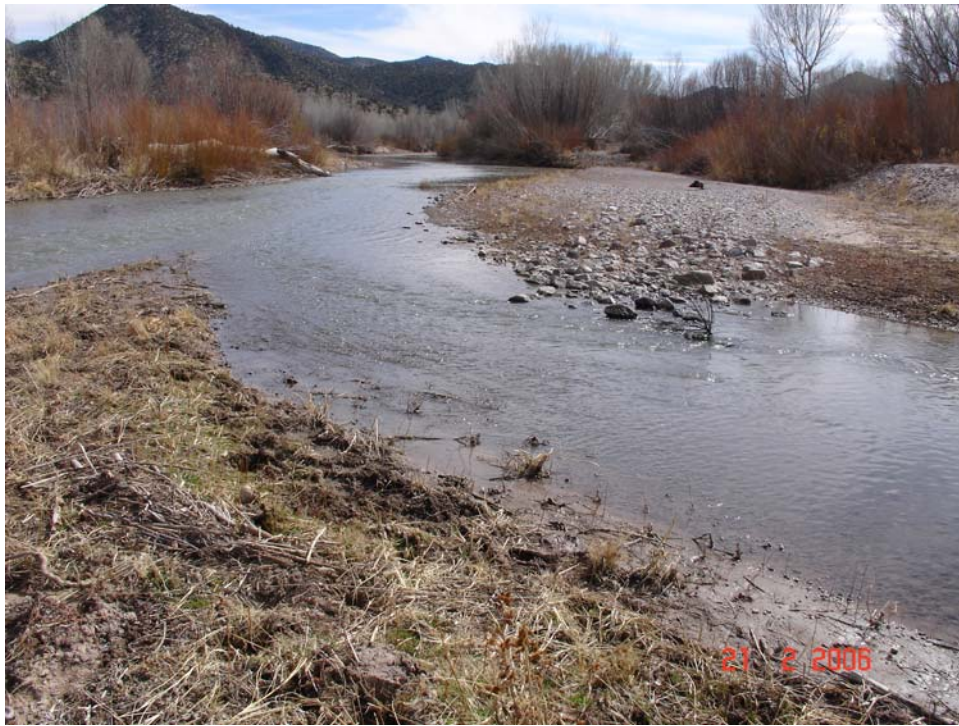
Figure A.19. View upstream of mid-channel bars and braided channel morphology in the lower portion of the Birds site. Bars were deposited during the 2005 flood.

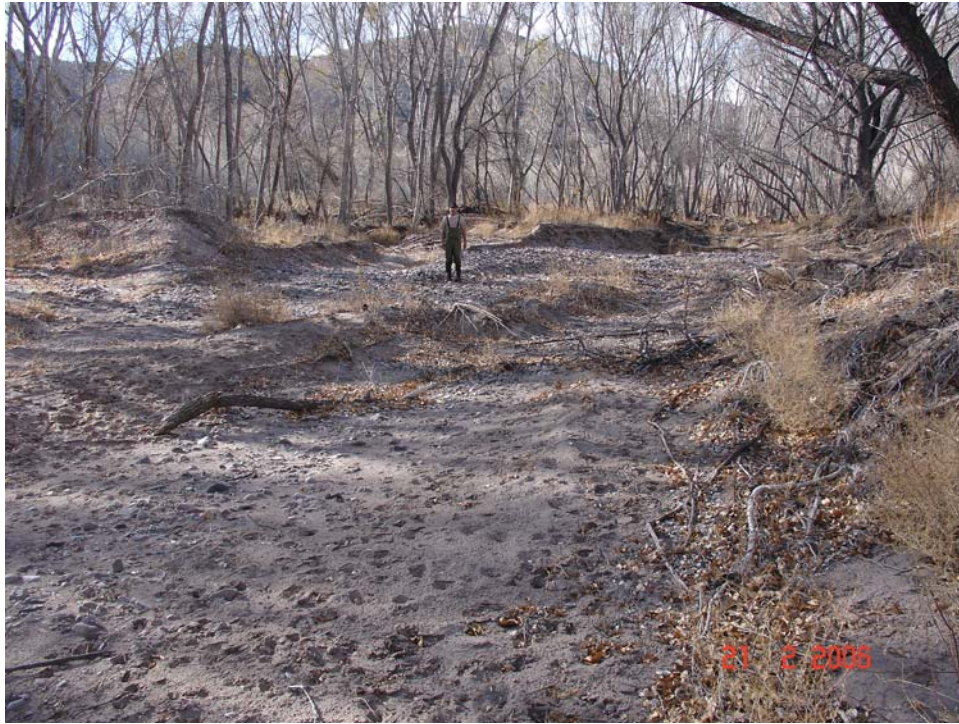
Figure A.21. View upstream of overbank channels scoured during the 2005 flood at the Birds site.

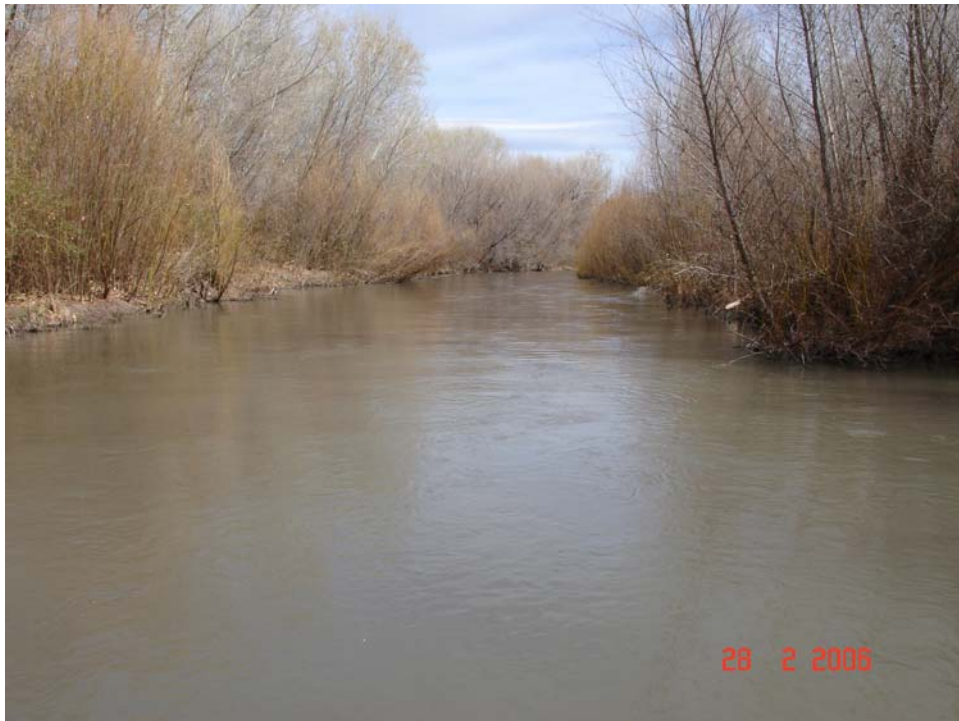
Figure A.27. View upstream of the Gila River in the Box site at a flow of 60 cfs. Note the very dense willow growth on both banks. At the time of the field survey the bed of the river was sand.

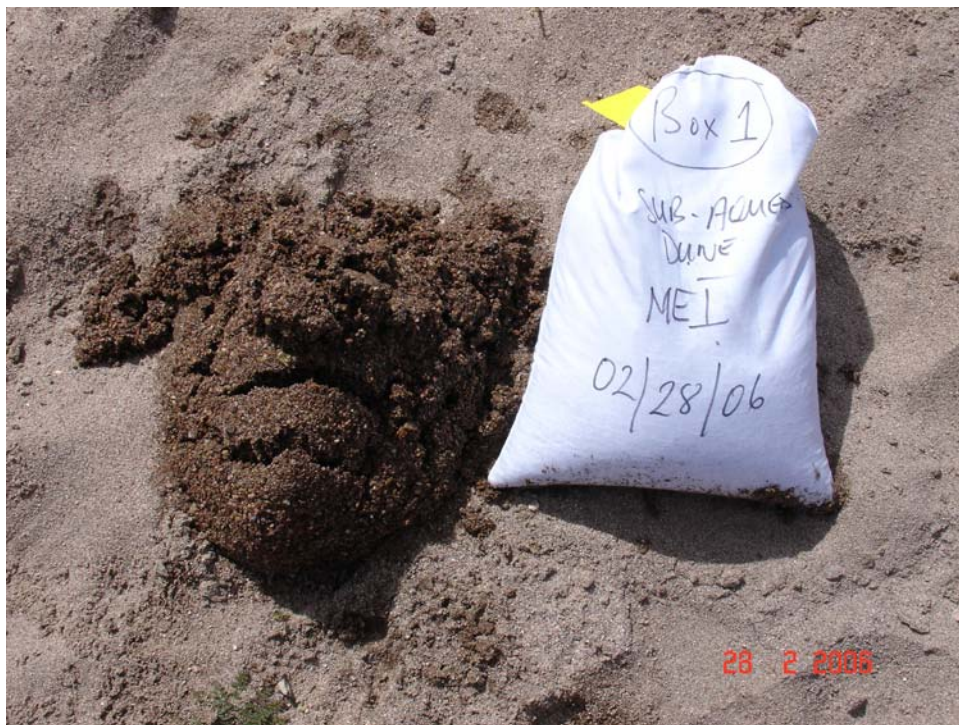
Figure A.29. Close up view of sand bed material at Cross Section 1 at the Box site. The D_{50} is 1 mm and the sand content is about 70 percent.

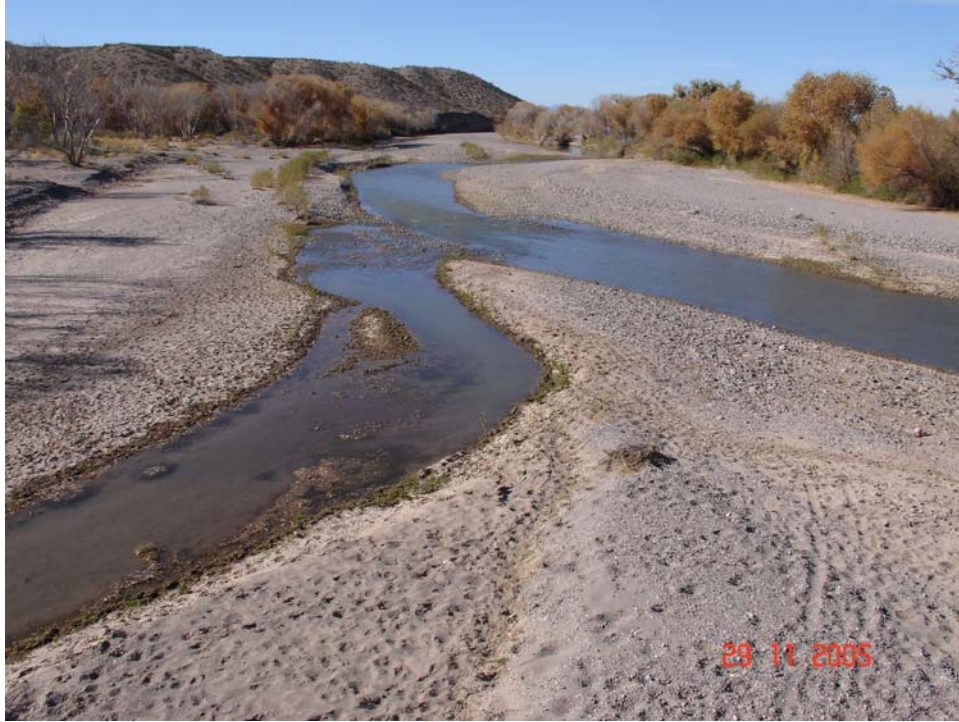
Figure A.30. View downstream from the Highway 92 Bridge of the Gila River at the Virden site. Channel is bounded by floodplain and terraces.

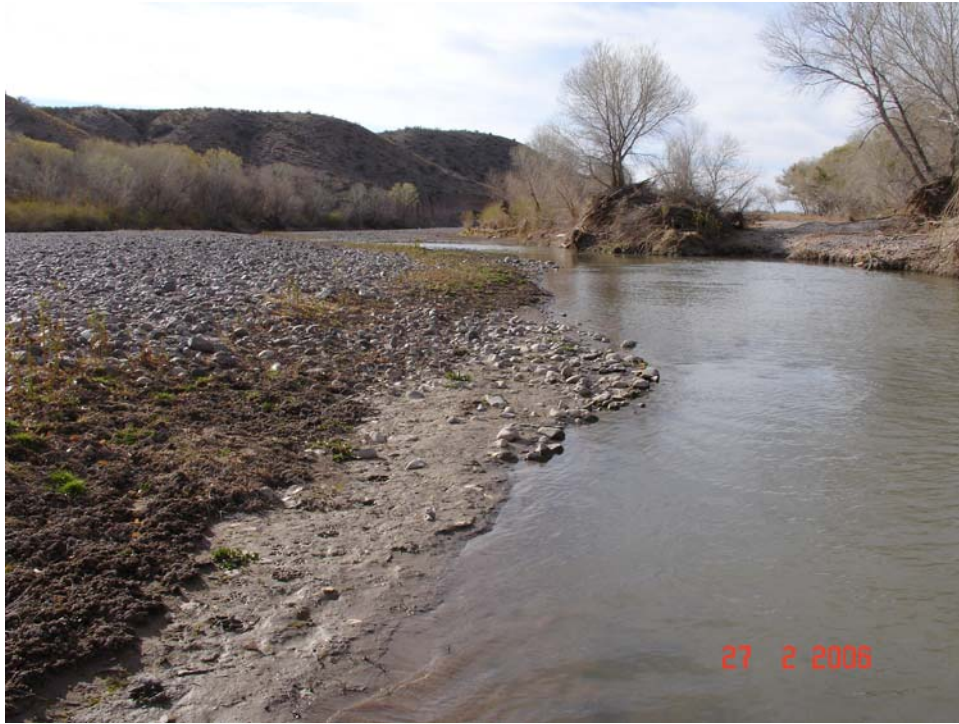
Figure A.32. View downstream of the Gila River at the Virden site showing bank erosion and an overbank flow path during the 2005 flood.

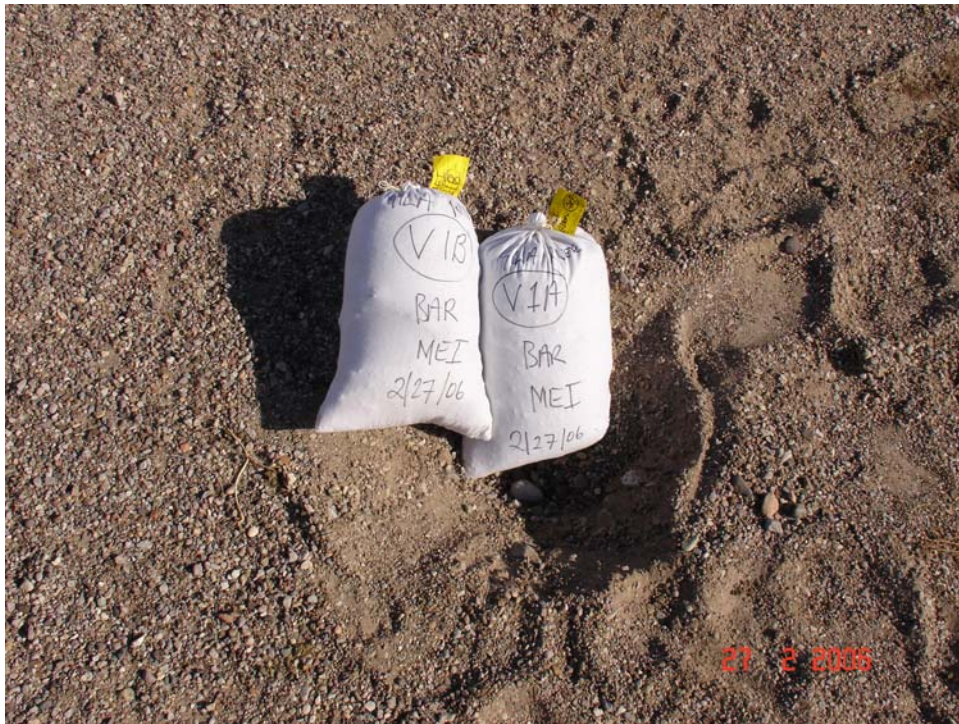
Figure A.34. Close up view of sediments deposited in the mid-channel bar at Cross Section 4 (V1) at the Virden site. The D_{50} is 1 mm and the sand content is about 55 percent.

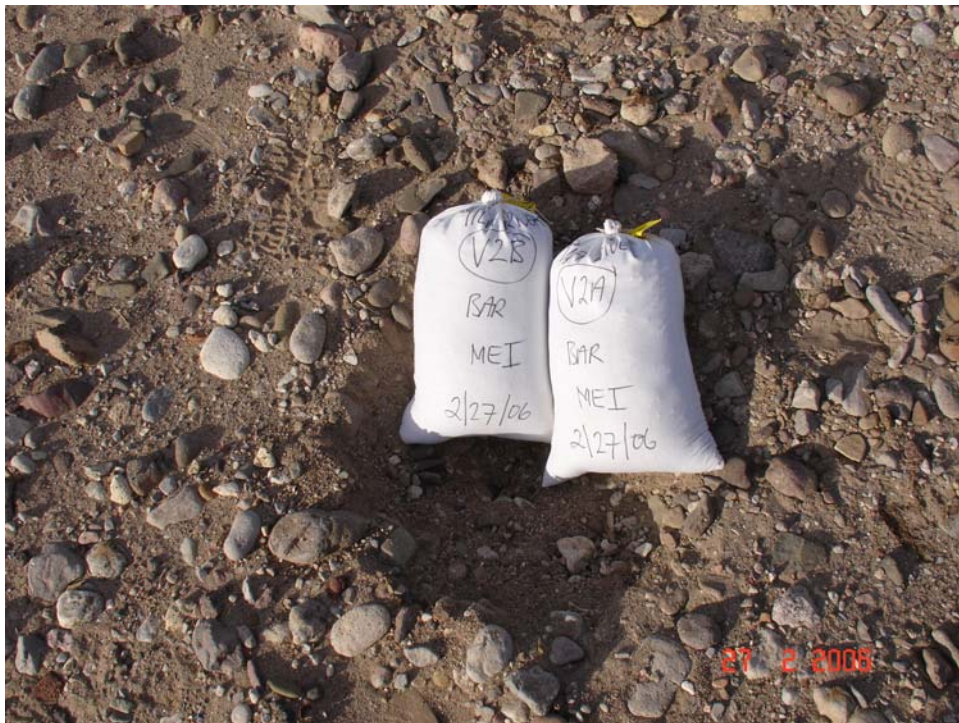
Figure A.35. Close up view of the bank-attached bar sediments (V2) at Cross Section 8 at the Virden site. The D_{50} is 4 mm and the sand content is about 33 percent.

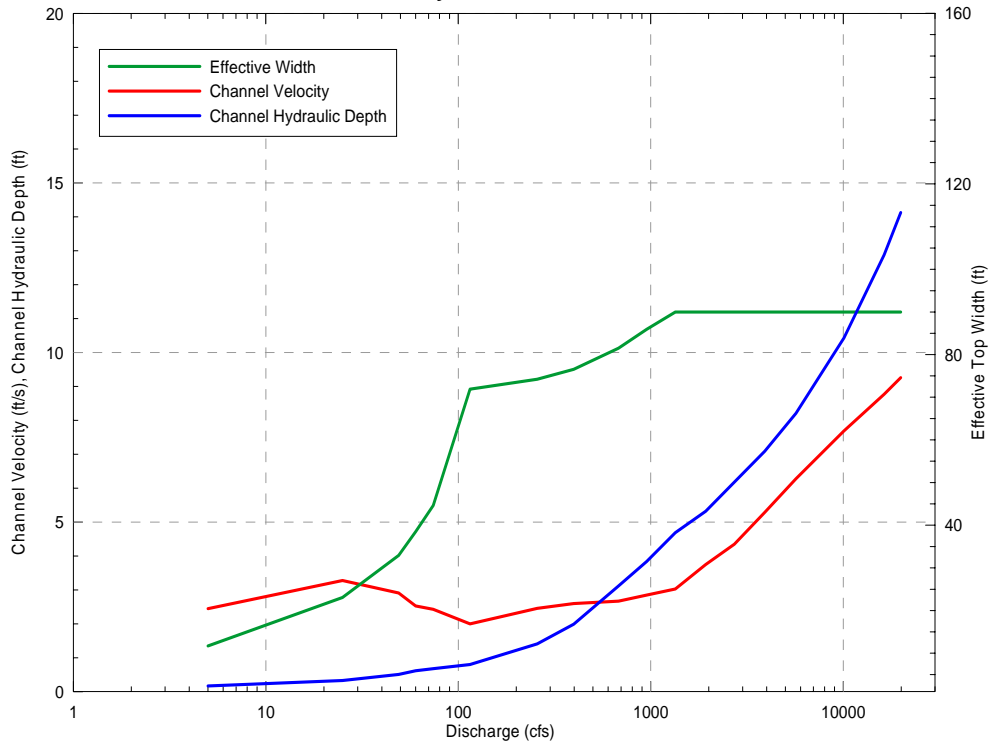
Turkey Creek XS7 - Run

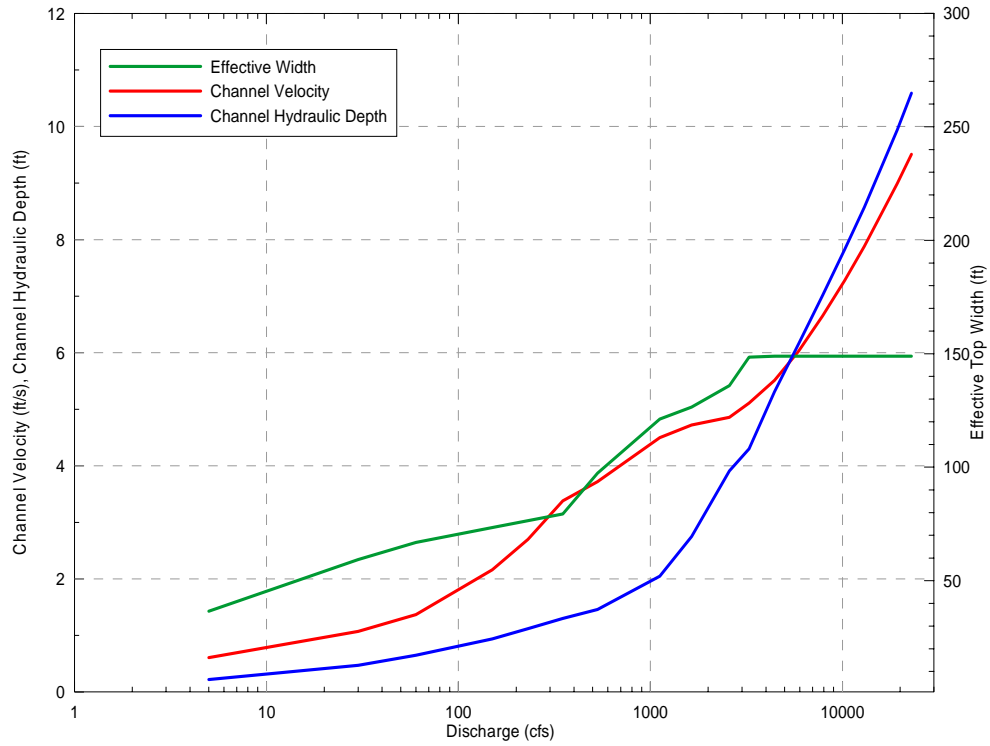
Birds XS9 - Riffle
