# The Vanishing Santa Cruz River

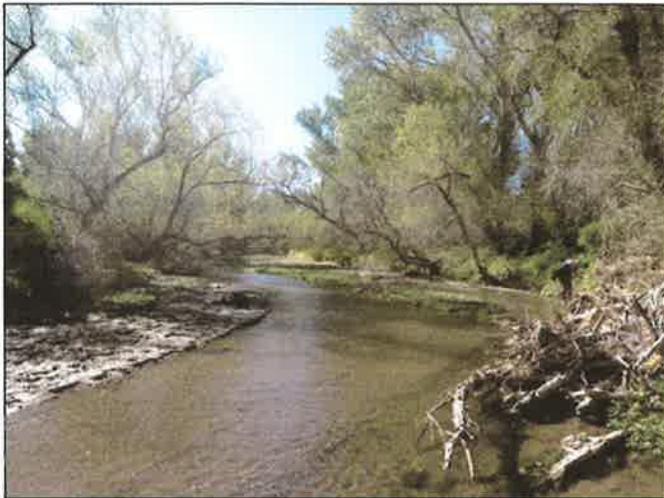
Santa Cruz River upstream of Santa Gertrudis Lane in 2012, flowing at approximately 12 cubic feet per second.

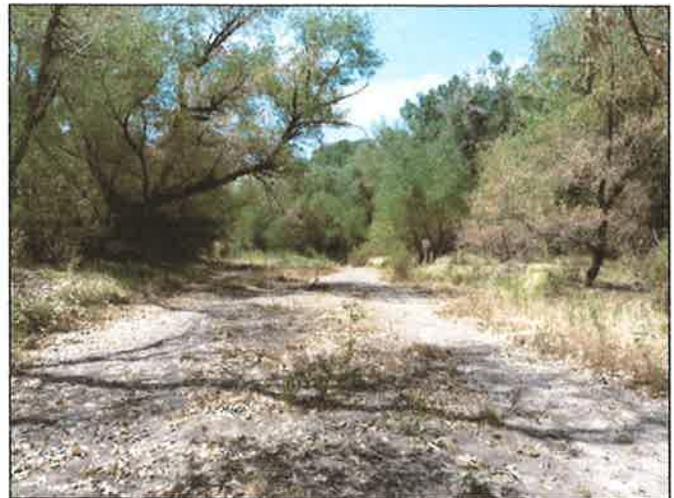
Santa Cruz River north of Santa Gertrudis Lane, July 3, 2013.

Recent changes to the river’s effluent inputs have reduced its flow; in fact, at Tumacácori NHP, the Santa Cruz stopped flowing in mid-April 2013 and has remained dry into July (time of writing). A no-flow period of this length has not previously

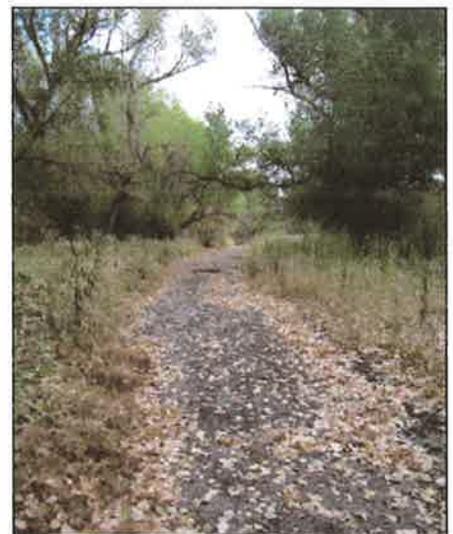
Figure 1. Cottonwood leaf drop at Tumacácori NHP along the dry bed of the Santa Cruz River, July 1, 2013.

The reduction of water levels in the river and its adjoining soils has put stress on riparian trees and plants. The cottonwood–willow forest managed by Tumacácori NHP represents one of the last vestiges of this plant association in the western U.S. In order to thrive, the dominant trees of the park’s riparian gallery forest, Fremont cottonwoods (*Populus fremontii*), need groundwater to remain at a level around 2 meters below the surface (Stromberg et al. 1996). If groundwater falls below the roots of the cottonwoods and other vegetation, then the plants begin to get stressed and, in response, drop their leaves to conserve water (Figure 1). If the plants continue to have limited access to groundwater, extensive vegetation mortality can result.

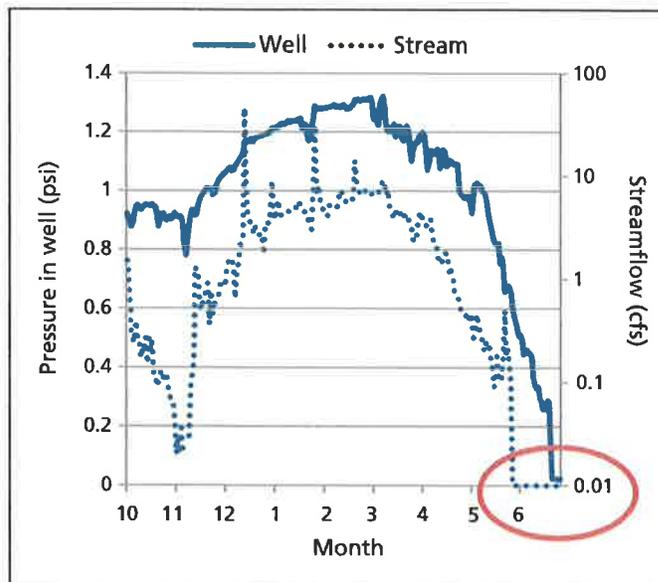
Figure 2. Water year 2013 flow rate (cfs) measured at the Tubac USGS gage and the pressure (psi) detected by the transducer in a groundwater monitoring well at Tumacácori NHP. Near-zero pressure indicates the well is dry.

At Tumacácori NHP, streamflow has ceased and groundwater levels are dropping as a result of the overall reduction in flow. Maintaining and replenishing the groundwater adjacent to the river requires a constant flow of river water; without it, evaporation, transpiration (both of which increase in extreme summer temperatures), and loss to surrounding deeper groundwater all combine to lower the surface-water level below the roots of riparian vegetation (Figure 2).
