The Vanishing Santa Cruz River

Background

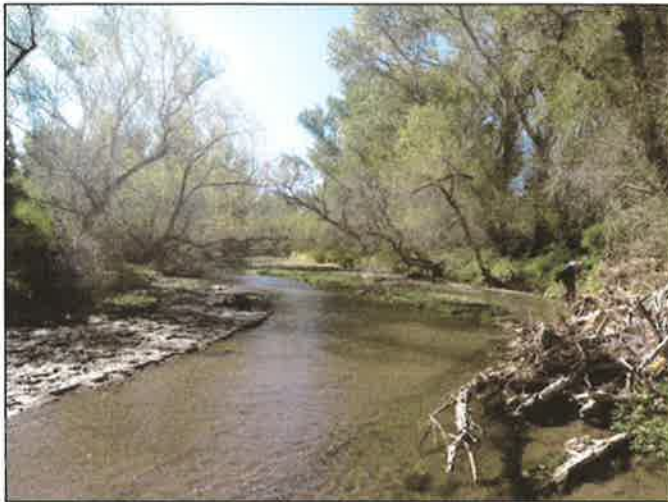
Santa Cruz River upstream of Santa Gertrudis Lane in 2012, flowing at approximately 12 cubic feet per second.

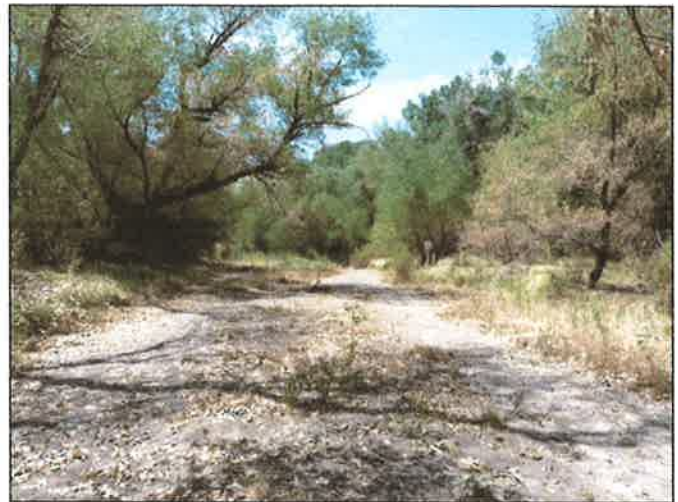
Santa Cruz River north of Santa Gertrudis Lane, July 3, 2013.

Recent changes to the river’s effluent inputs have reduced its flow; in fact, at Tumacácori NHP, the Santa Cruz stopped flowing in mid-April 2013 and has remained dry into July (time of writing). A no-flow period of this length has not previously

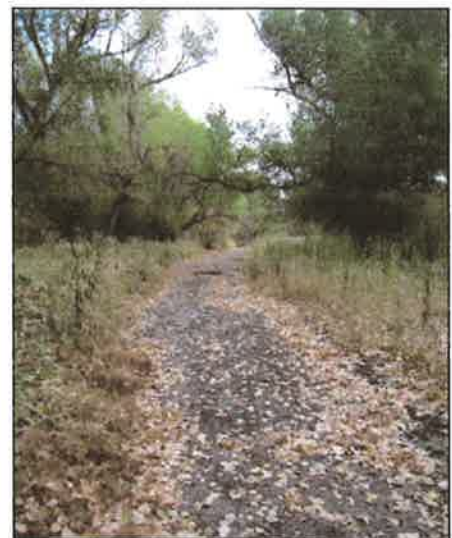
Figure 1. Cottonwood leaf drop at Tumacácori NHP along the dry bed of the Santa Cruz River, July 1, 2013.

The reduction of water levels in the river and its adjoining soils has put stress on riparian trees and plants. The cottonwood–willow forest managed by Tumacácori NHP represents one of the last vestiges of this plant association in the western U.S. In order to thrive, the dominant trees of the park’s riparian gallery forest, Fremont cottonwoods (*Populus fremontii*), need groundwater to remain at a level around 2 meters below the surface (Stromberg et al. 1996). If groundwater falls below the roots of the cottonwoods and other vegetation, then the plants begin to get stressed and, in response, drop their leaves to conserve water (Figure 1). If the plants continue to have limited access to groundwater, extensive vegetation mortality can result.

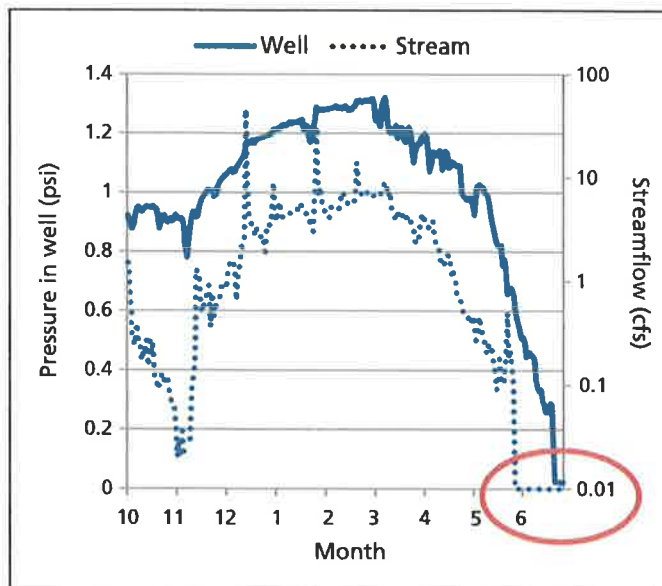
Figure 2. Water year 2013 flow rate (cfs) measured at the Tubac USGS gage and the pressure (psi) detected by the transducer in a groundwater monitoring well at Tumacácori NHP. Near-zero pressure indicates the well is dry.

At Tumacácori NHP, streamflow has ceased and groundwater levels are dropping as a result of the overall reduction in flow. Maintaining and replenishing the groundwater adjacent to the river requires a constant flow of river water; without it, evaporation, transpiration (both of which increase in extreme summer temperatures), and loss to surrounding deeper groundwater all combine to lower the surface-water level below the roots of riparian vegetation (Figure 2).
