Arizona State Land Department
May 29, 2015 (Initial Draft)

Presentation to ANSAC: Salt River Navigability

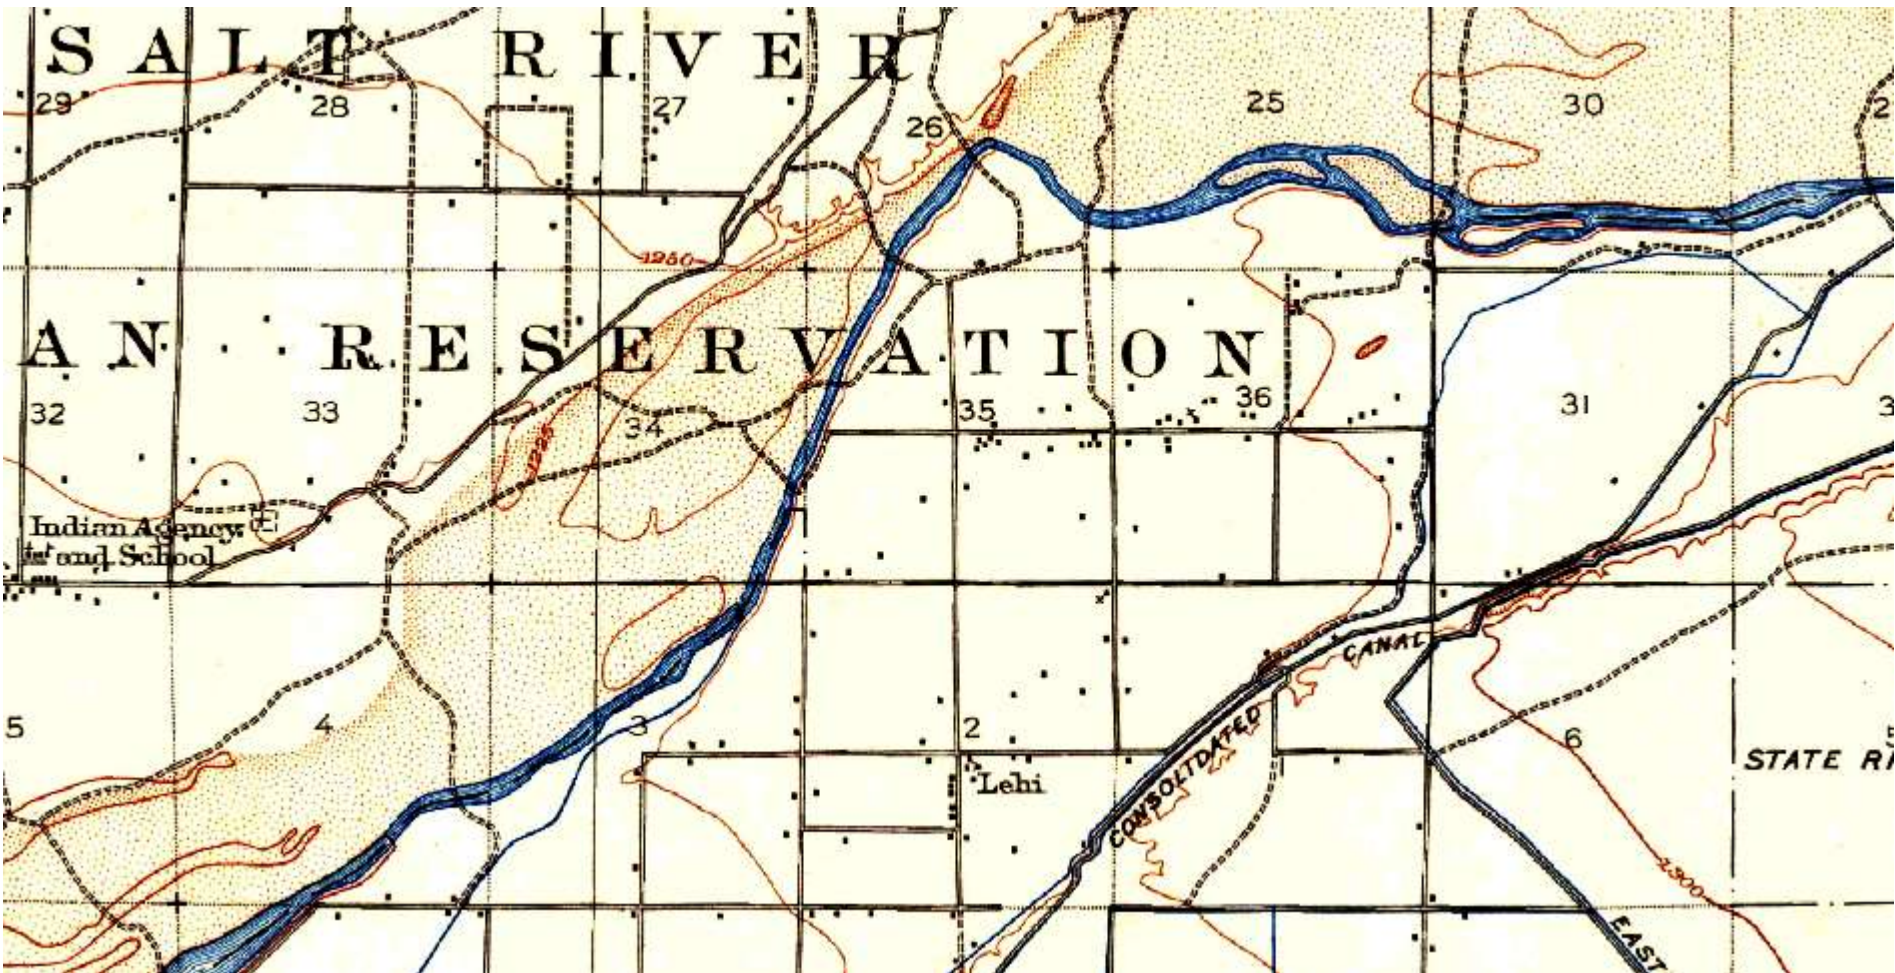
Is this river segment braided?

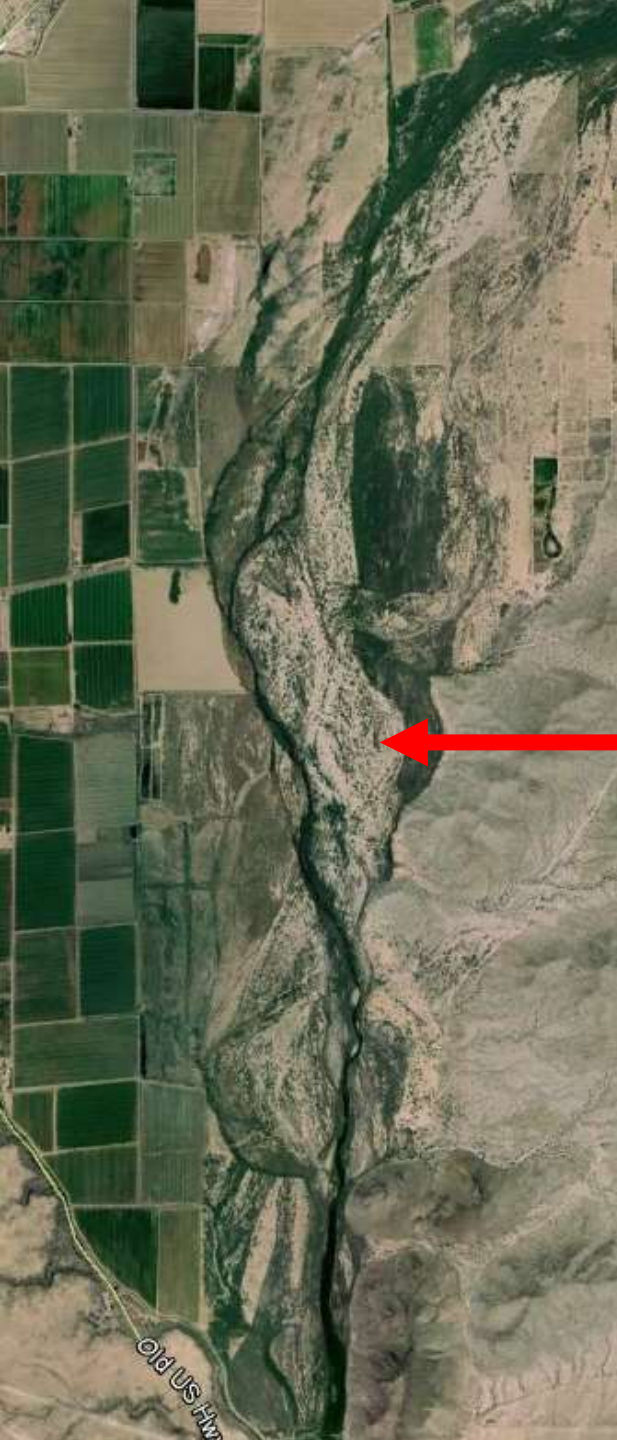
Gila River @ Arlington, AZ

Non-braided main channel >>

Boating occurs on ordinary flows in the main channel, not on the flood channel.

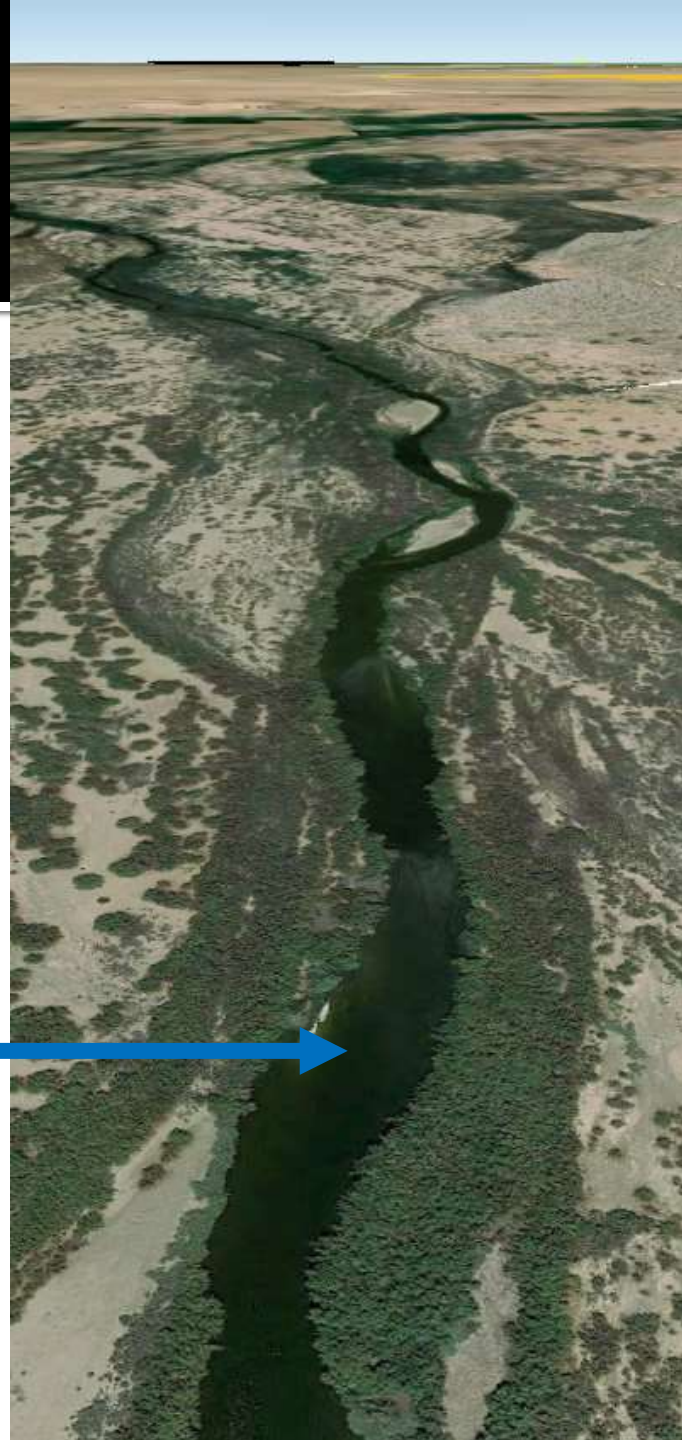
Gila River @ Arlington, AZ

Non-braided main channel >>

Boating occurs on ordinary flows in the single thread main channel, not on the braided flood channel.

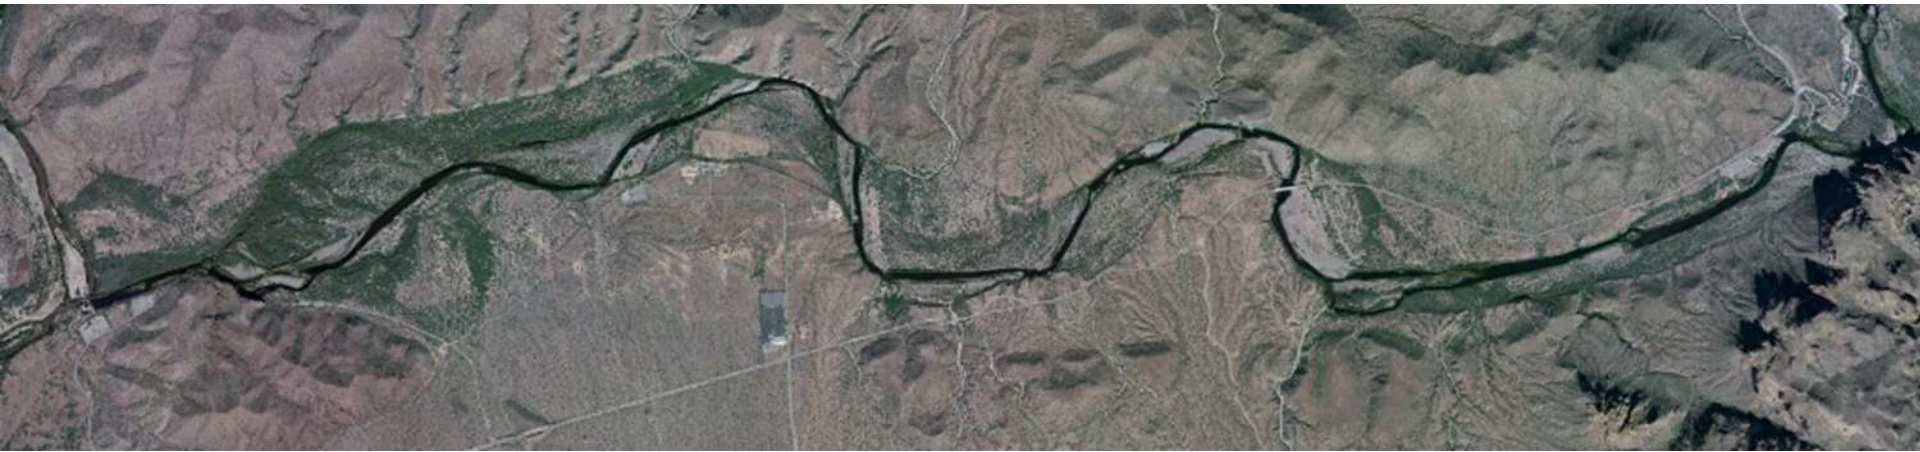
2013

Salt River: Stewart Mtn Dam area to Verde River confluence

- Channel Response to Flooding – Salt River
 - Salt River Segments 1-4
 - Minimal in bedrock canyons
 - Salt River Segments 5-6
 - Typical alluvial river response
 - Widening, possible braiding during flood
 - Scouring, deposition & reshaping of floodplain possible
 - Low flow channel returns after flood recedes
 - Migration of low flow channel within floodplain likely
 - Burkham; Huckleberry

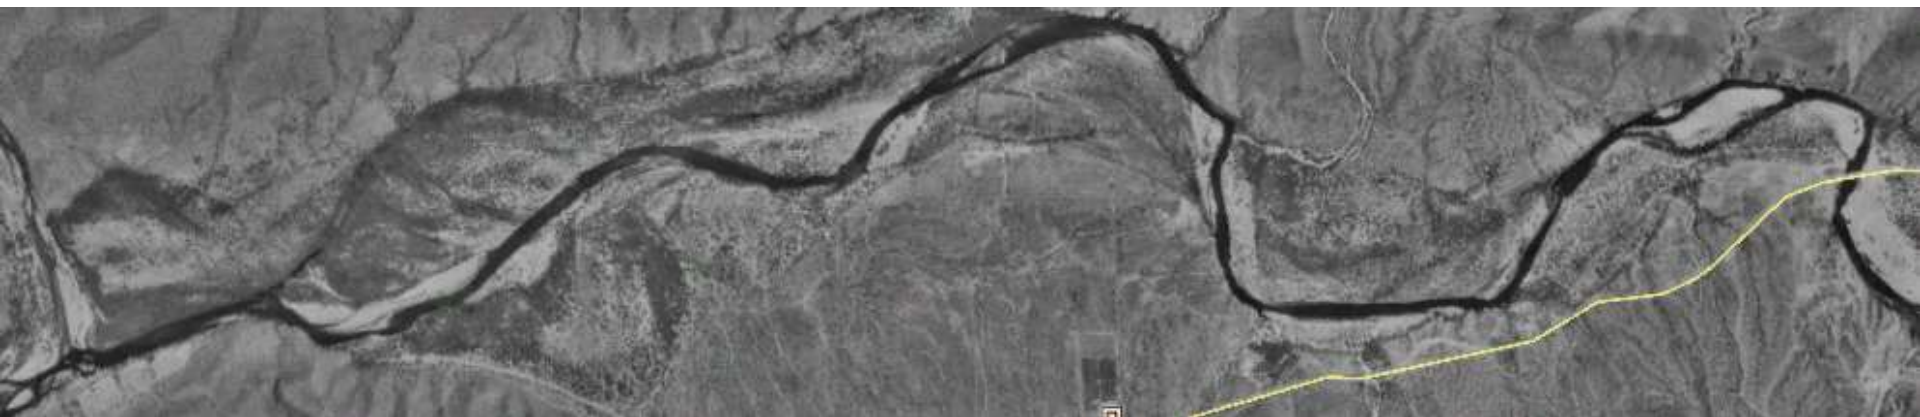
July 26, 1992

Salt River: Verde River confluence to Blue Point

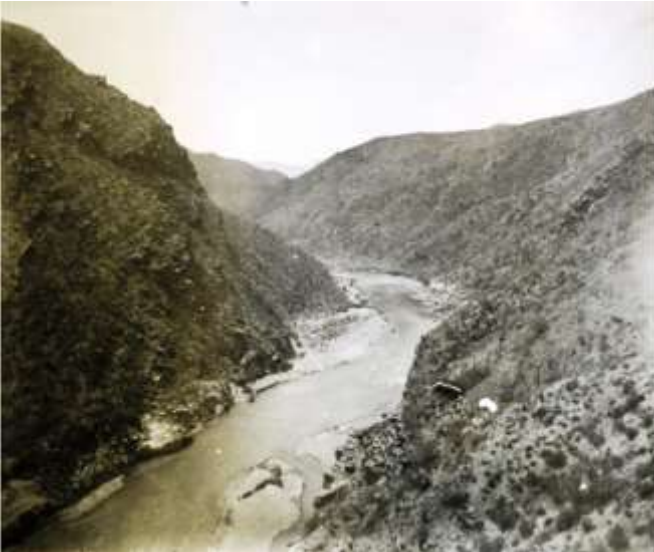
Salt River
Pre-Roosevelt near Dam Site

- Sand Bars
 - Raised area of sand at or near the water surface
 - Occupies part of the stream bed channel
 - Salt River: point bars more likely than in-channel bars

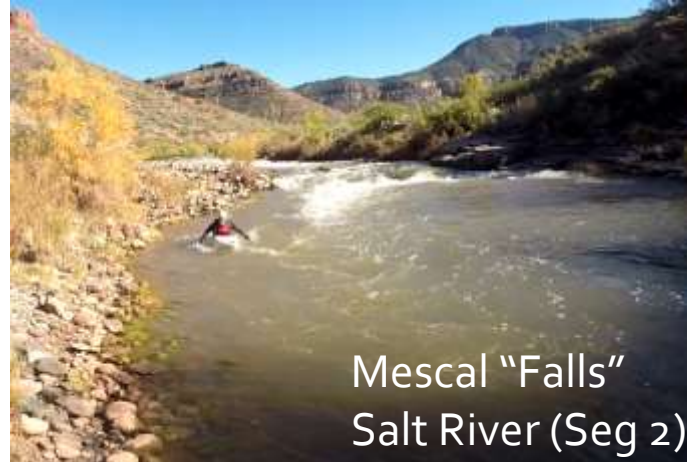
Mescal "Falls"
Salt River (Seg 2)

- Waterfalls:
 - Definition: River flow over a vertical drop.
 - Not drowned out at high flow
 - Permanent feature
 - Rapids are less steep, may be drown out
 - None on Gila, Salt, or Verde River in AZ
 - Some Rapids are named "falls"

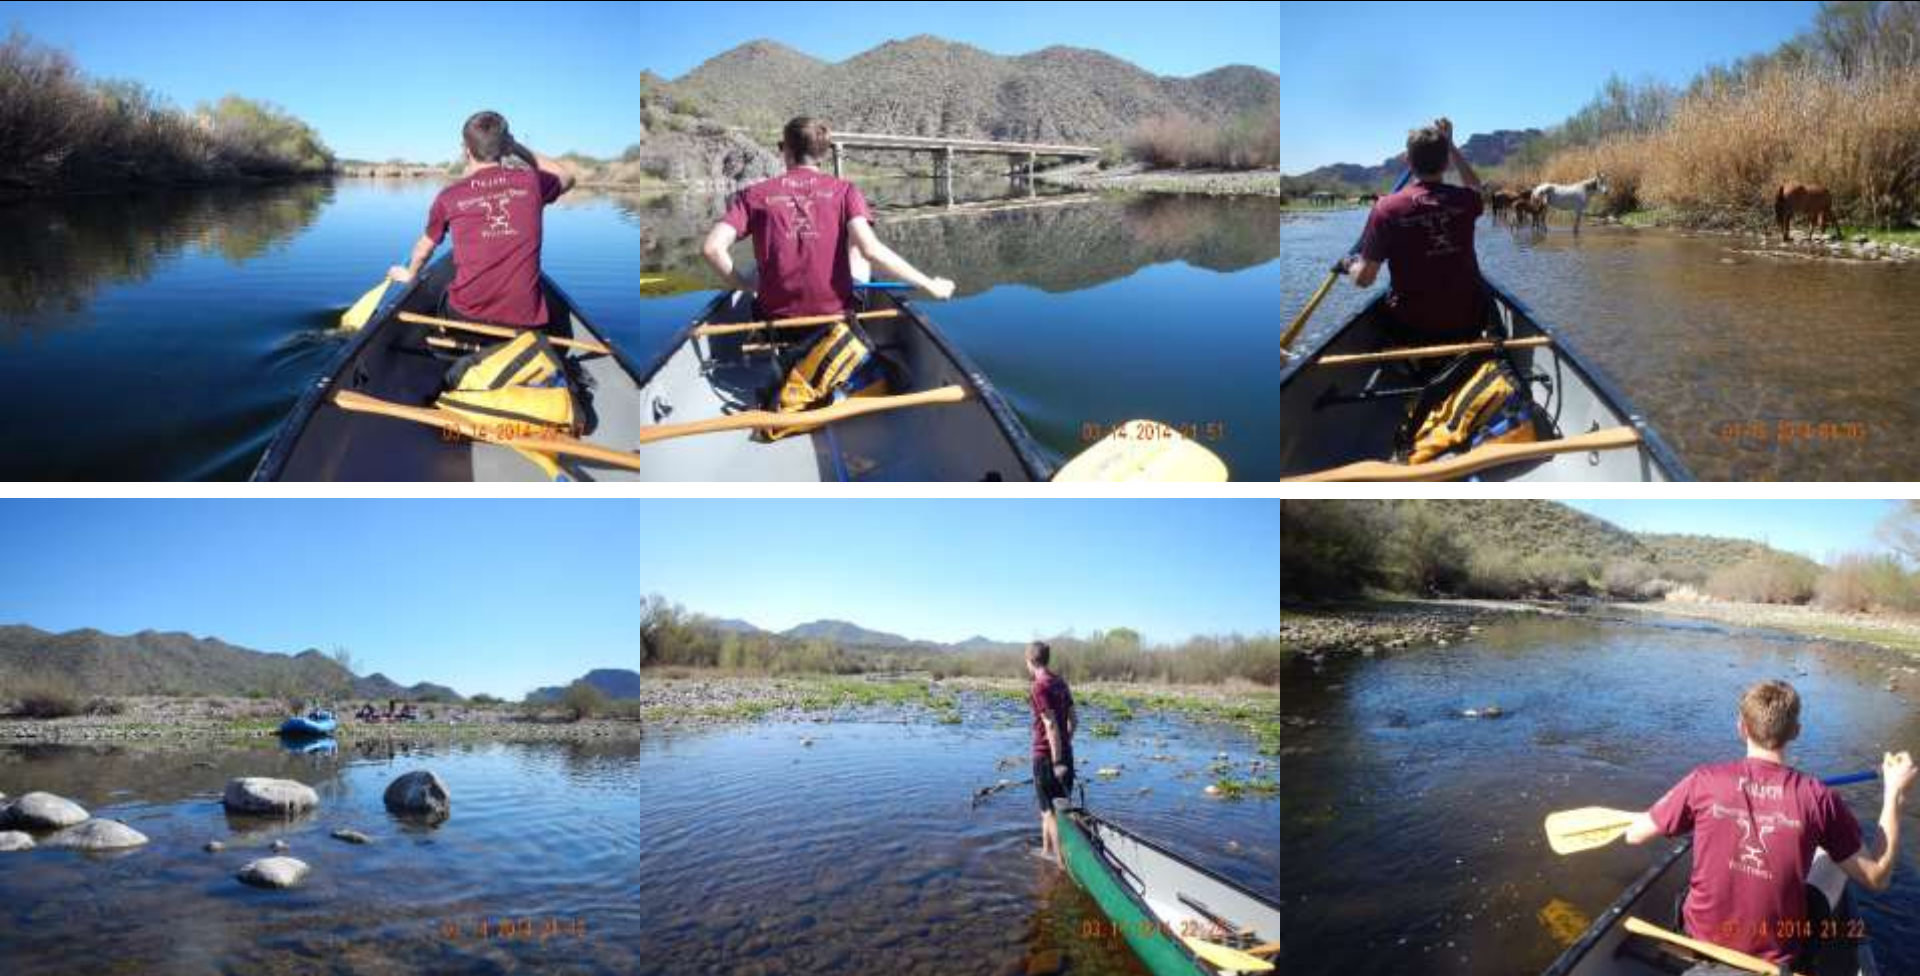
Segment #5 Field Photos

82% of Segment 5 was pools, with depths > 1 ft at 8 cfs

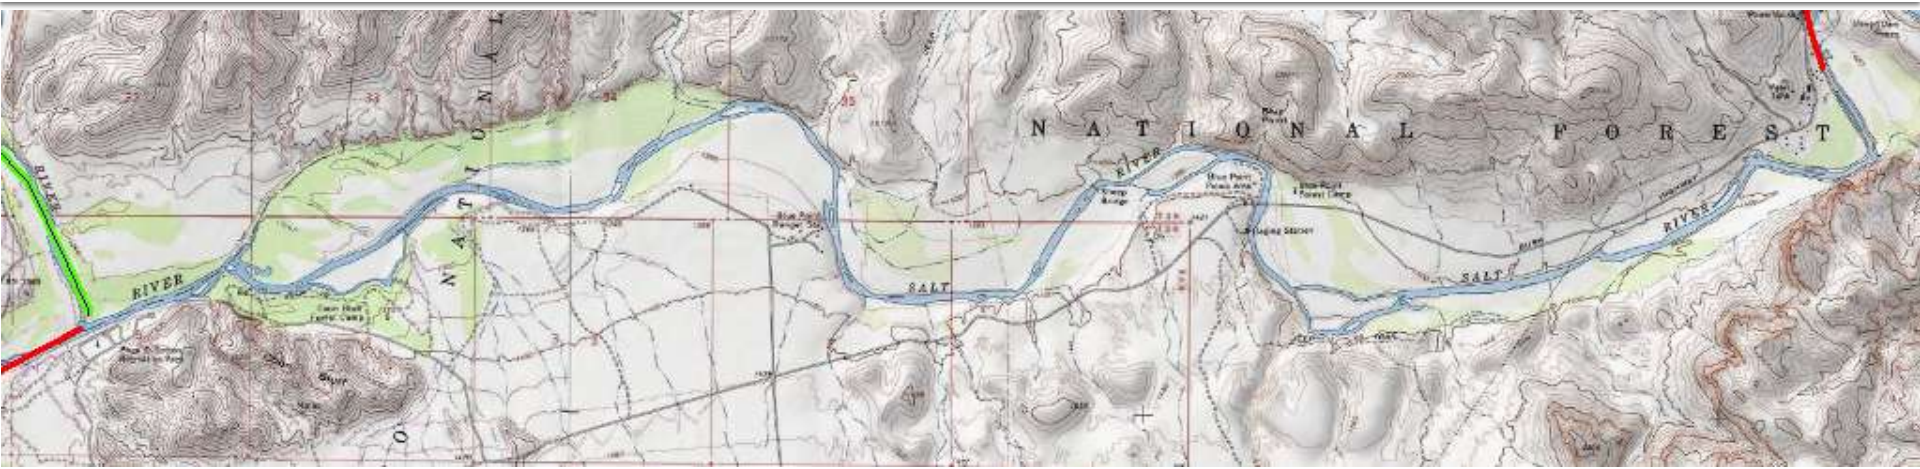
2011

Historical Maps: Segment #5

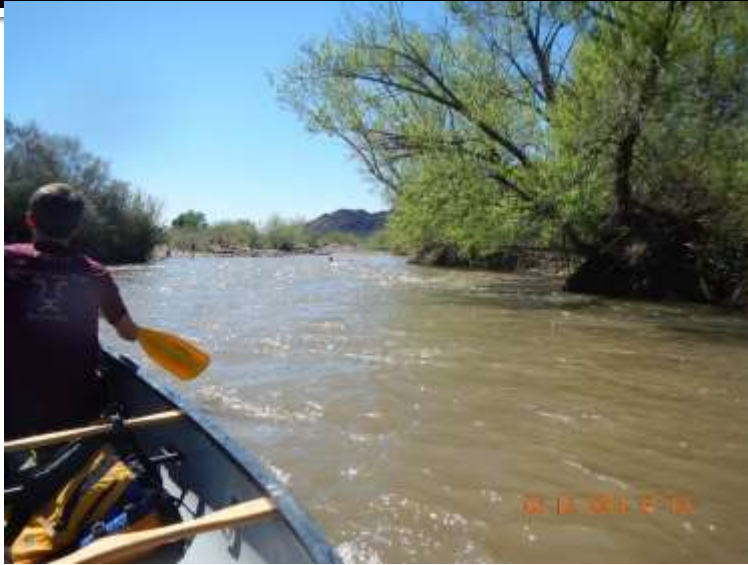
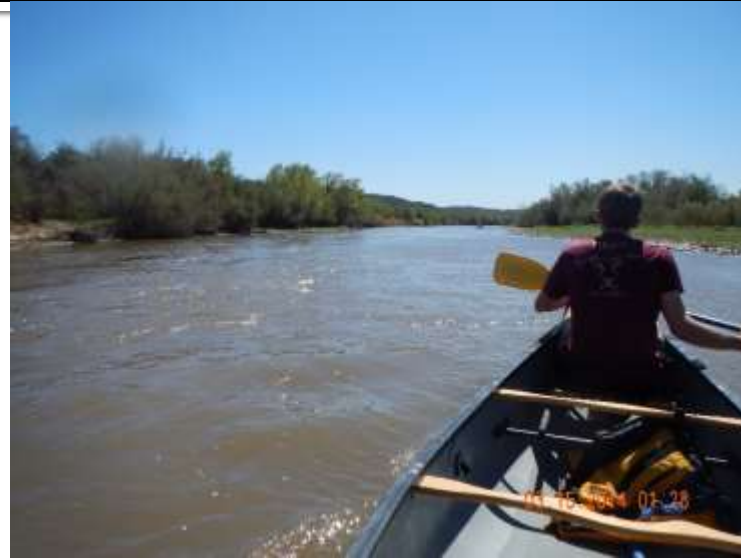
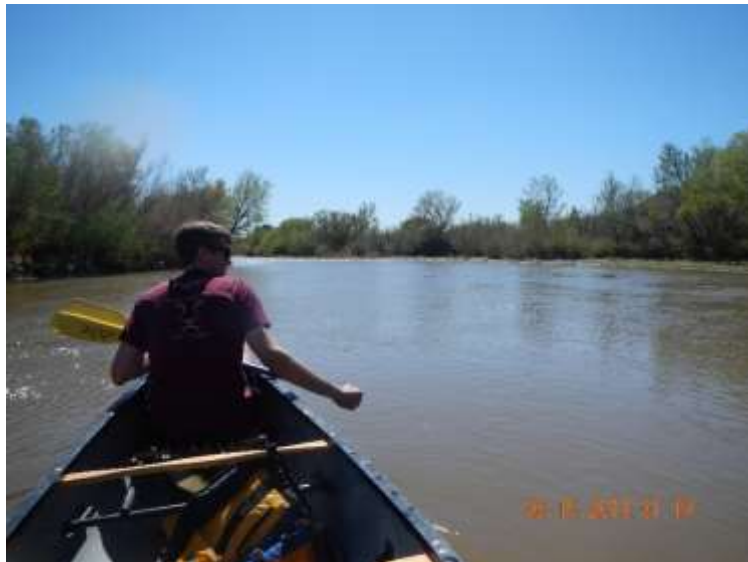
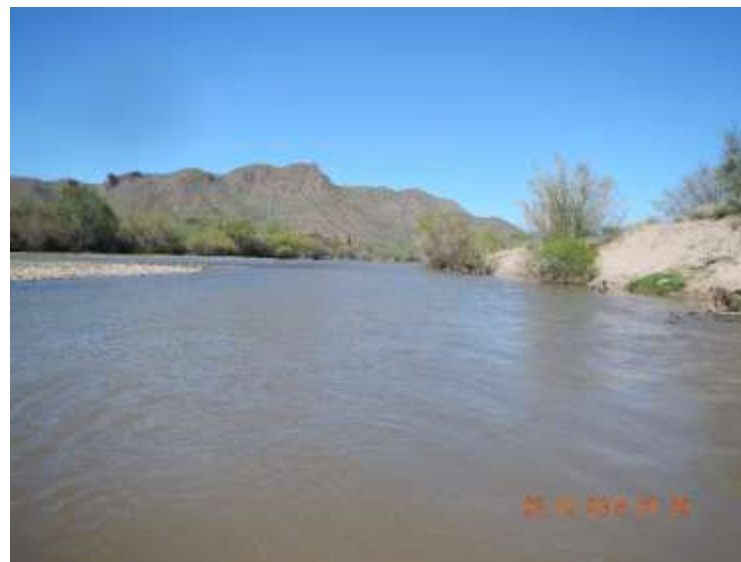
Salt River Segment #6

March 15, 2014
@ 283 cfs

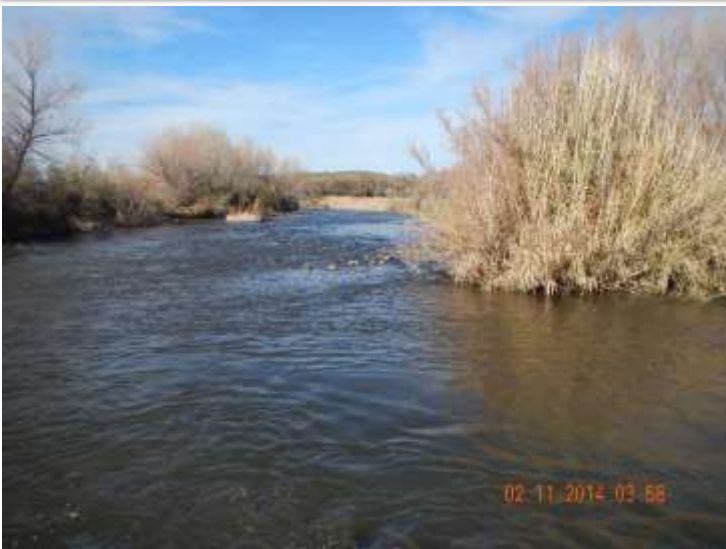
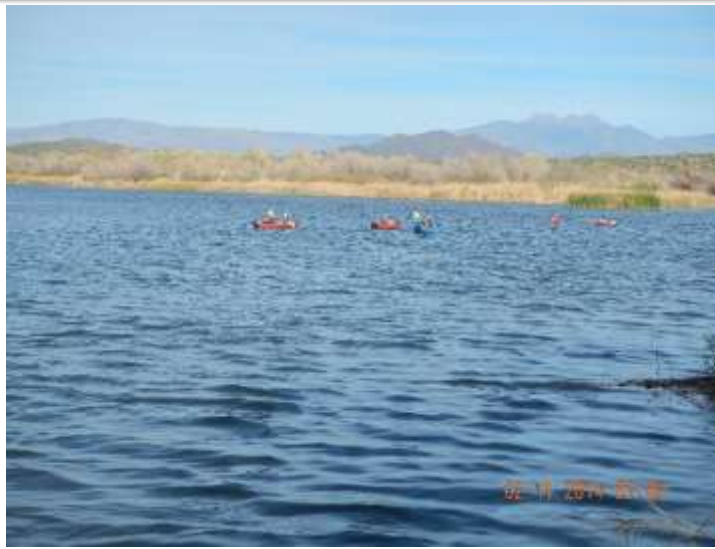
Salt River Segment #6

February 11, 2014
@ 370 cfs

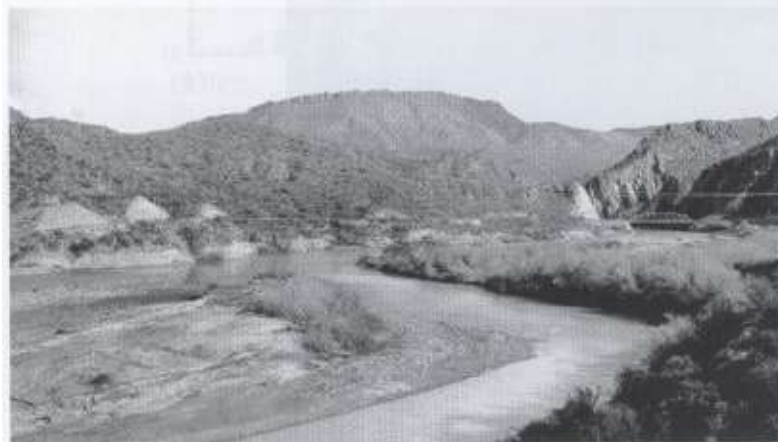
B. (February 3, 1979.) The brush-covered island is now densely covered with mostly nonnative tamarisk, although many native species also occur in this reach, including cottonwood, coyote willow, black willow, and various species of brickellbush. The bar in the left foreground was scoured during large floods in both 1978 and 1979. (R. M. Turner.)

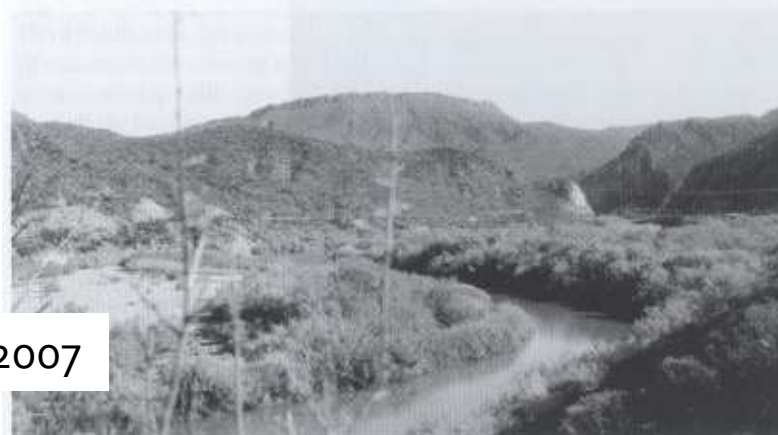
C. (November 25, 2000.) Flood frequency on the Salt River did not change significantly in the twentieth century, as it did on other rivers in the region, although four one-hundred-year floods did occur in a fifteen-year period. The 1993 flood, which had a peak discharge of 143,000 ft³/s at the gaging station on the bridge visible in the distance, did little to slow the advance of riparian vegetation—in particular tamarisk—at this site. Native species, notably carrizo grass, have also increased, although they are difficult to distinguish from the tamarisk in this view. (D. Oldershaw, Stake 955.)

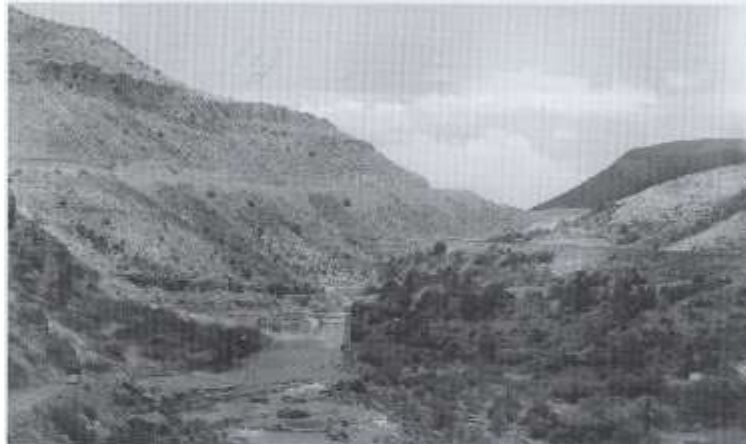
B. (June 25, 1964.) The water is low (about 97 ft³/s), exposing the bedrock that forms the channel bed and the low-water control downstream from the gaging station. In the intervening twenty-nine years, three floods with peaks of greater than 50,000 ft³/s passed through this reach. At this time, tamarisk is interspersed with the native shrubs on the floodplain and lines river left, which was mostly devoid of woody vegetation in 1935. Fan palms (*lower right*), which are not native to this area, were planted as part of a roadside park well before this photograph was taken. The roadcut on the skyline has been widened. (R. M. Turner.)

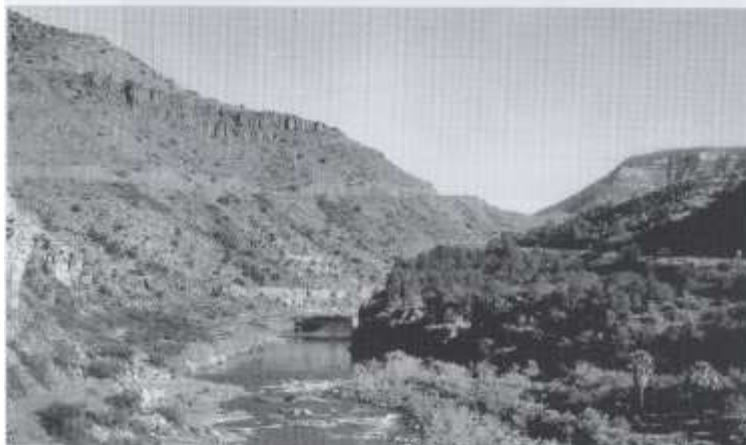
C. (October 25, 2000.) The water level is only slightly higher in 2000 than it was in 1964. In the intervening thirty-six years, two floods have exceeded 70,000 ft³/s, and four have exceeded 50,000 ft³/s. Despite these floods, riparian vegetation along the banks has increased, in particular nonnative tamarisk. The palms have grown considerably. (D. Oldershaw, Stake 363.)

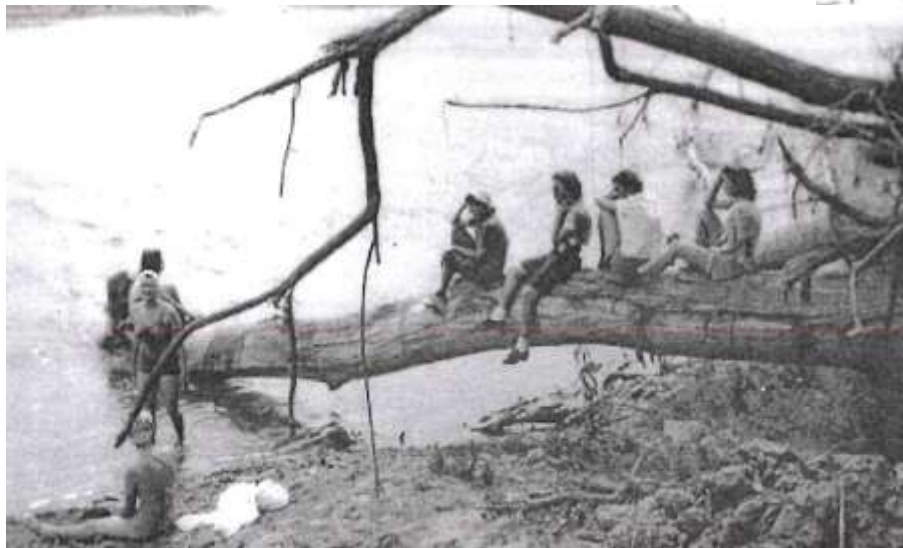
The "Ole Swimmin Hole" in 1917 was in the Salt River west of town. Boys dove under banks to catch fish in bare hands.

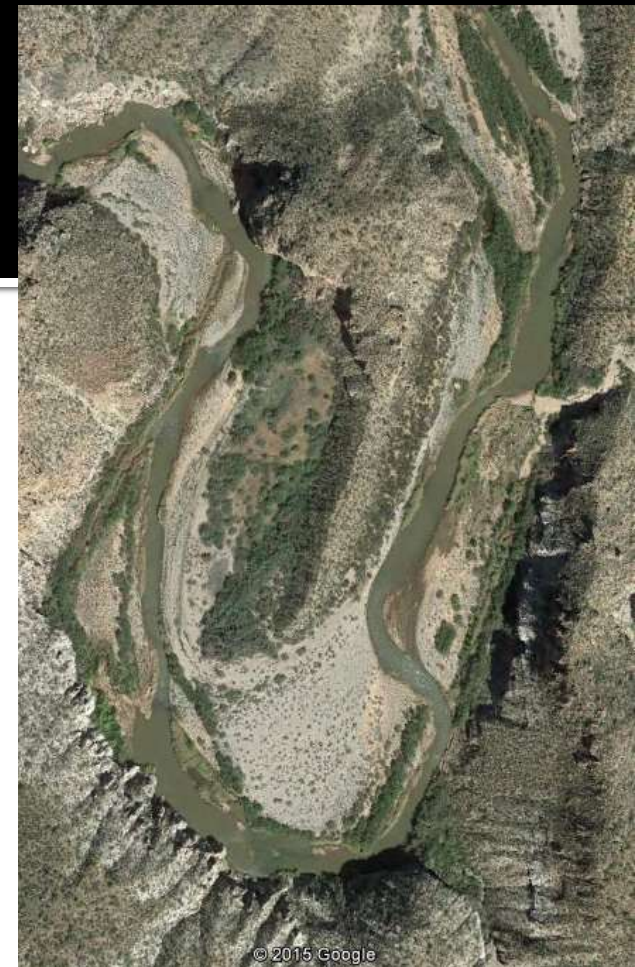
Geology: Key Findings

■ Channel Pattern

■ Single Channel (Segments 1-4)

- Bedrock Canyons (Segments 1-4)
 - Intervening Flats (broader alluvial valley reaches)
 - No Significant Change in Channel Morphology
- Alluvial Valley (Segment 5-6)
 - Minimal bedrock (Granite Reef, Tempe Butte)
- Affects of Floods
 - Segments 1-4: Minimal due to Bedrock Control
 - Segments 5-6: Reshaping of Flood Channel
 - Ordinary, Low-Flow Channel Recurs After Flood
 - Low Flow Channel Can Move During Large Floods
 - Floods Aren't "Ordinary"

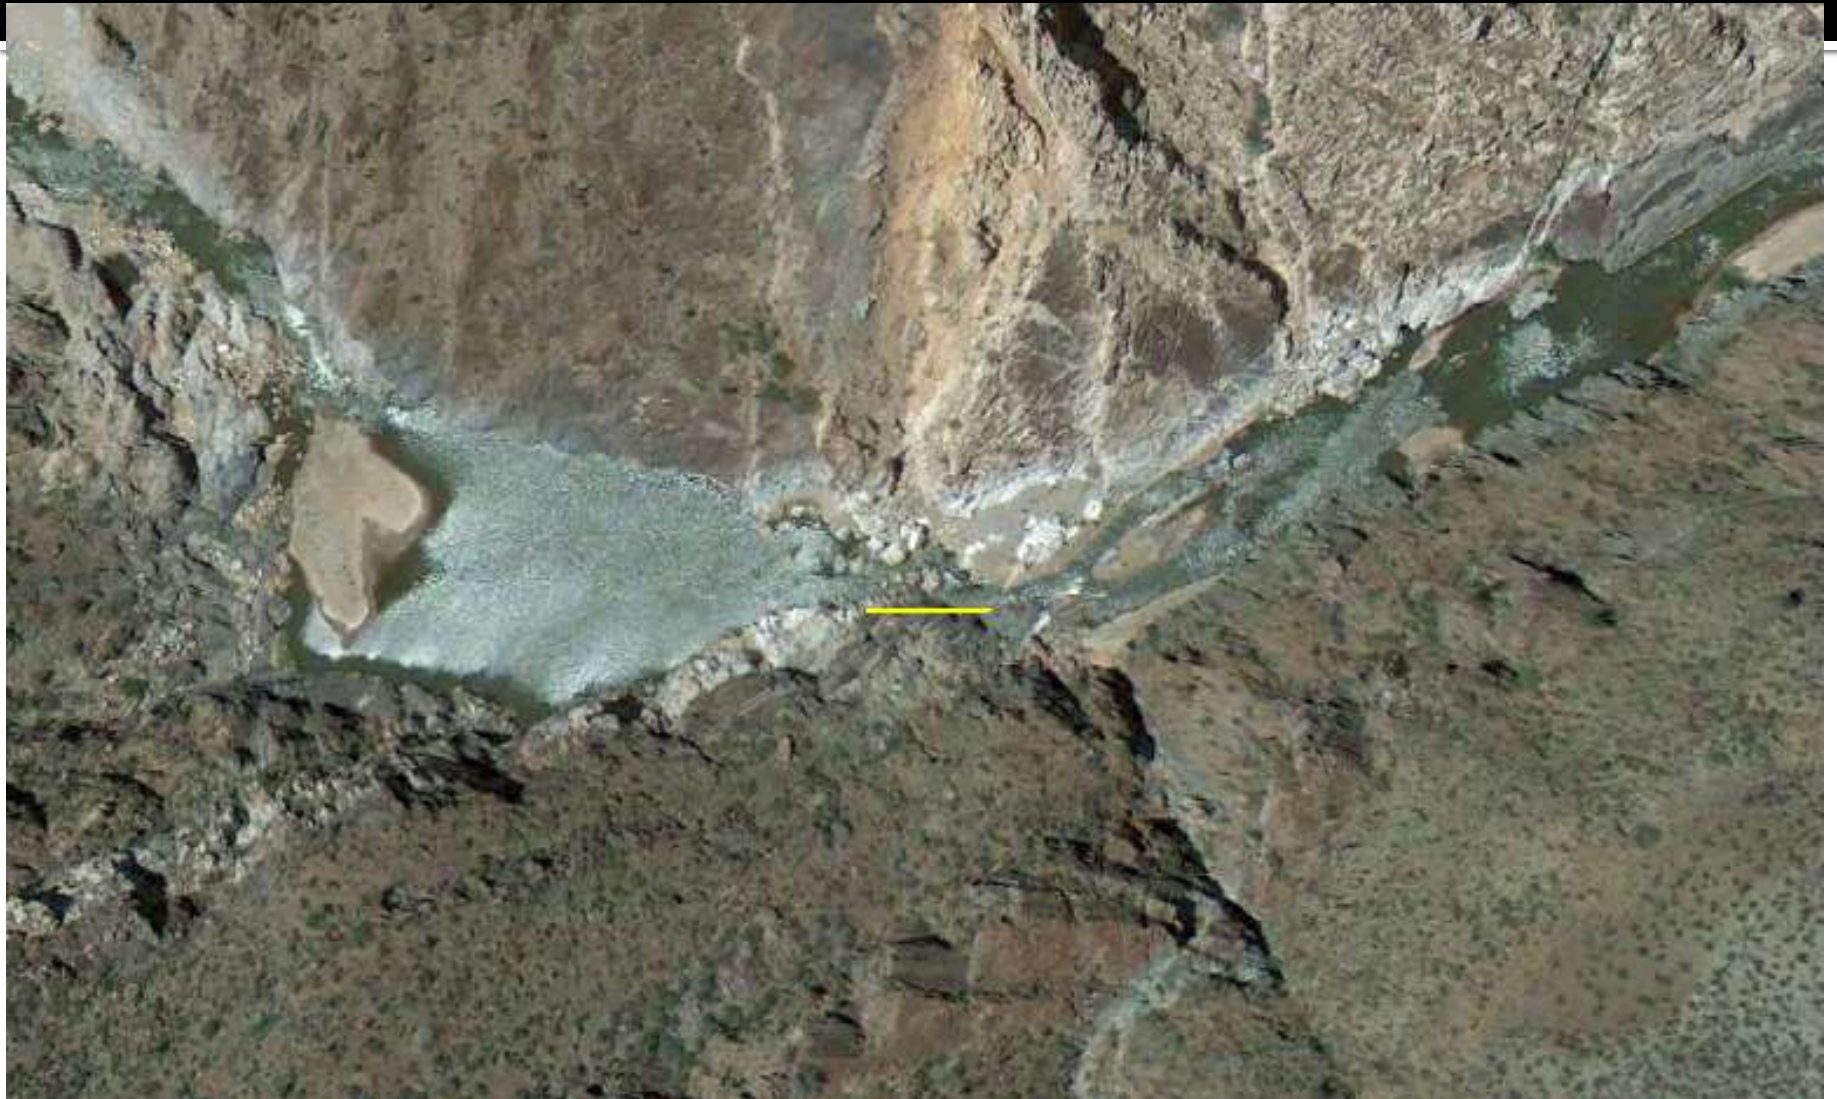
Quartzite "Falls" Rapid

Google Earth Aerial, June 5, 2012 @ 94 cfs Yellow bar = 100 ft.

- Class III-V (Pre-Dynamite)
 - Depends on Flow Rate
 - During Most High Flow Raft Trips, Class IV-V
 - Characteristics
 - Short (~100-150 ft. long whitewater)
 - Constriction
 - Boulders & Bedrock Sill
 - Portage – normally on river left
 - Pool immediately below rapid
 - Portage Recommended (Pre-Dynamite)
 - Now commonly run or short portage (<100 ft.)

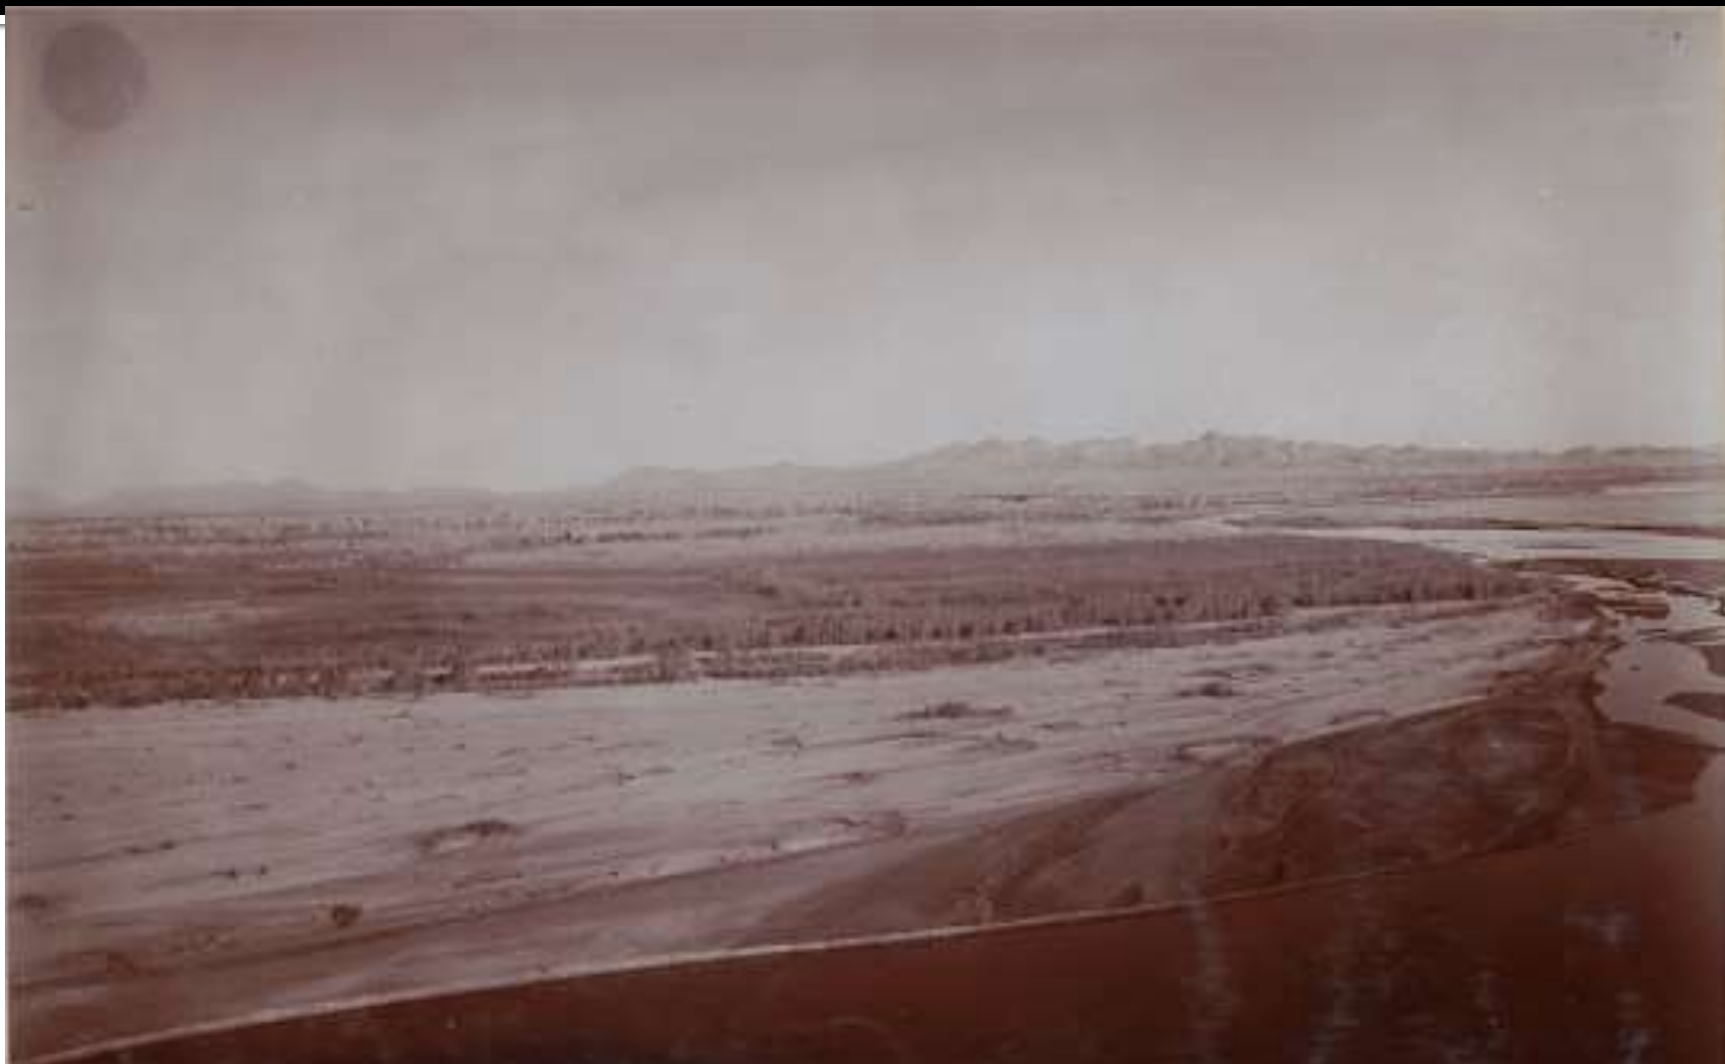
- Characteristics
 - Many Rapids
 - Compound Channel, some “braiding”
 - Channel Position Changes due to Flood Erosion & Meandering
 - Sand Bars & Islands
 - “ever changing sand bars that hindered navigation”
 - Tidal bores, high tides
- Not Listed in Rivers & Harbors Act of 1899

Navigable Lower Colorado River, UC Riverside Collection, Lippincott 1880-1920
