Channel Changes of the Gila River in Safford Valley, Arizona 1846-1970

GEOLOGICAL SURVEY PROFESSIONAL PAPER 655-G

By D. E. BURKHAM

GILA RIVER PHREATOPHYTE PROJECT

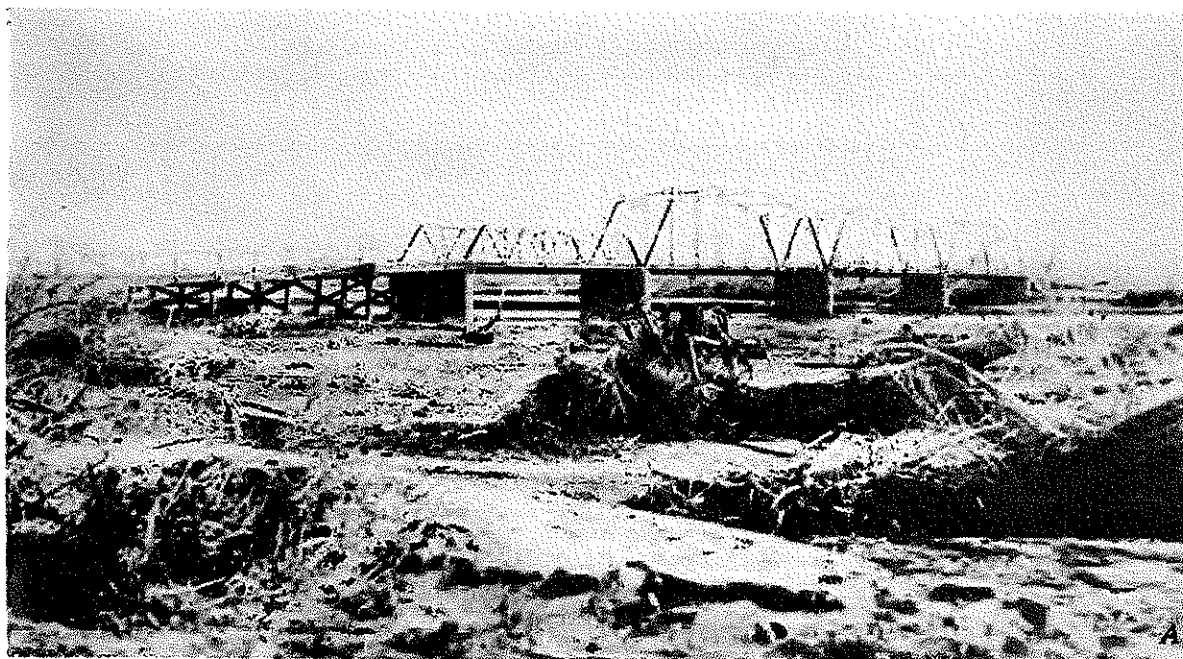
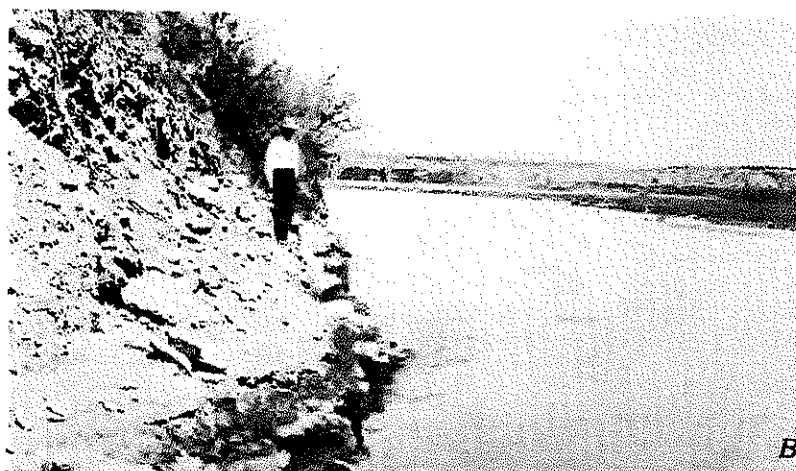
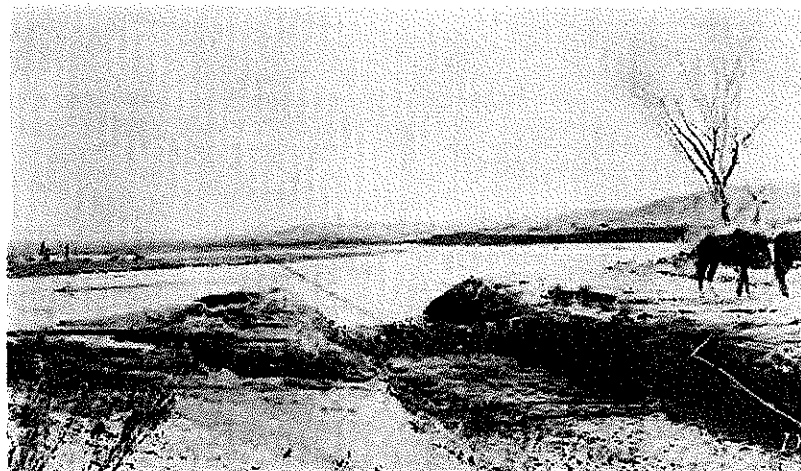
FIGURE 3.—Gila River in 1916. *A*, Looking upstream at the bridge at Pima; the drift in the foreground probably is cottonwood. *B*, Looking downstream at Black Point near Bylas; the trees in the background across the river probably are cottonwood. *C*, Erosion on the left bank of the river at Bylas; the alluvial fan on the right side of the river at the mouth of Salt Creek (not shown in photo-

graph; see pl. 1) is causing a realignment of the river. *D*, Gila River near Bylas; debris in the left background is uprooted cottonwood. Photograph *A* is from Olmstead (1919, pl. 11); photographs *B*, *C*, and *D* furnished by the U.S. Bureau of Indian Affairs, Phoenix, Ariz.

Most of the dense stands of willow and cottonwood that grew along the Gila River prior to 1905 were destroyed during 1905-17 (fig. 3). The stream channel was relatively barren in 1909 (fig. 4); therefore, most of the destruction probably occurred during 1905-9.

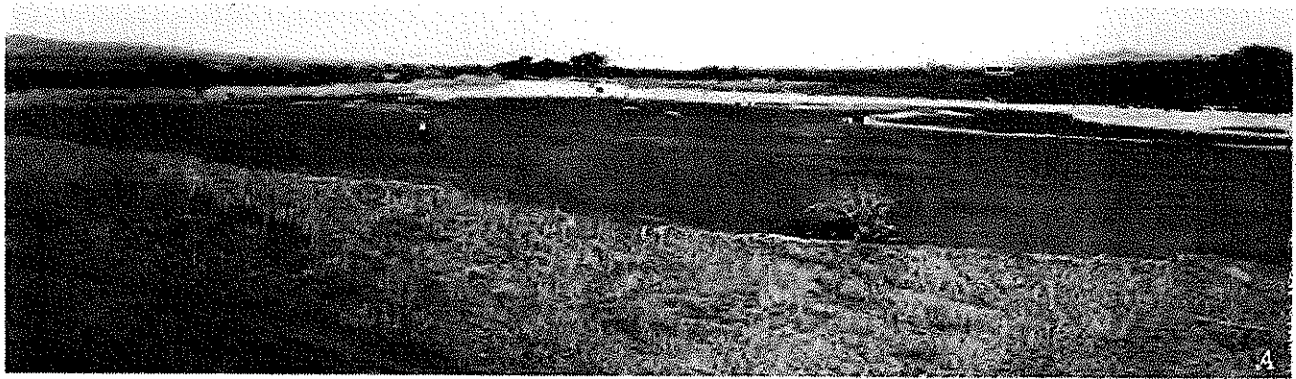
FIGURE 4.—Gila River in 1909 and 1969. *A*, Looking downstream near Geronimo in May 1909. *B*, Looking downstream near the railroad siding at Calva in 1909. *C*, Looking downstream near the railroad siding at Calva in 1969 (arrow indicates location of railroad bridge); the bottom-land vegetation was eradicated in 1966 to control evapotranspiration, and the photograph in figure 6 shows the same area before eradication. Photographs *A* and *B* furnished by the U.S. Bureau of Indian Affairs, Phoenix, Ariz. Photograph *C* furnished by Mr. R. M. Turner, Tucson, Ariz.

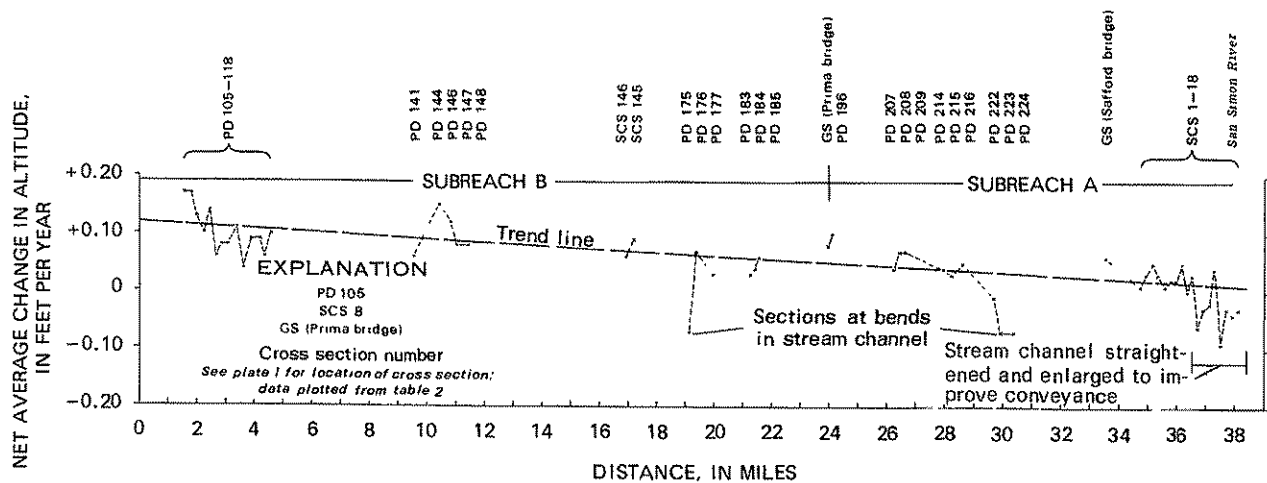
FIGURE 7.—Net average change in the altitude of the bottom land, 1935-70, at cross sections in subreaches A and B of the Gila River. Distance was measured along the centerline of the stream channel (1960).

From 1935 to 1970, the net change in the altitude of the bottom land has been an increase at 45 of the 57 cross sections in subreaches A and B, although data show short periods of scour at some of the other sections (table 2; fig. 7). The author hypothesizes that the increase in sediment accretion in the downstream direction occurred because more coarse material is deposited in the bottom land in the lower part of the valley than in the upper part and because streamflow is depleted by infiltration and diversion. Coarse material originating in steep watersheds tributary to subreaches D and C and part of subreach B is deposited directly in the bottom land. In subreach A and in the other part of subreach B, only the fine material makes its way to the bottom land, and most of the fine material is carried through the valley and is deposited in the San Carlos Reservoir.

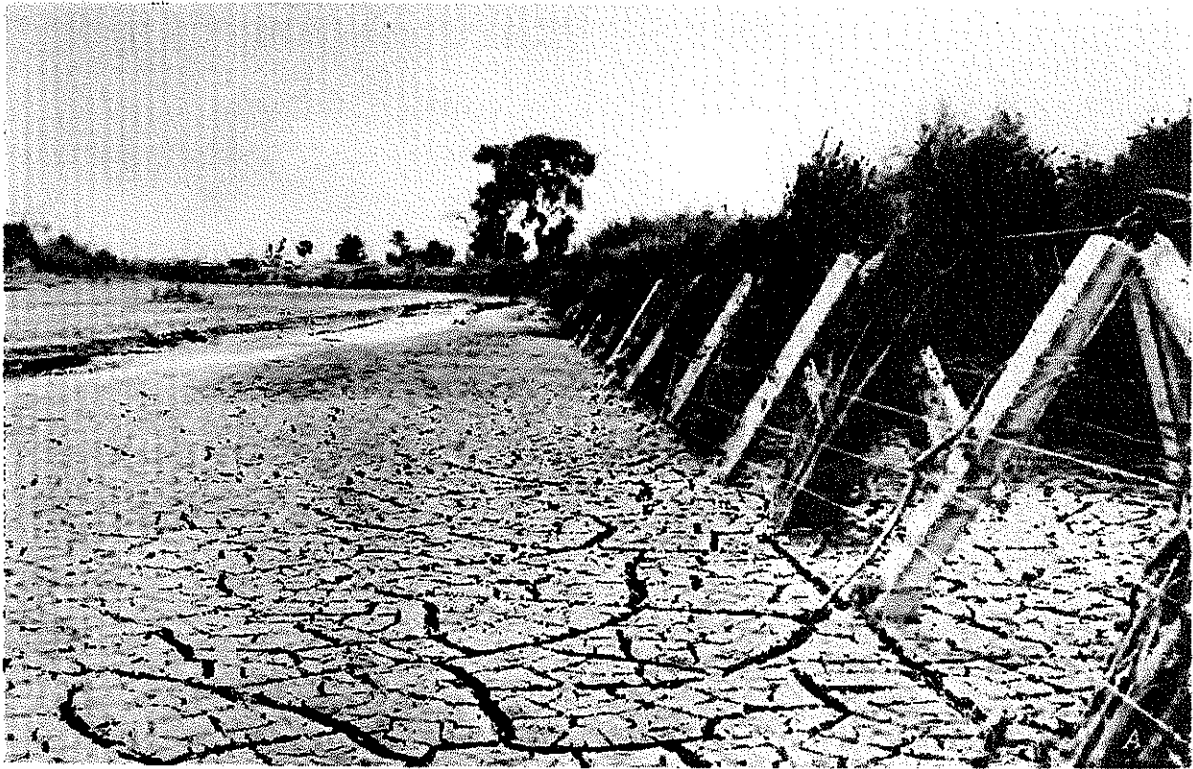
The erosion-control treatment used by the Soil Conservation Service (fig. 8) undoubtedly had some short-term local effects because it was applied during a period having few major floods; however, saltcedar became established naturally, and any reduction in erosion effected by the willow probably would have occurred later as a result of the saltcedar.

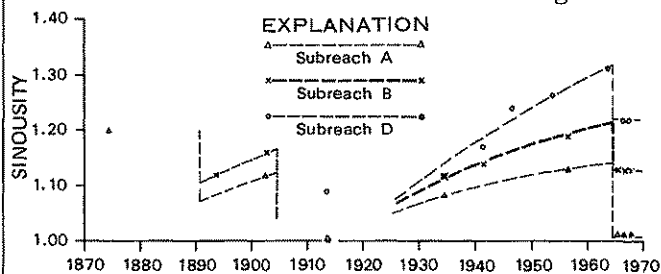
FIGURE 9.—Sinuosity of the stream channel of the Gila River in Safford Valley, 1875-1970.

inside of bends. Because the altitude of the streambed has not changed significantly, the increase in channel length has resulted in a decrease in stream-channel slope. The author hypothesizes that an increase in the number of alluvial-fan deposits and the depletion of streamflow in the downstream direction caused the increase in sinuosity in the downstream direction (fig. 9).
