- (B) Historic American Engineering Record (HAER No. AZ-29) Ash Avenue Bridge (Tempe Bridge, Old Tempe Bridge and Salt River Bridge) spanning the Salt River at the foot of Ash Avenue. January 1991.

Ash Avenue Bridge
(Tempe Bridge, Old
Tempe Bridge, and
Salt River Bridge)
Spanning Salt River
at foot of Ash Avenue
Tempe,
Maricopa County,
Arizona

HAER No. AZ-29

WRITTEN HISTORICAL AND DESCRIPTIVE DATA

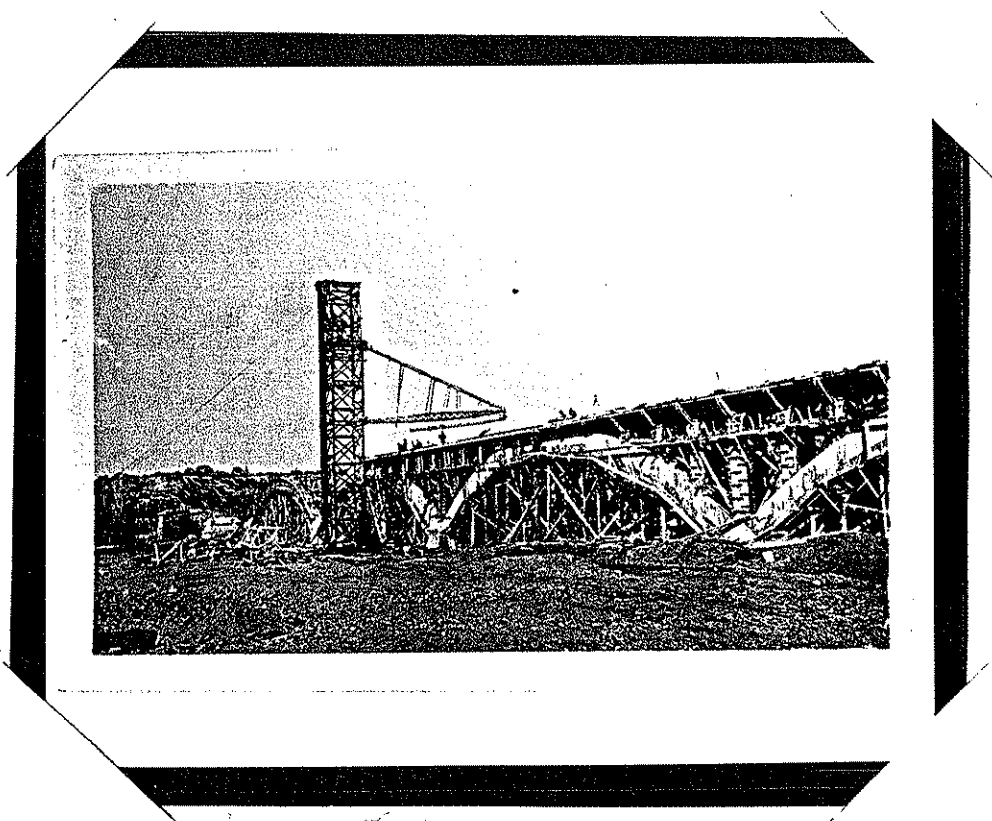
HISTORIC AMERICAN ENGINEERING RECORD
SEE INDEX TO PHOTOGRAPHS FOR CAPTION
HAER No. AZ-29-11

Initially estimated to cost \$78,397,²³ the final cost of the bridge was about \$120,000. Much of the cost increase probably can be attributed to the increase in length and width of the completed bridge over that provided in the original design, and to the difficulties caused by river floods during construction (HAER photograph AZ-29-11).
