ARIZONA NAVIGABLE STREAMS ADJUDICATION COMMISSION
FINAL REPORT
SMALL AND MINOR WATERCOURSES PILOT STUDY

CONTRACT No. A7-0109-001

September 1999

**SMALL AND MINOR WATERCOURSES PILOT STUDY
FINAL REPORT**

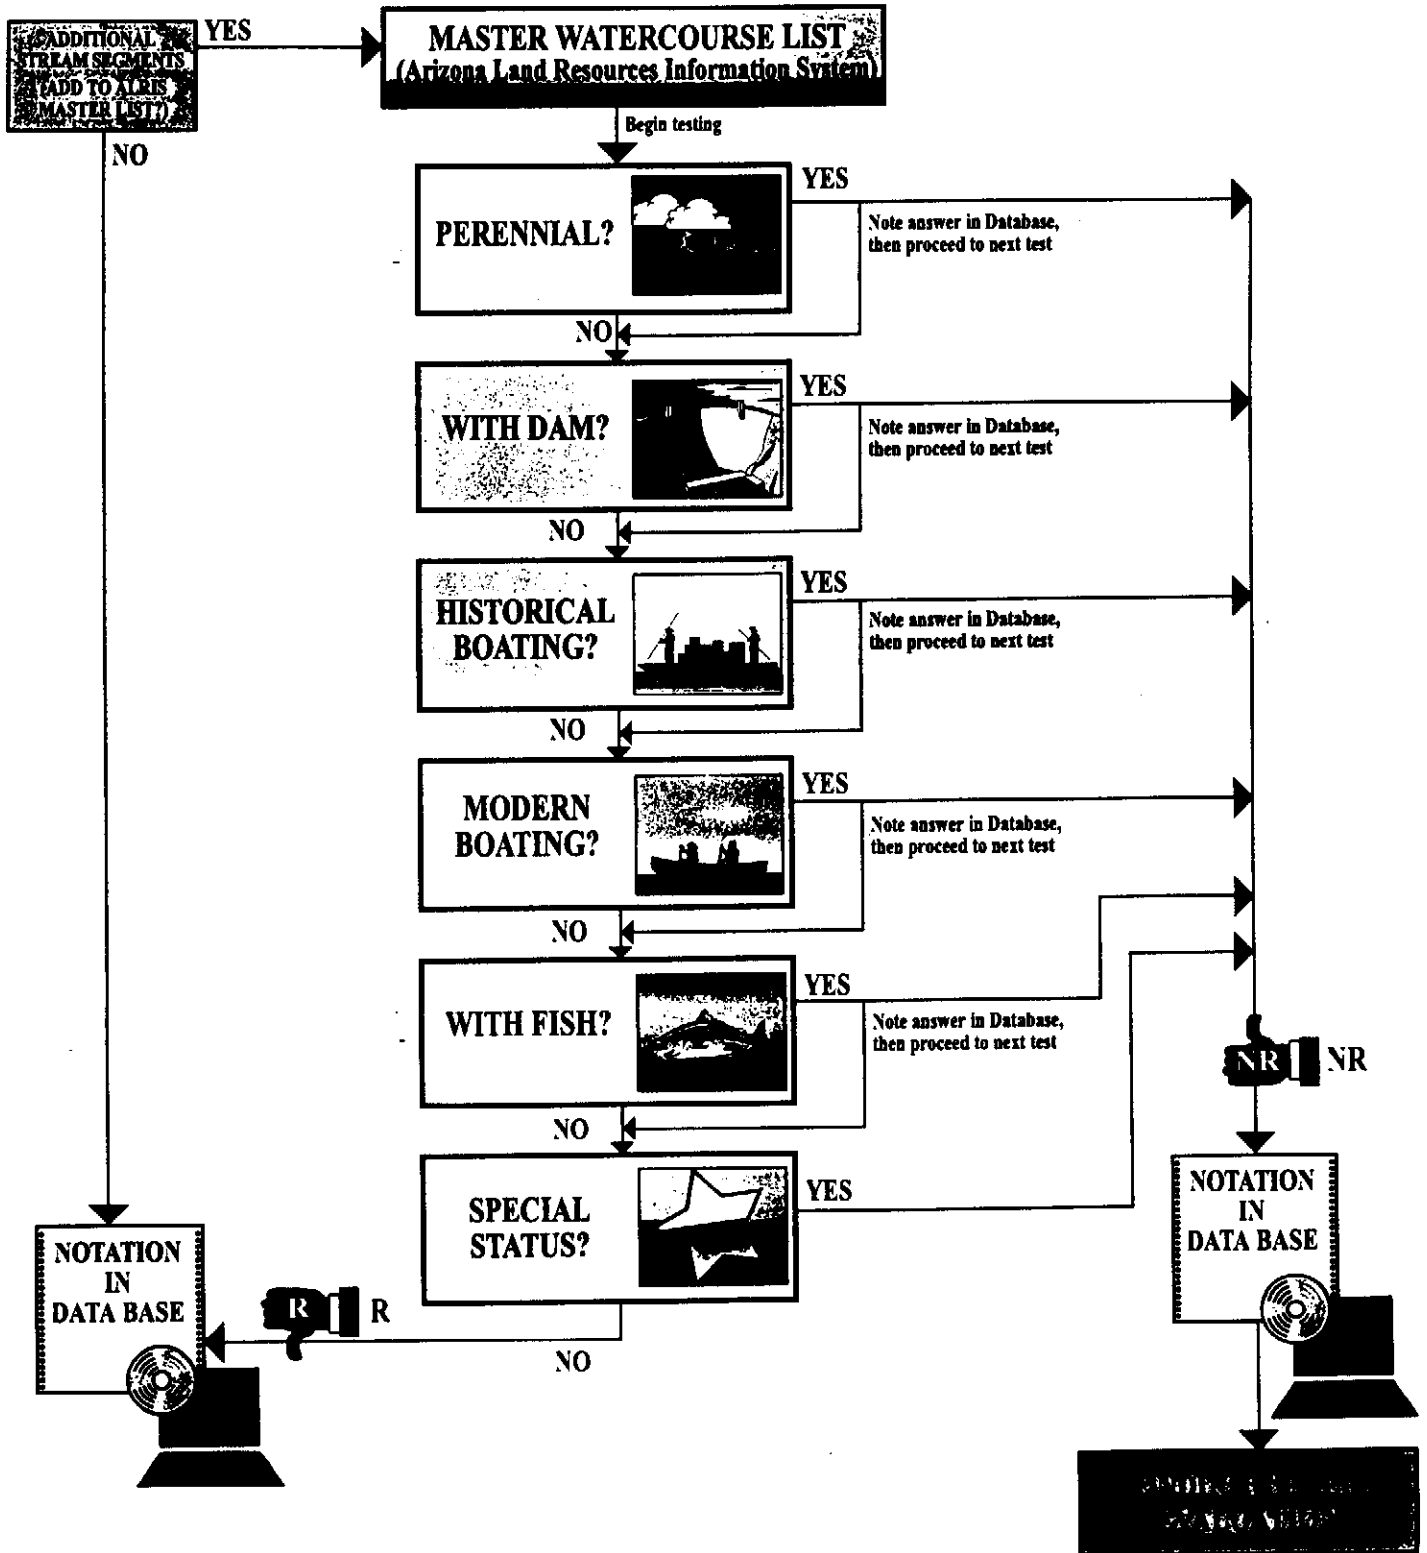
Figure 2
LEVEL 1 SCREENING PROCEDURE

A database query – a digital expression of the Level 1 screening procedure – was applied to the GIS watercourse database to sort and divide the watercourses into two resultant datasets. Watercourses testing negatively to all of the six criterion were determined most likely to be non-susceptible to navigation. These watercourses were rejected for further evaluation and analysis under the multi-level watercourse evaluation system and comprise the Rejected Level 1 (RL1) dataset. Watercourses that tested affirmatively to at least one of the criterion proceed to qualitative analysis at Level 2 and comprise the Not-Rejected Level 1 (NRL1) dataset. Section 3.1 of this report presents more detailed information regarding the methodology utilized in Level 1 evaluation.

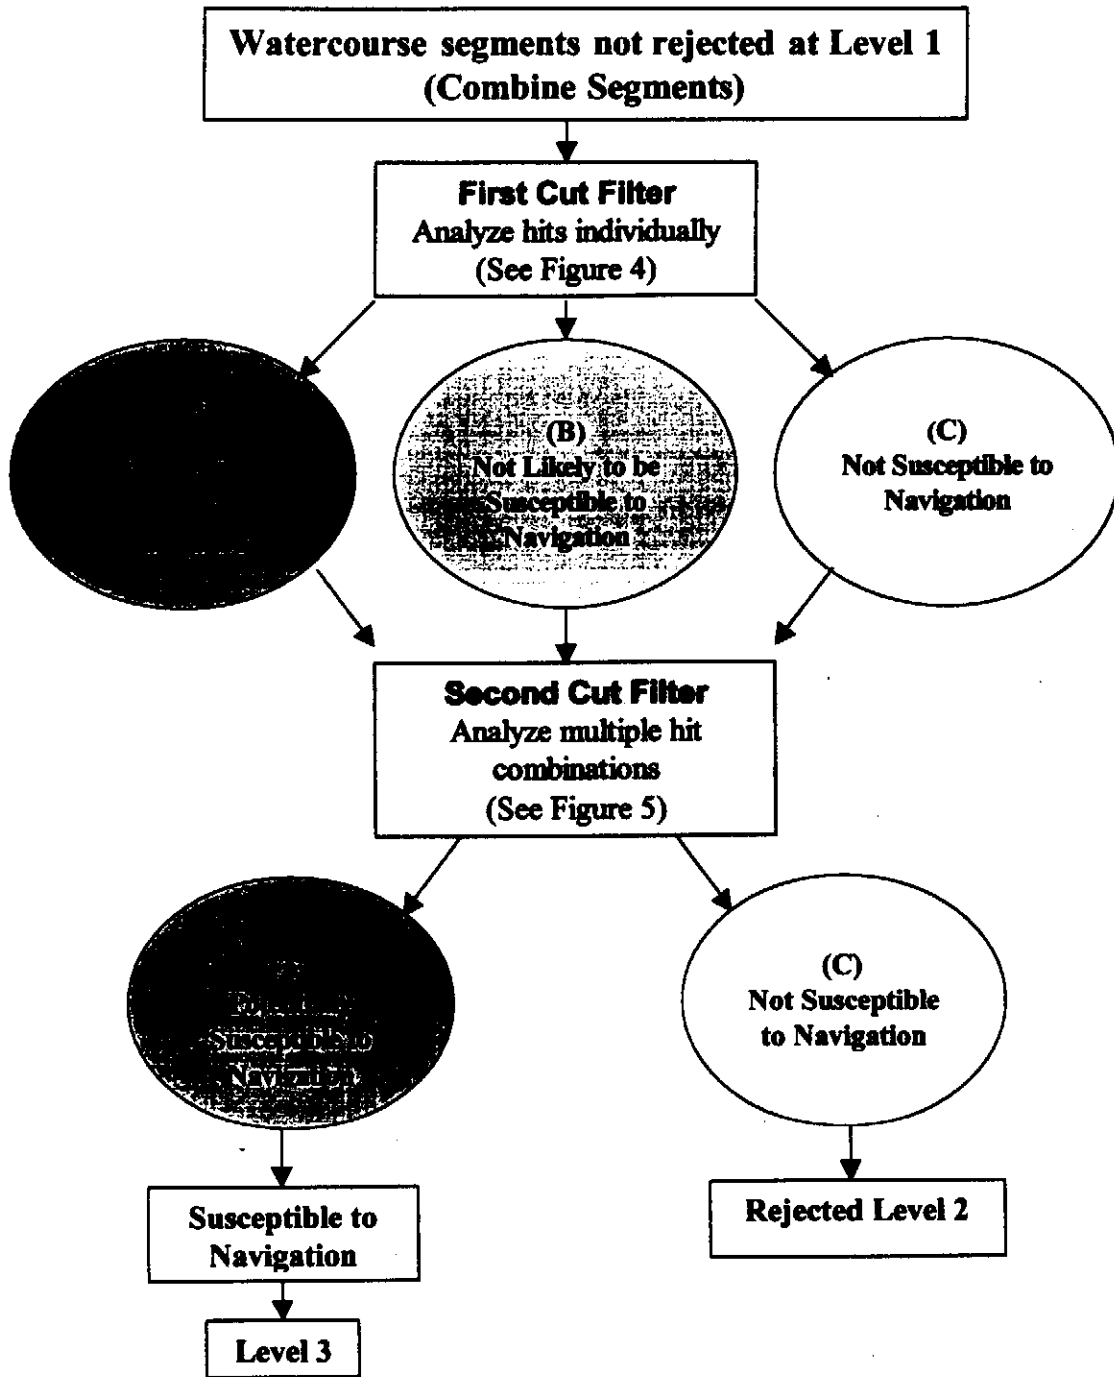
Figure 3
LEVEL 2 SCREENING – CONCEPT

The Level 2 method of approach is more qualitative than the binary data queries employed at Level 1. Level 2 assessment involves the qualitative review of watercourse location, typical watershed characteristics, typical watercourse characteristics, among other features, for verification and interpretation of the reason(s), which caused them to advance from Level 1. In concept, the recommended Level 2 methodology involves the further assessment of those watercourse characteristics that tested positively at Level 1 in two parts as shown in Figure 3 and briefly described below:

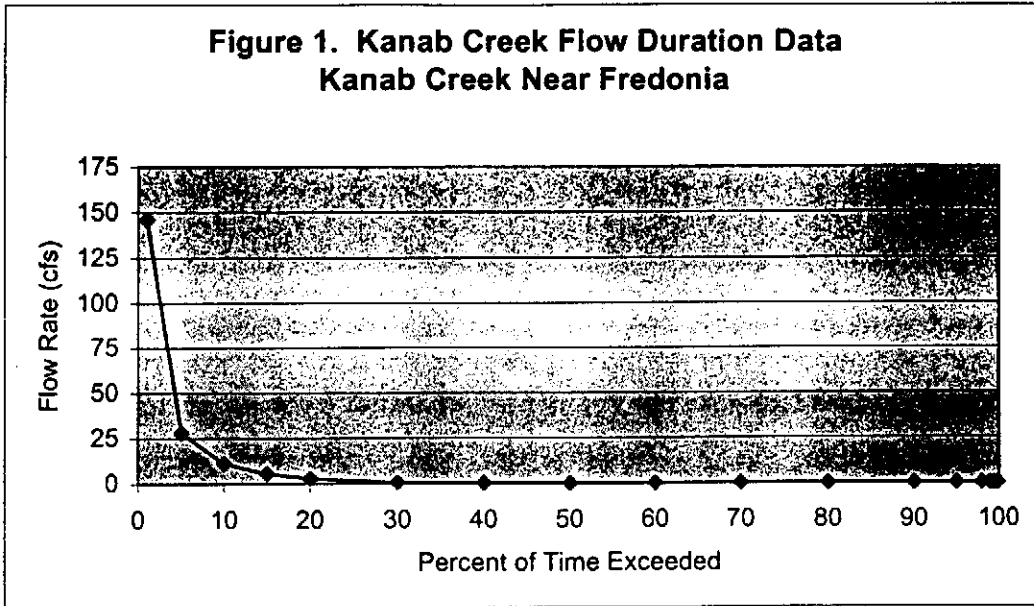
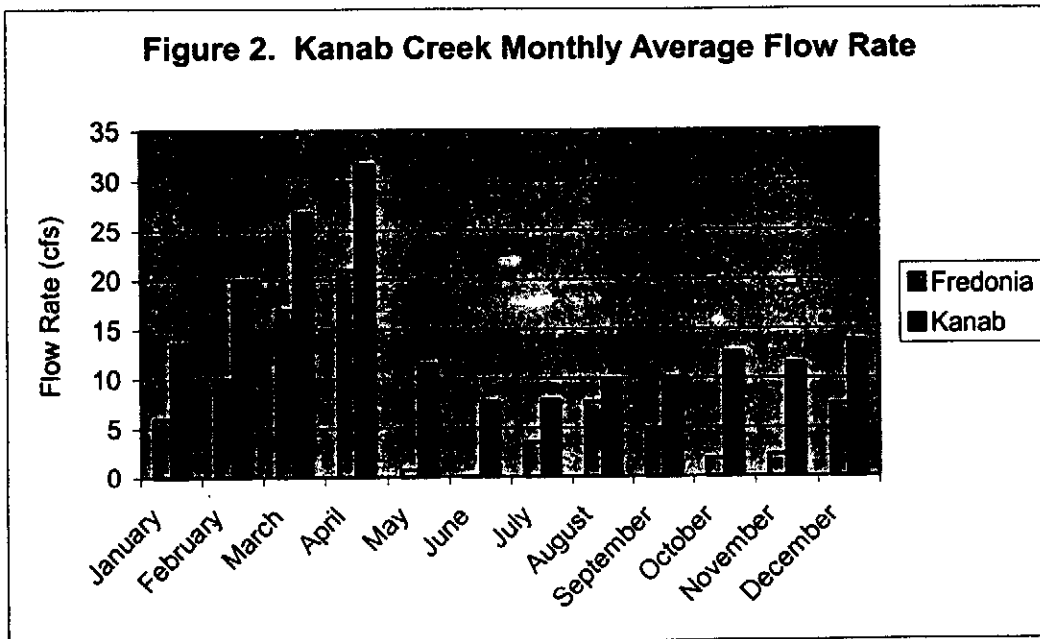
The flow data summarized above indicate that the lower reach of Kanab Creek is not perennial at the USGS gage near Fredonia, with zero flow about 50 percent of the time. Upstream near Kanab, monthly average flow rates confirm published descriptions of perennial flow, although no flow duration data were readily available. Diversion and groundwater pumping probably deplete surface runoff supplies from Kanab Creek near Fredonia. Higher periods of flow occur in late winter and early spring during snowmelt, with

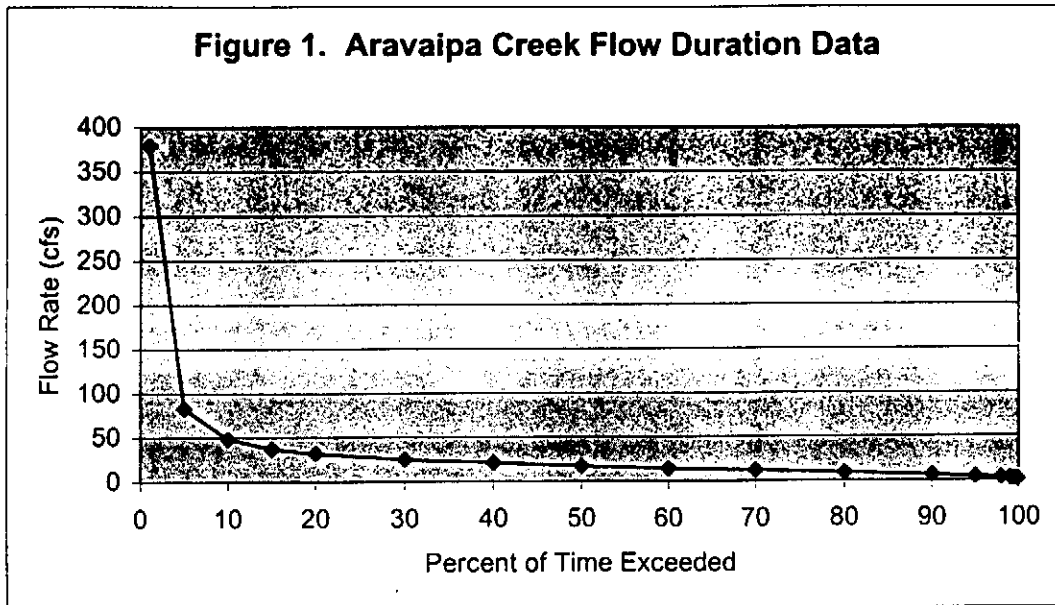
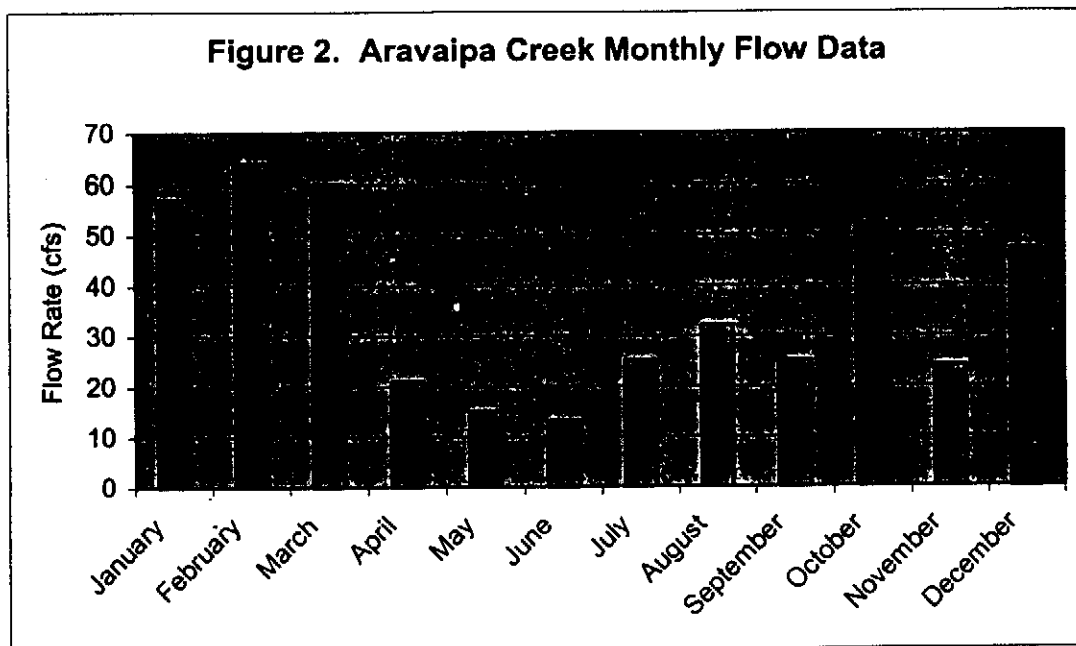
The flow data summarized above confirm that Aravaipa Creek is perennial, and that flow rates average 50-60 cfs between January and March each year. The average annual flow rate is 36 cfs, although the median flow rate (50% duration) is only 17 cfs. The flow data reported above generally applies to the lower and middle reaches of Aravaipa Creek. These data do not apply to the upper reach, which is not perennial and typically has a dry streambed.

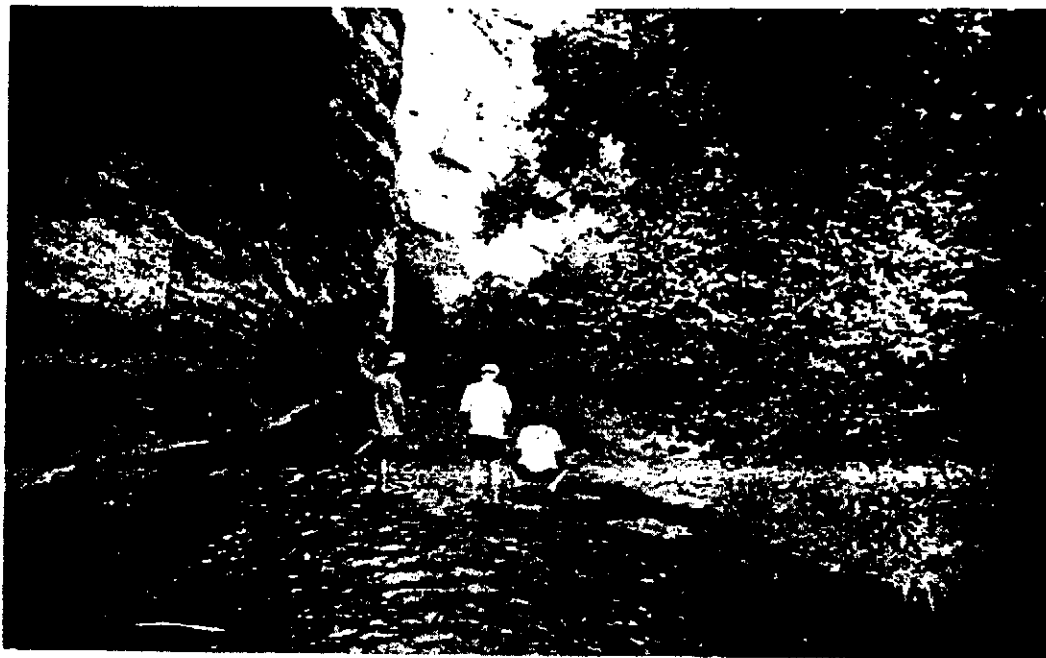
Photograph #1

Aravaipa Creek above Turkey Creek (Canyon Reach) at approximately 17 cfs on July 2, 1999.

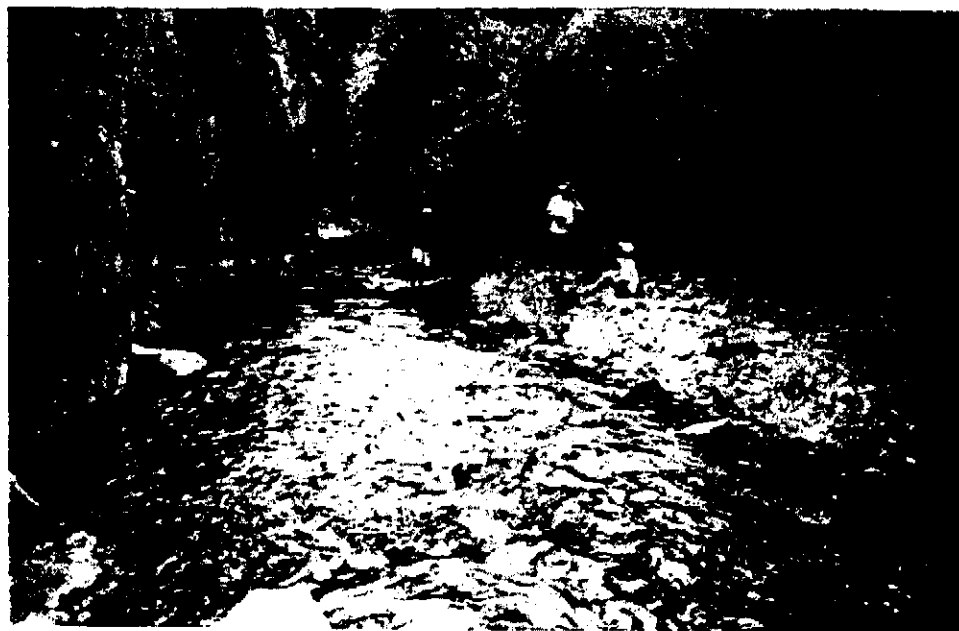
Photograph #2

Aravaipa Creek below Painted Cave Creek (Canyon Reach) at approximately 17 cfs on July 5, 1999.

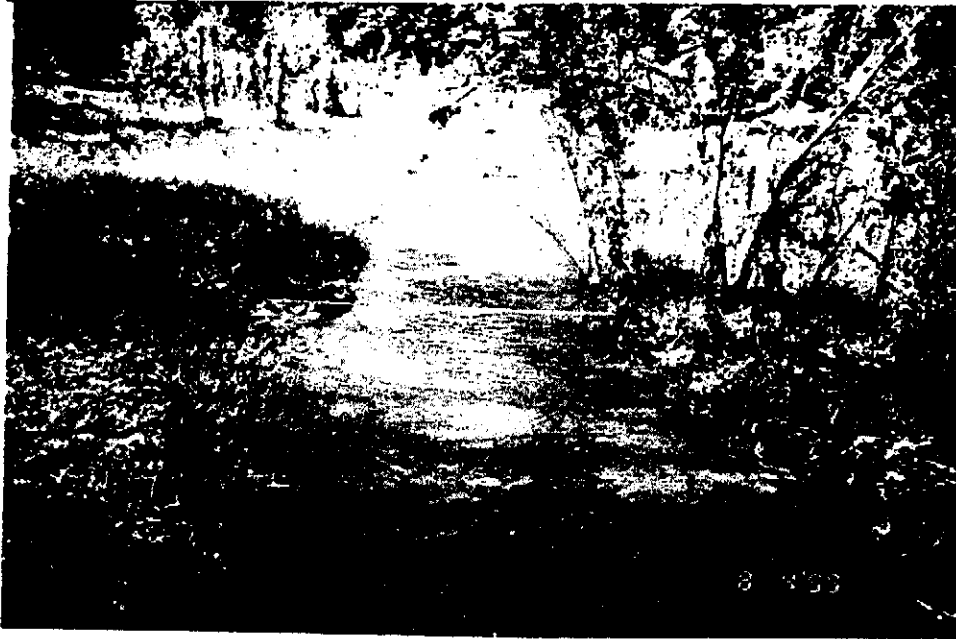
Photograph #1

Pinal Creek at Inspiration Dam near Globe, at approximately 8 cfs on August 4, 1999 (Lower Reach).

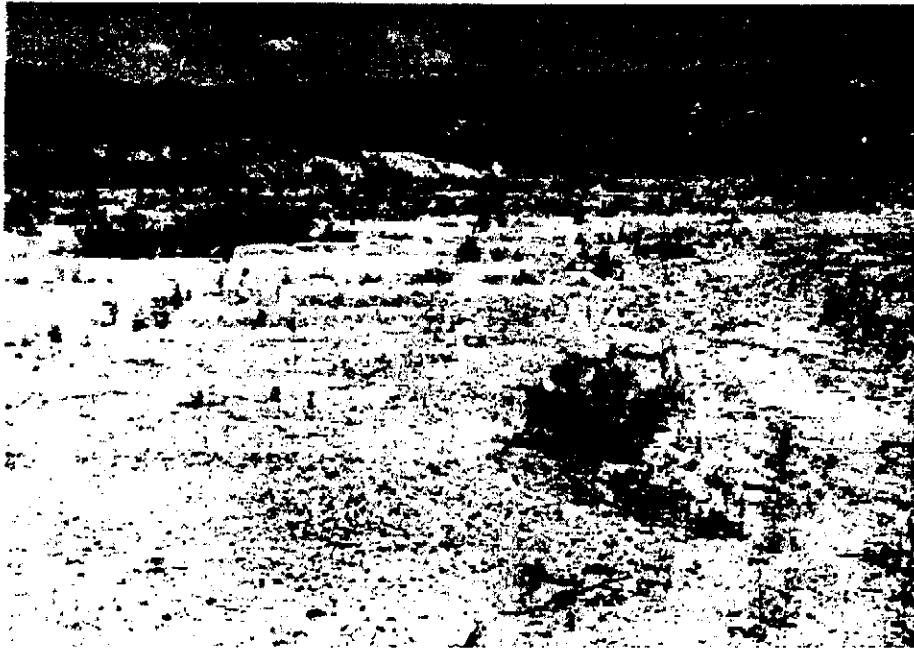
Photograph #2

Pinal Creek upstream of Wilbanks Drive Bridge below Miami Wash at 0 cfs on July 15, 1998 (Upper Reach).
